Construction Defect Litigation from the Plaintiff Perspective

Construction Defect Litigation from the Plaintiff Perspective is a series of case studies in successful planning, analysis and execution of expert work on behalf of plaintiff real property owners. This program will walk you through the process, standards and reasoning for inspection, analysis, testing, reporting, specifying repairs, and estimating costs of the repair work.

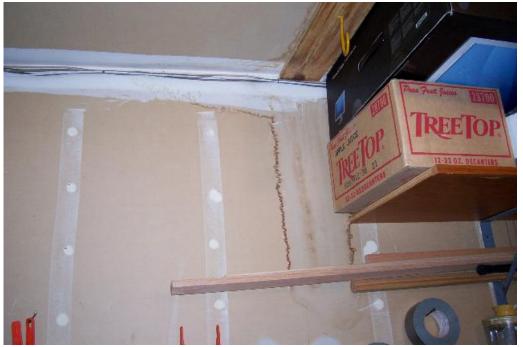
PF 01.325 PF 01- 325.jpg Garage: unit C garage - water damage at ceiling and walls. Lots of water per owner.

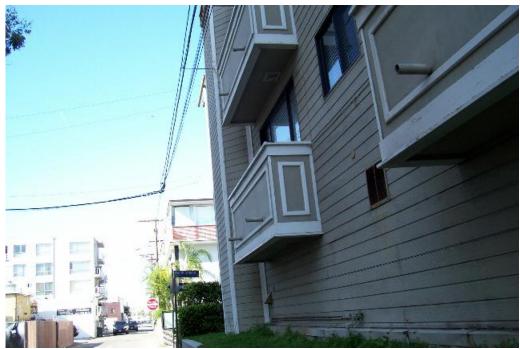
PF 01.342 PF 01- 342.jpg

Right elevation: trim at planter on level 2 with deteriorated trim.

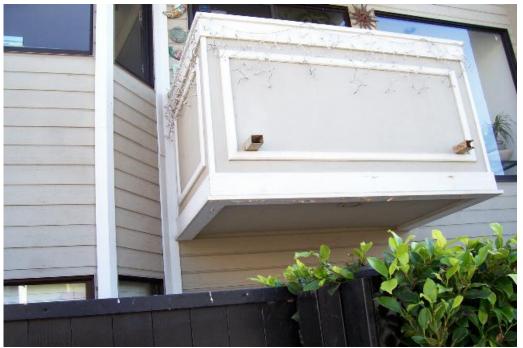
PF 01.348 PF 01- 348.jpg

Front elevation: trim on level 2 deck on left in poor condition.

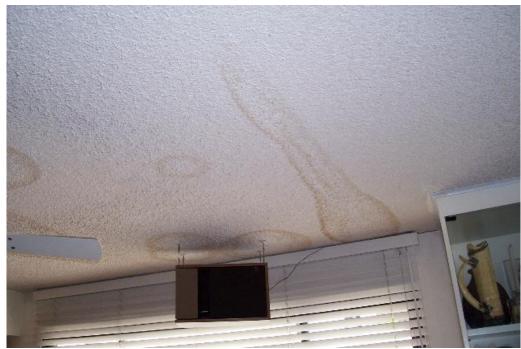
PF 01.070 PF 01- 070.jpg Unit C dining room: Ceiling stains surrounding ceiling fan and above speaker. The floor is concrete.

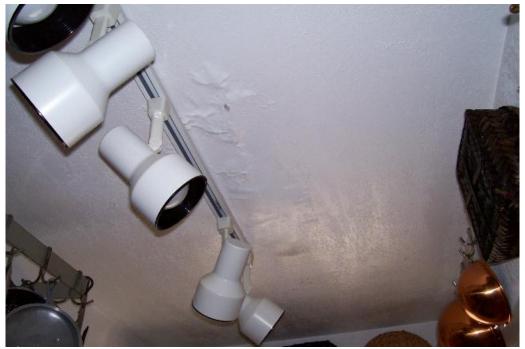
PF 01.083 PF 01- 083.jpg Unit C kitchen: Ceiling damage.

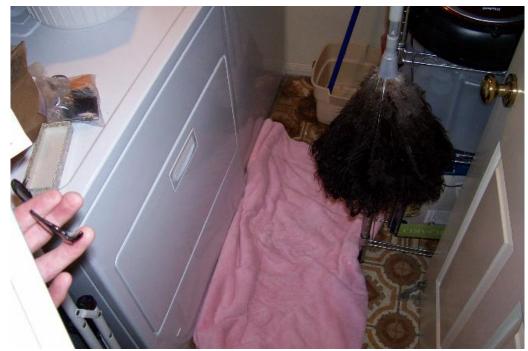
PF 01.162 PF 01- 162.jpg

Unit C laundry room: leaks at interior from test C. Test C water from vent - water on floor and dryer.

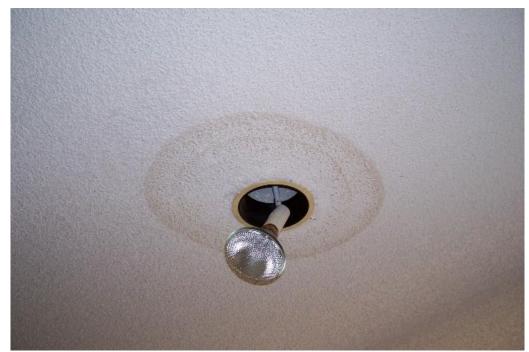
PF 01.097 PF 01- 097.jpg

Unit C bedroom #2: ceiling stain at can light in center of room, at back and front.

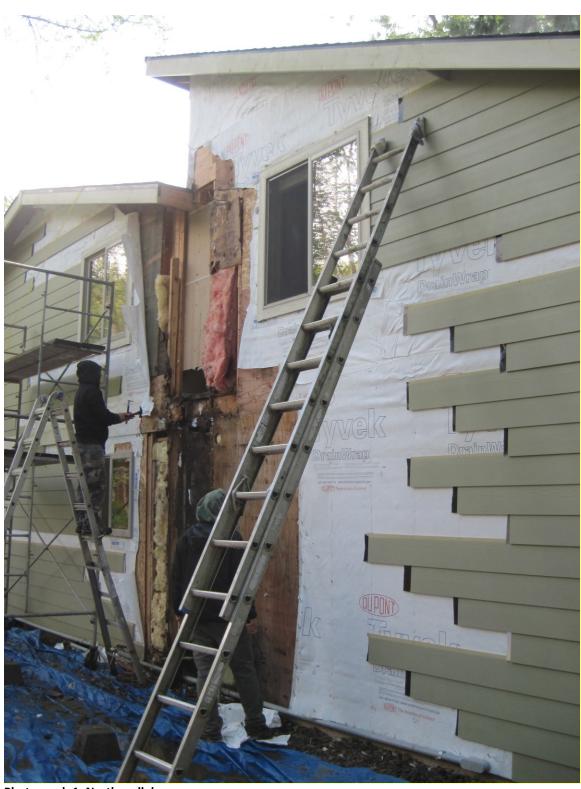
Photograph 1: North wall damage

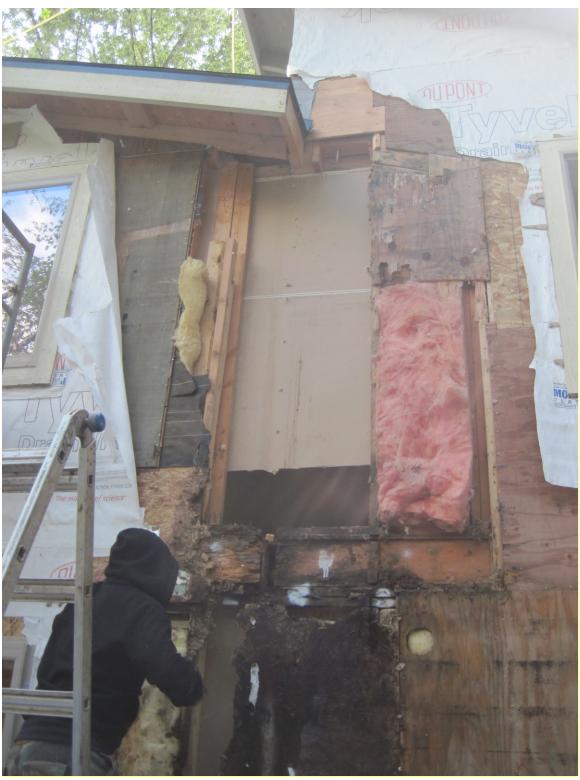
Photograph 2: North wall upper level damage

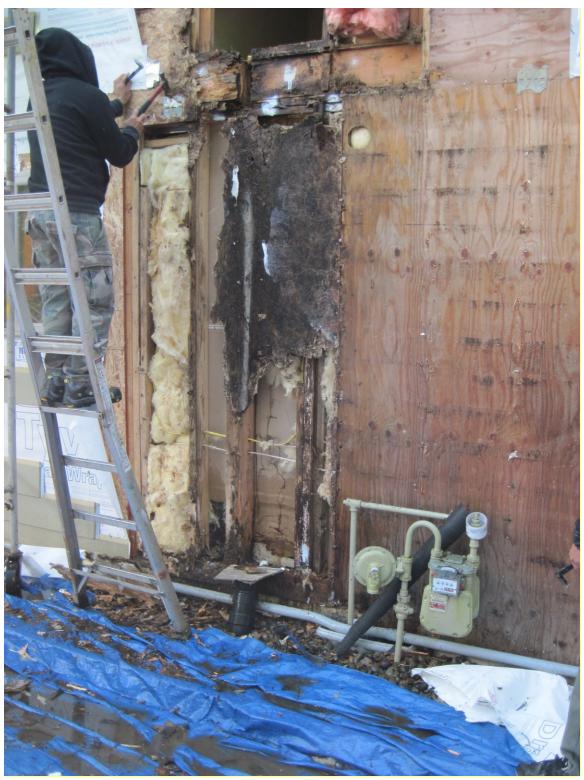
Photograph 3: North wall main level wall damage

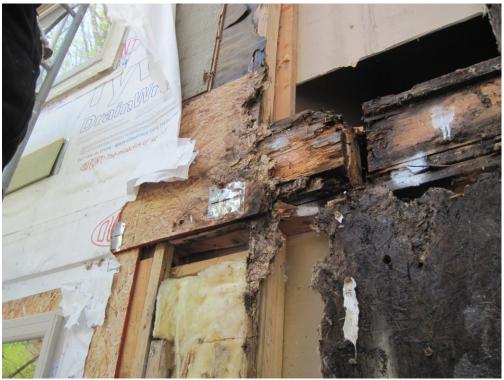
Photograph 4: North wall damage at upper level floor

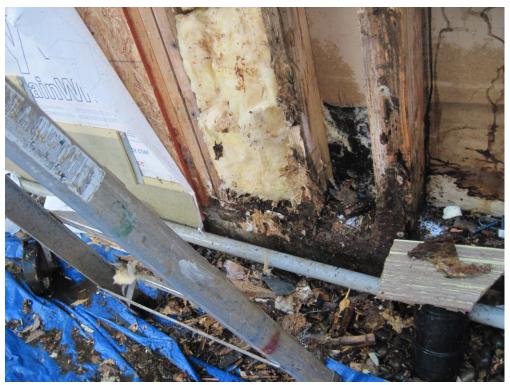
Photograph 5: North wall damage at foundation

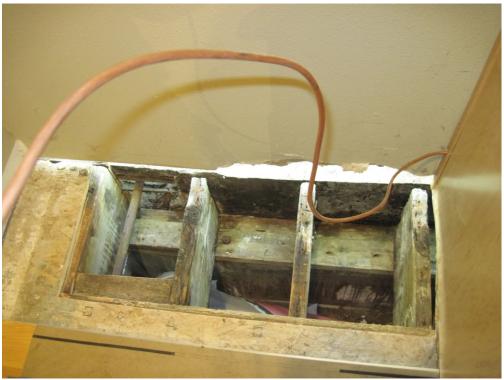
Photograph 6: Deteriorated main floor joists at north exterior wall

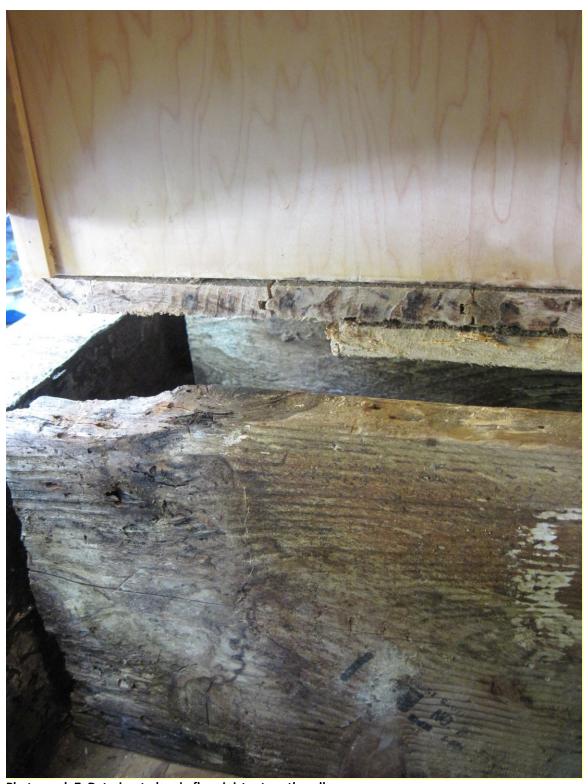
Photograph 7: Deteriorated main floor joists at north wall

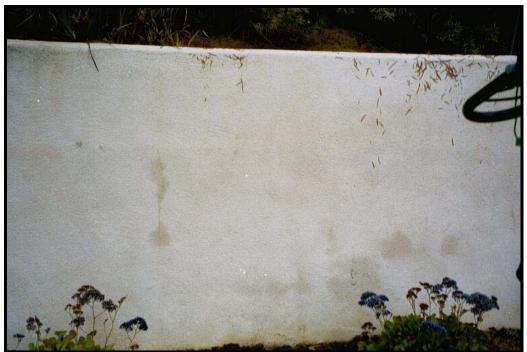
PF 10-36 -36 jpg

Retaining wall at right elevation +/- 20' from front elevation. Has wet spots and vertical hair line crack +/- 4".

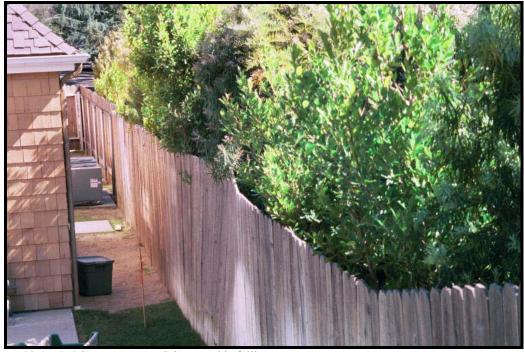
PF 03-05-053 jpg Fence undulates and is falling over.

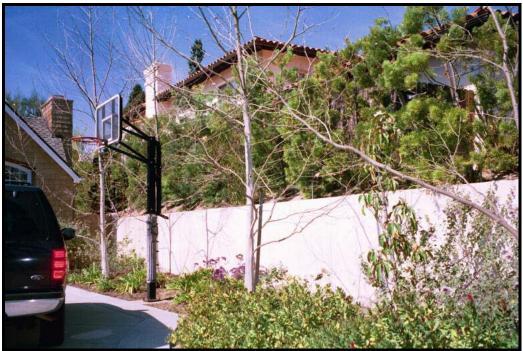
PF 01-23 -023 jpg Five to six foot retaining wall at right yard. Sprinklers on this side of wood fence are controlled by owner up hill. Sprinklers by developer.

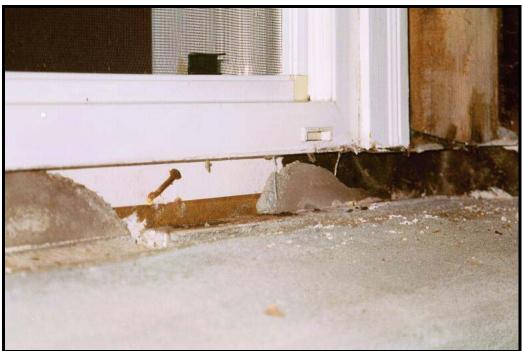
PF 09-05 077 .jpg

Below window with exterior sill removed. See diagrams A/7 and B/7. Bent, rusted nails at nail fin penetrate sisal flashing. Building paper over sisal / reverse lap. Exposed framing below mullion between two nail fins. Also see digital video.

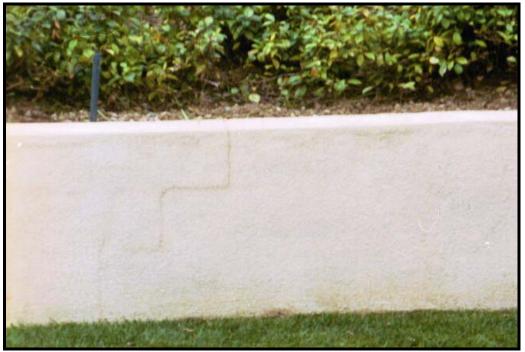
PF 10-37 -37 jpg Backyard low retaining wall has cracks at block joint in 8 locations in +/- 40'.

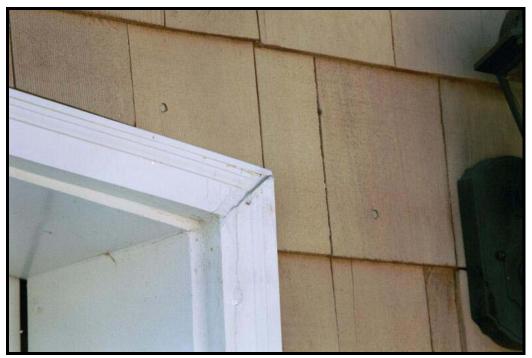
PF 01-17-017 jpg Poor workmanship at casing installation at garage doors. Sheet metal head flashing does not completely cover. Common defect at multiple locations.

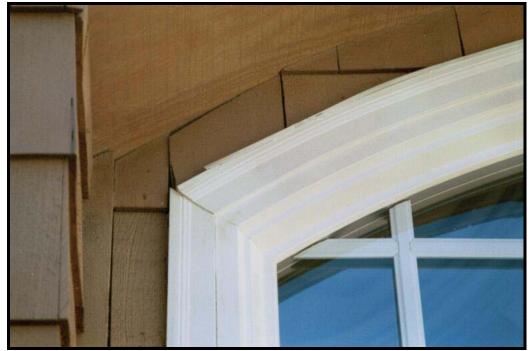
PF 01-19 -019 jpg Window trim with poor workmanship at miter joint and sheet metal flashing is greater than one inch too short. Sill trim below is buried by concrete trim above veneer.

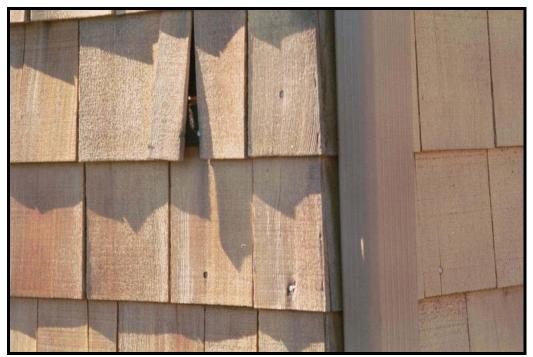
PF 01-09 -009 jpg Typical siding detail with over driven nails, stains from rusted fasteners, cracked shingles, exposed underlayment.

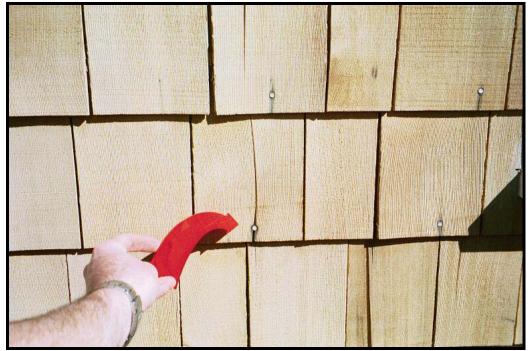
PF 06-21 021 .jpg Cracked shingle at fastener (12 each)

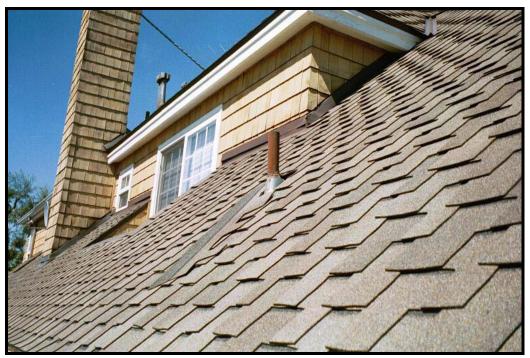
PF 07-12–036 jpg Three loose shingles at roof from left elevation.

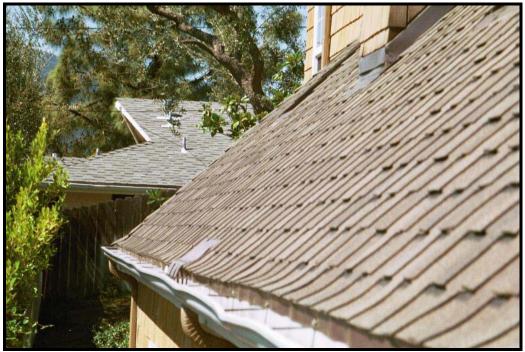
PF 07-13-037 jpg Three loose shingles at roof from left elevation.

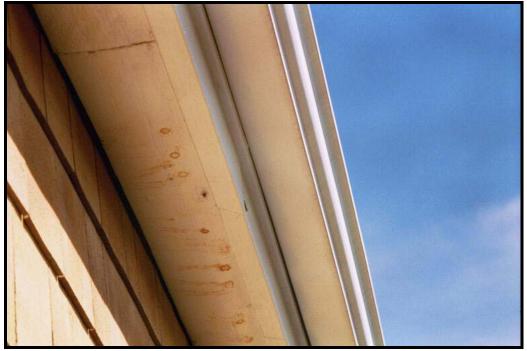
PF 03-17-065 jpg Stains at soffit. Presumably from over-shooting roof run-off.

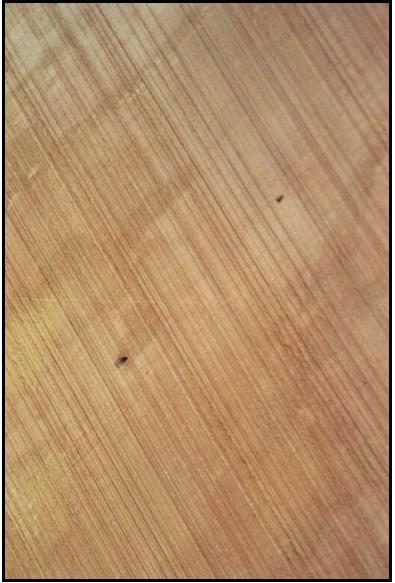
PF 02-24-048 jpg Over driven and loose finish nails - typical.

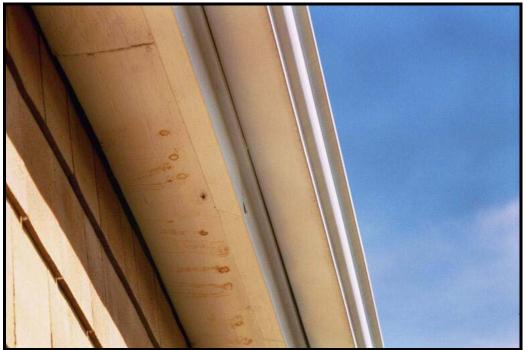
PF 03-17-065 jpg Stains at soffit. Presumably from over-shooting roof run-off.

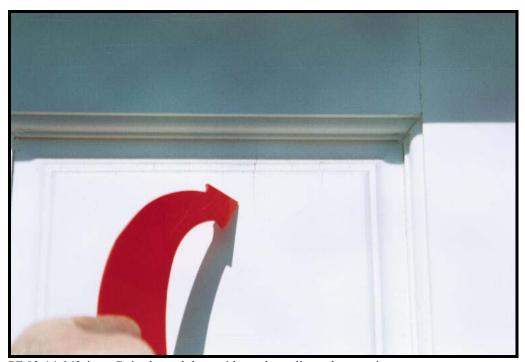
PF 03-14-062 jpg Raised panel door with cracks, splits and separation.

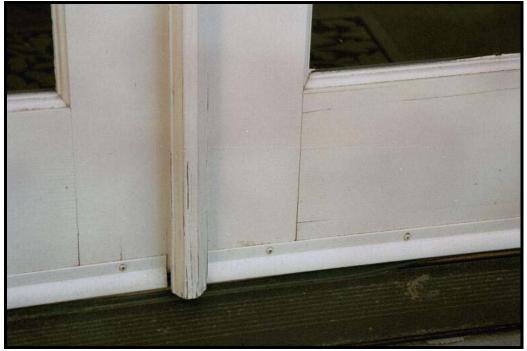
PF 02-14-038 jpg Stiles and rails are splitting at family room doors and lights.

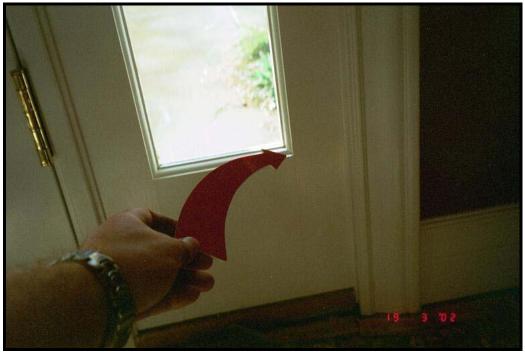
PV 04-09-172 jpg Sidelite at right water leak at lower pane at point of arrow.

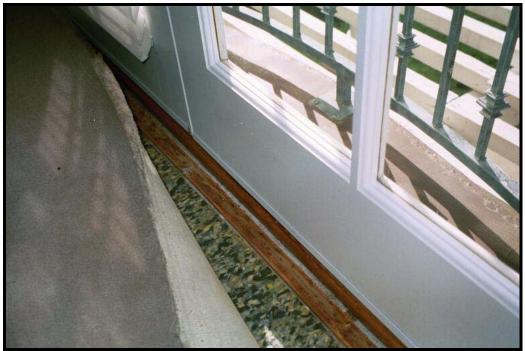
PF 05-07-103 jpg Stains at back elevation French doors.

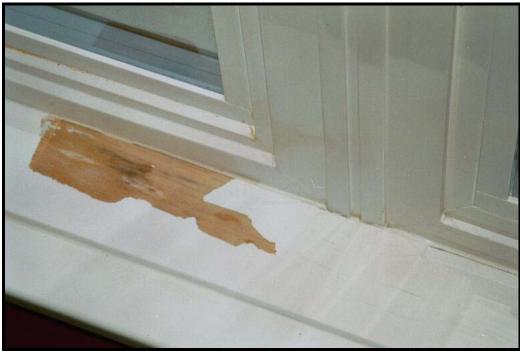
PF 04-03-075 jpg Damaged interior at living room window at front elevation.

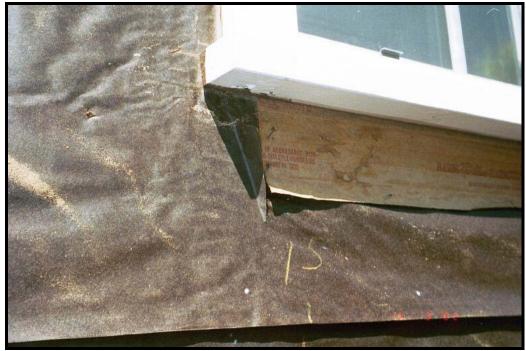
PV 03-12-150 jpg Staining at sisal kraft. Sisal kraft cut through to shear panel.

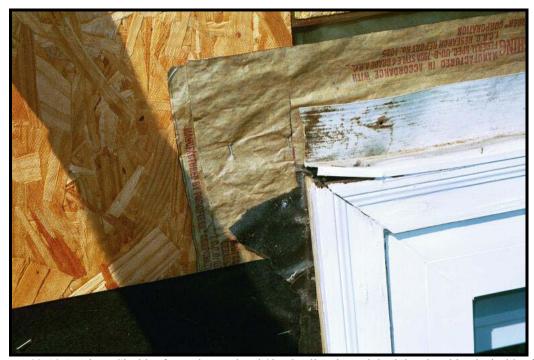
PV 03-19-157 jpg Sisal kraft cut short at head / jamb, slice through both head and jamb sisal kraft to shear panel. Sisal kraft is deteriorated.

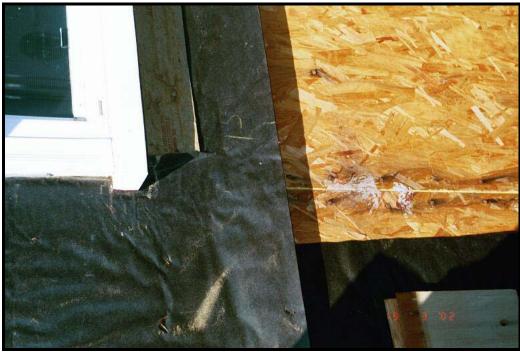
PV 03-20158 .jpg Rusted nails and staining at shear panel.

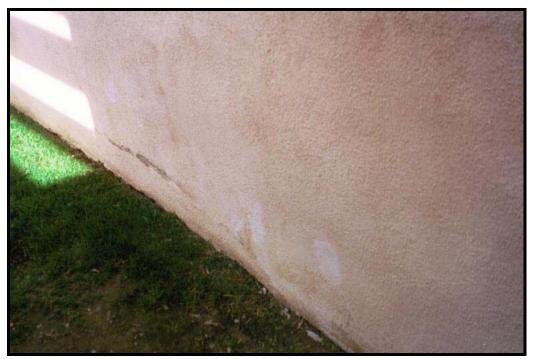
PF 02-07-031 jpg Spalling stucco and efflorescence approximately four feet wide by two feet high.

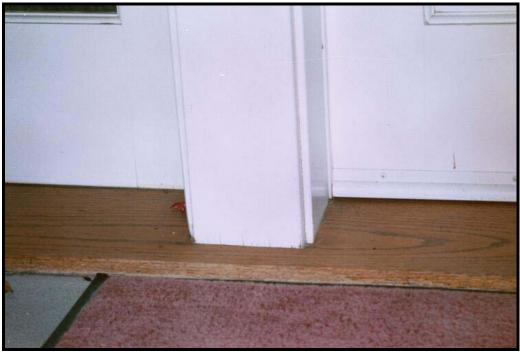
PF 01-22 jpg Styles and rails of entry door, sidelites and trim are separating (typical), end grain cracking/splitting at trim. Note there is approximately eight feet of protective overhang.

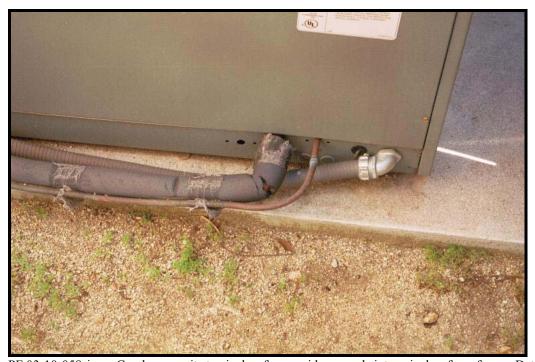
PF 03-10-058 jpg Condenser units ten inches from residence and sixteen inches from fence. Deteriorated insulation.

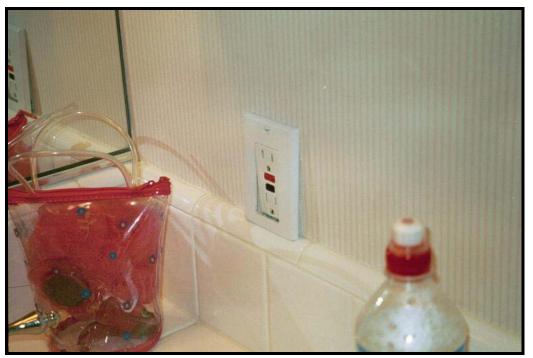
PF 05-16-112 jpg Electrical outlet at bathroom 2 is loose at sink. Requires repair.

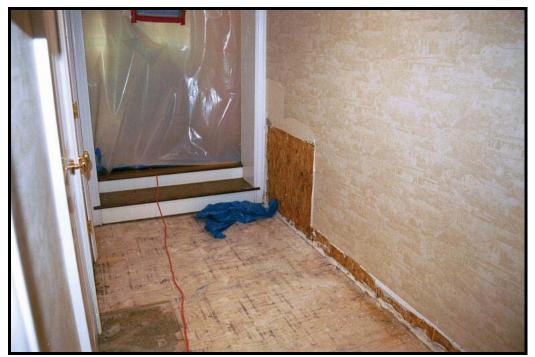
SB 03.24 JPG-95 Spots on OSB sheer panel in hall – hygienist Bancrof Thinks it maybe mold.

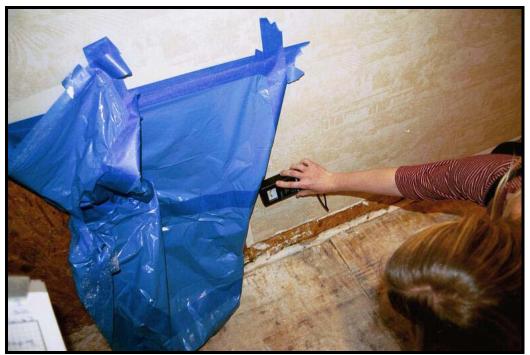
SB 03.16 JPG-87 Moisture in hall, >20% - off scale.

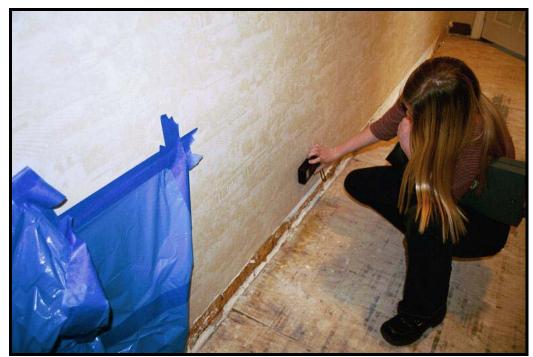
SB 03.17 JPG-88 Moisture in hall, >20% - off scale.
