# River Front Living

*100 Main St, Seattle, WA*

Date: May 12, 2014  
To: PFCS - PDX  
PFCS - PDX  
T: (503) 246-3744 E: pdxstaff@petefowler.com  
From: Pete Fowler Construction Services, Inc.  
Project: River Front Living (PFCS 14-000)  
Regarding: Property Condition Assessment  
Note: Confidential Attorney-Client and Attorney Work Product. Protected under all applicable evidence codes.

The following report conforms to ASTM (American Society for Testing and Materials) E-2018, Standard Guide for Property Condition Assessments, with the primary goal being to identify and communicate physical deficiencies for the property located at 100 Main St, Seattle, WA.

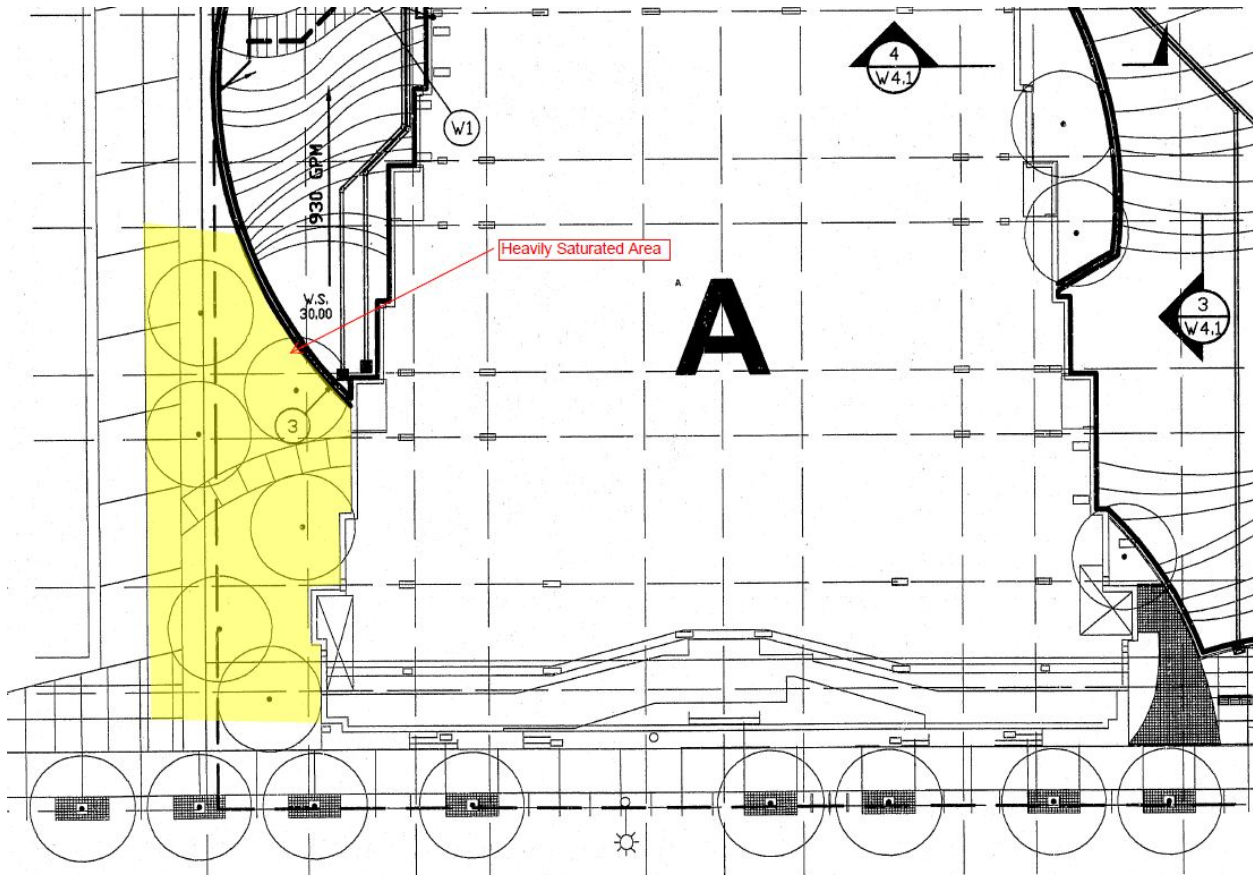
Area - Building A North Saturated Area

Issue	Inspect below grade walls for cracks and moisture.
Investigation	Visual inspections performed at P1 and P2.
Analysis	<p>Visual inspections performed of P1 and P2 levels. In general, below grade concrete assemblies are performing as intended. PFCS did not note any excessive cracks, beyond 1/8th of an inch throughout the subterranean parking levels. All concrete columns were observed to be in good condition. See conclusions for isolated conditions noted.</p> <p>PFCS Identified 3 items requiring analysis:</p> <ul style="list-style-type: none"> <li>• Item 1. Moisture intrusion at Building A - Level P2 - North Elevation</li> <li>• Item 2. Grease migration at Building A - Level P2 - West Elevation</li> <li>• Item 3. Moisture intrusion at Building B - Level P1 below interior water feature</li> </ul>
Conclusion	<p>PFCS recommends that all water intrusion conditions are considered as immediate repairs, as these become significantly more expensive, if not addressed.</p> <ul style="list-style-type: none"> <li>• Item 1. Moisture intrusion at Building A - Level P2 - North Elevation.</li> <li>• ** PFCS noted excessive saturation of soils along North elevation of building A due to excessive irrigation, and lack of drying cycles.</li> <li>• ** RECOMMENDATION: Turn down or completely turn off irrigation along North elevation of building A. This area does not have any dry time, due to its exposure and significant shading provided by the structure. Clean and eliminate efflorescence along moisture intrusion area and monitor for future performance. Once irrigation is adjusted, moisture intrusion may stop. If moisture intrusion continues, repairs may be required, such as exposing waterproofing system and termination bar at exterior, and or concrete repairs from the interior of the structure.</li> <li>• Item 2. Grease migration at Building A - Level P2 - West Elevation.</li> <li>• ** Grease migrating into concrete structure from tieback assemblies. Aesthetic condition only.</li> <li>• *** RECOMMENDATION: Clean off grease that has migrated into the concrete structure.</li> <li>• Item 3. Moisture intrusion at Building B - Level P1 below interior water feature.</li> <li>• ** Also see G2043B. Water migration through concrete directly below interior entry water feature.</li> </ul>

Conclusion (continued)	<ul style="list-style-type: none"><li><b>** RECOMMENDATION:</b> Turn off water feature and clean area of water intrusion, located within P1. Monitor condition while water feature is turned off in order to positively determine that the source is the water feature. It is likely that the water feature is the source and waterproofing repairs will be required.</li></ul>
Costs

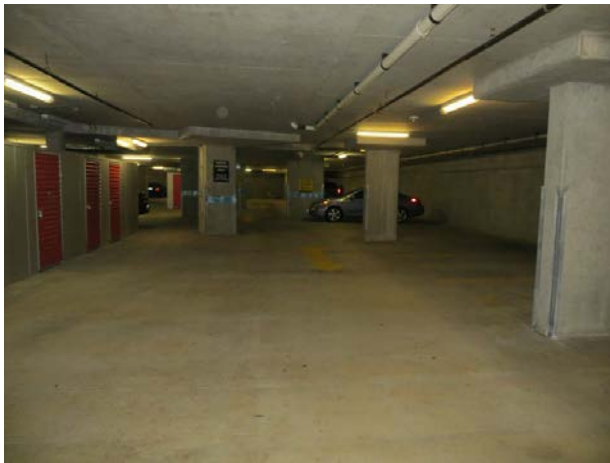
AP-01.624; 04/21/2014

Issue	Inspect concrete structure for excessive cracks and or moisture intrusion conditions.
Investigation	Visual inspections of P1 and P2 levels.
Analysis	PFCS has performed a visual inspection of parking levels P1 and P2 at both structures. In general, the overall condition of the concrete subterranean structure is in very good condition. Vehicular pathways are well marked, signage is adequate, all parking stalls are marked, and concrete appears to be free from significant cracks.
Conclusion	No repairs recommended.
Costs

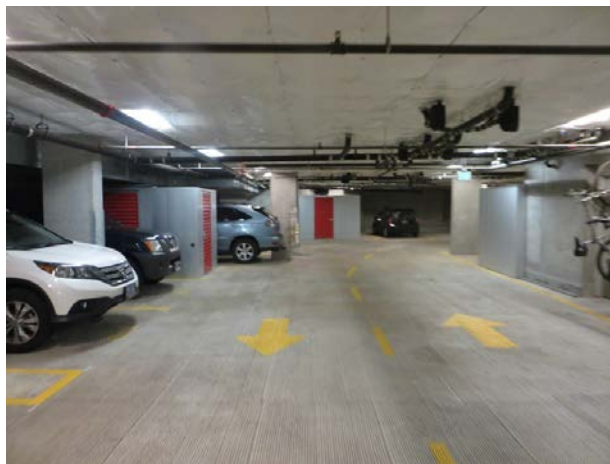
AP-01.517; 04/21/2014

Issue	Verify attachment and coverage.
Investigation	Visual inspections.
Analysis	PFCS observed insulation attached to the parking garage ceiling, under livable space. All insulation was noted to be in good condition, well attached, with good coverage.
Conclusion	No repairs required.
Costs

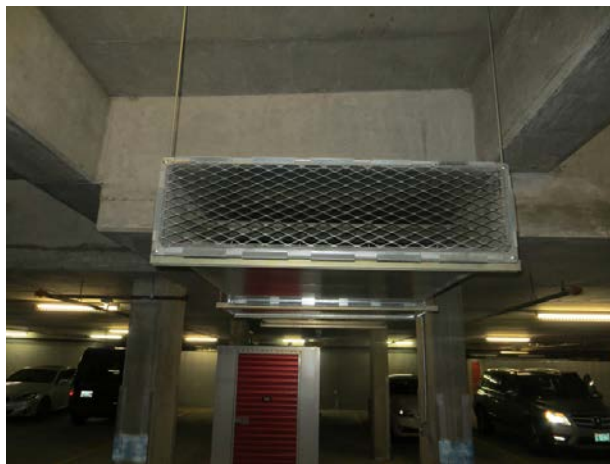
AP-01.628; 04/21/2014

Issue	Verify subterranean venting.
Investigation	Visual inspections.
Analysis	Venting was observed throughout the subterranean levels. No issues identified.
Conclusion	No repairs required.
Costs

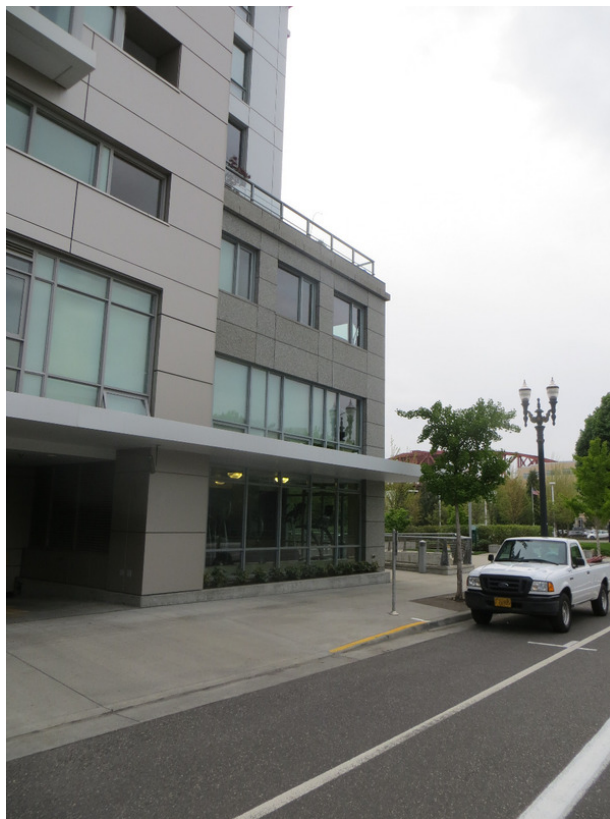
AP-01.010; 04/21/2014

Issue	Inspect for performance against weather.
Investigation	Visual inspections.
Analysis	Masonry panels were observed to be in good condition. No signs of distress throughout the property was noted by PFCS.
Conclusion	No repairs recommended.
Costs

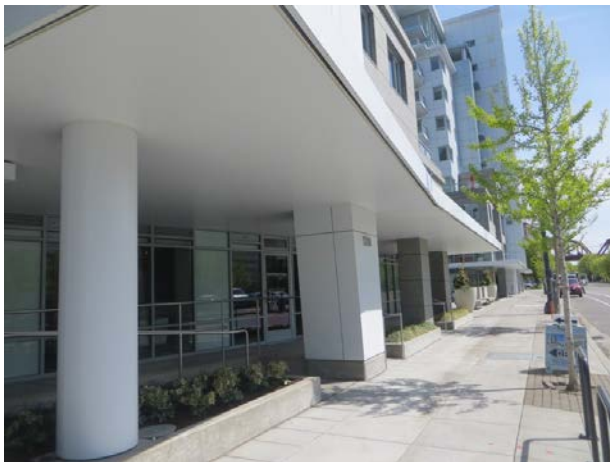
BW-01.318; 04/08/2014; Elevation Front / West

Issue	Damaged exterior soffit components, exterior gypsum ceiling.
Investigation	Visual inspection.
Analysis	PFCS has performed an exterior inspection and noted moisture damage at numerous locations of exterior gypsum soffit, located at Building A entry, and commercial areas. The source of the moisture is run off from the outside edge detail of decks. Unfortunately, the edge allows for the moisture to wick up (capillary action) onto the gypsum soffit ceiling, causing the outside edge to be damaged. Based on interviews of Jason Cunningham (on-site building engineer), this is an area that has been repaired numerous times in the past.
Conclusion	PFCS recommends a new detail to be considered for this area, in order to avoid continuous repairs. It is recommended that the HOA board consults with the original architect of record in order to consider a detail that would promote a long term solution. PFCS recommends that the detail include a gutter system to allow for the run-off to be captured without damaging the soffit ceiling, or consider a new material to be installed at the initial 18" of soffit area, such as a metal panel consistent with the architecture of the buildings, which can handle the weather exposure of the Pacific Northwest.

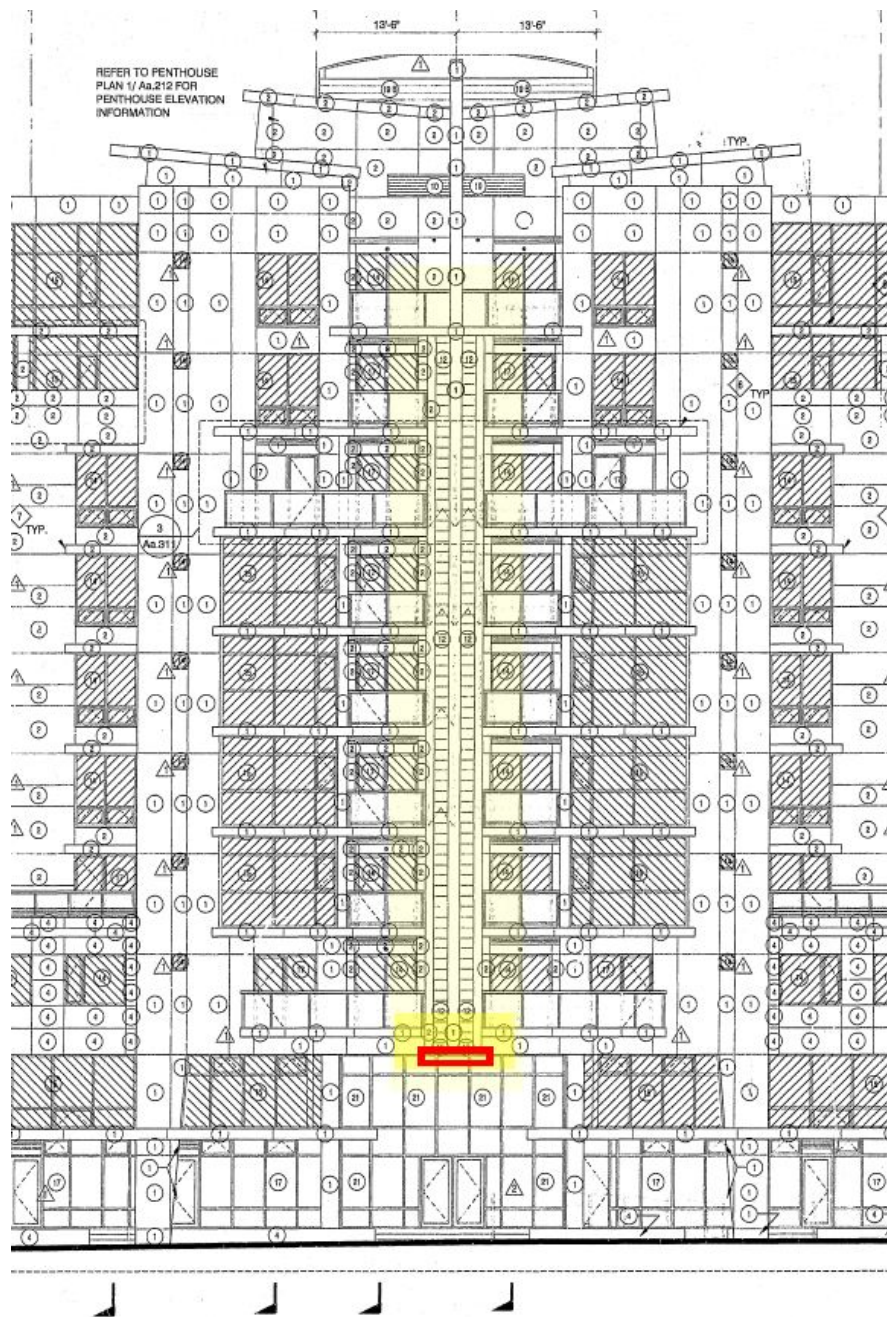
Area - Building A Entry - Panel Moisture Intrusion

Issue	Inspect for areas of possible moisture intrusion, and/or where panels are not performing as intended.
Investigation	Visual inspection of building exteriors.
Analysis	<p>PFCS performed numerous visual inspections of building exteriors. In general the metal cladding system is performing as intended, however an isolated location was identified that requires further research / investigation.</p> <p>Product: Aluminum Composite Cladding Systems  Product Description: Aluminum Composite panels, RDX- ACM Dry Joint Rainscreen System  Manufacturer: Armetco  Installer: Streimer Sheet Metal</p>
Conclusion	<p>Item 1: Further investigation required for Building A, area above entry, where moisture intrusion enters metal cladding system and water then drips onto sidewalk above entry (major pedestrian pathway to building). Water intrusion possibly right at lower unit balconies.</p> <p>Item 2: Further investigation is required for the North elevation of Building A, to the right of the man door, due to moss growth.</p>

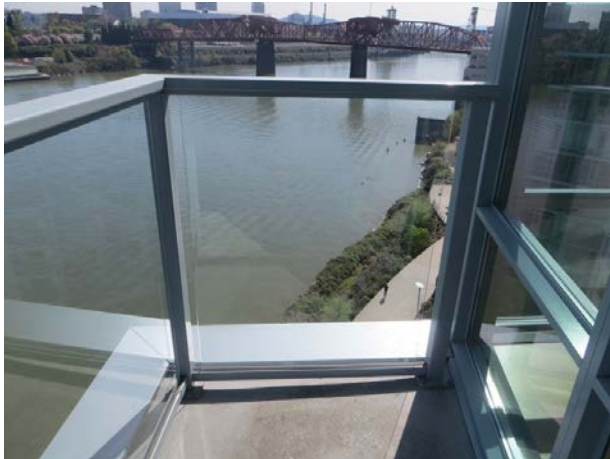
BW-01.080; 04/08/2014; Elevation Right / South

Issue	Inspect for corrosion and or breakdown of surface finish.
Investigation	Visual inspections of numerous deck assemblies and deck rail systems.
Analysis	<p>Glass view railings exist on all view balconies. Metal frames are powder coated aluminum finish. Tempered glass panels over the rail system, as per code. No issues were observed by PFCS. All finishes were noted as in good condition, with no corrosion noted.</p> <p>Product: Aluminum Series 200 top rail with base plate mounting method and decorative horizontal mid-rails.  Finish Coating: PPG Duracron S600 "Seafoam" finish  Manufacturer: Sapa Architectural Products</p>
Conclusion	No repairs required.
Costs

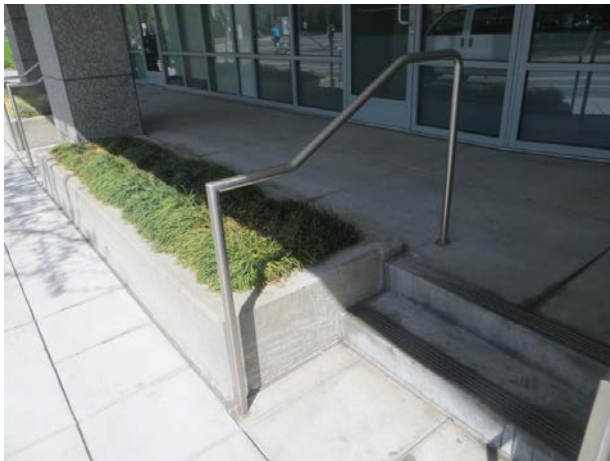
BW-01.311; 04/08/2014; Elevation Front / West,  
Elevation Left / North

Issue	Investigate finishes and structural integrity.
Investigation	Visual inspections.
Analysis	Handrails at street level, western elevations. All handrails were noted to be in good condition. None of the finishes were noted to be in distress. All handrails were solid with adequate structural integrity.
Conclusion	No repairs required.
Costs

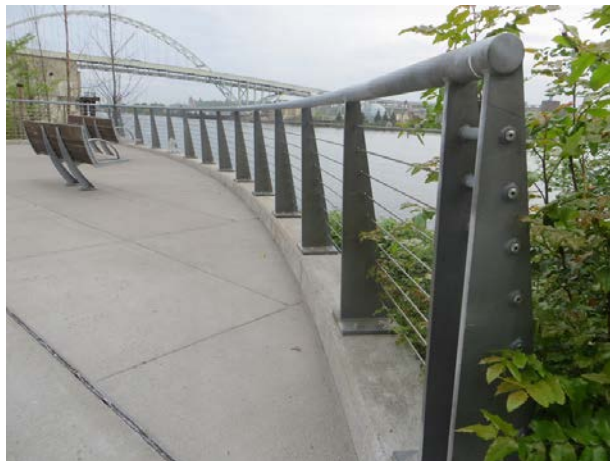
AP-01.041; 04/21/2014

Issue	Investigate finishes and structural integrity.
Investigation	Visual inspections.
Analysis	Handrails at river-walk area, eastern elevations. All handrails were noted to be in good condition. Metal handrail system with cables. All cables were noted to be present and tight. None of the finishes were noted to be in distress. All handrails were solid with adequate structural integrity.
Conclusion	No repairs recommended.
Costs

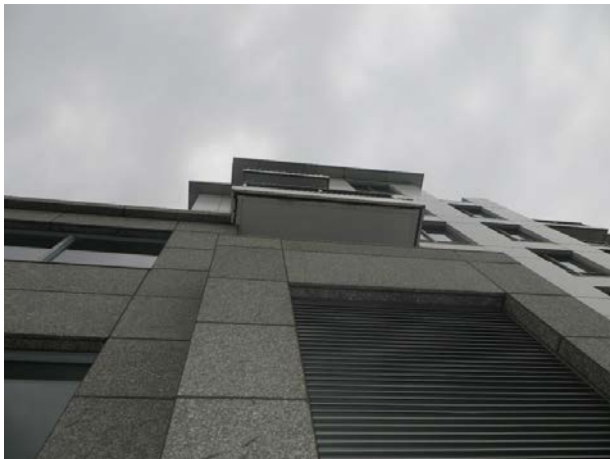
AP-01.119; 04/21/2014; Elevation Right / South

Issue	Inspect finishes for corrosion or any distress.
Investigation	Visual inspections.
Analysis	Metal louvers were observed at numerous locations, mainly associated with garage venting and mechanical rooms. All louvers were observed to be in good condition, with no corrosion noted.
Conclusion	No repairs recommended.
Costs

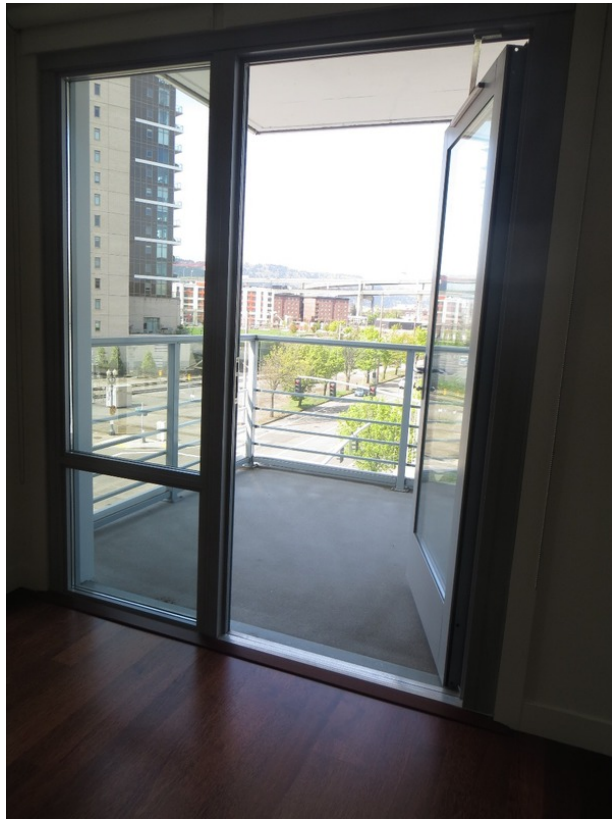
**BW-01.261; 04/08/2014; Building Interiors,  
Elevation Front / West**

Issue	Inspect for sealant failures or glazing failures.
Investigation	Visual inspections.
Analysis	<p>PFCS performed visual inspections of the common and residential units, where accessible throughout our inspections. The windows are AAMA certified (see inspection photographs), and manufactured in Canada by Starline Windows. All caulking around windows was observed to be in good condition. All glazing seals were observed to be performing with no failed units noted throughout. Per interview with Jason Cunningham (on-site building engineer) and Sean Rogers (property manager), there have been no reported leaks at windows throughout the history of the project.</p> <p>Product Manufacturer: Starline Architectural Windows  Series 9000 - Double Glazed Window Wall  Series 9502 - Double Glazed Swing Door  Series 9503 - Triple Glazed Swing Door  Product Description: Thermally broken 4 1/2" aluminum casement / fixed window with seismic jambs</p>

Conclusion	No repairs recommended. PFCS recommends inspections of sealant joints at windows, once a year.
Costs

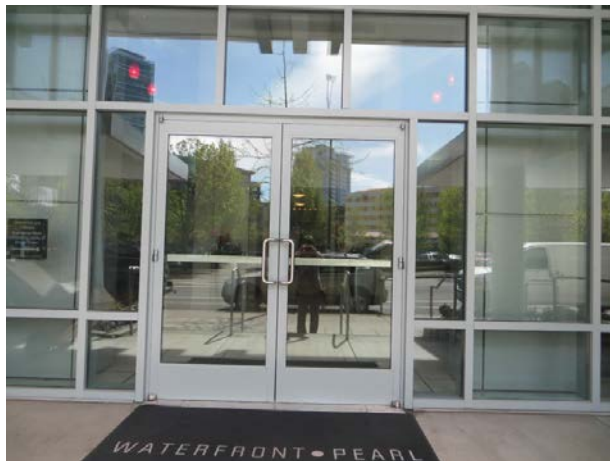
BW-01.368; 04/08/2014; Elevation Front / West

Issue	Inspect for sealant failures and operational status.
Investigation	Visual inspections.
Analysis	PFCS performed visual inspections of common area doors throughout the buildings. The main entry doors were observed to be well covered, where the building was providing good protection of the main entries. All doors and hardware were noted as operational with no issues. All finishes were noted as in good condition with no immediate maintenance required.
Conclusion	No repairs recommended.
Costs

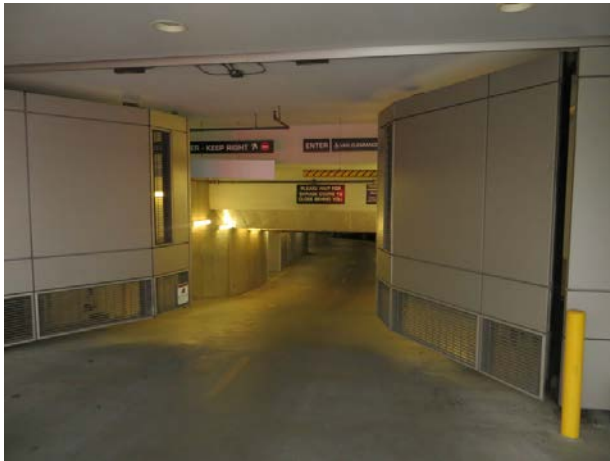
AP-01.126; 04/21/2014

Issue	Inspect operational status and finishes.
Investigation	Visual inspection.
Analysis	Garage doors were observed to be functioning as intended, with frequent use, due to only one entrance into subterranean garage structure. Door was observed to open with ease, once activated by an approaching car. A dent was noted from the exterior (aesthetic item), with no immediate need for repairs. Opener motor was noted to be by Chamberlain Elite and serviced by Metro Security Access Control Company.
Conclusion	No repairs required.
Costs

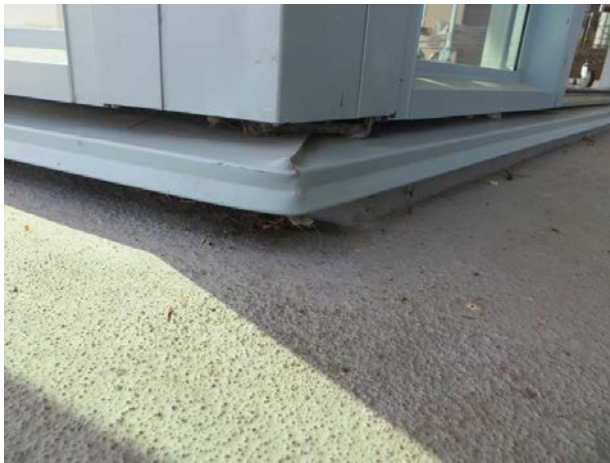
BW-01.085; 04/08/2014; Elevation Right / South

Issue	Identify and inspect product transitions and associated sealant joints.
Investigation	Visual inspections.
Analysis	PFCS inspected wall flashing details, as available throughout numerous inspections. Flashing details were observed at product transitions and generally observed in areas where required by code and industry standards. Based on interviews, no water intrusion events have been noted throughout the buildings.
Conclusion	No repairs required.
Costs

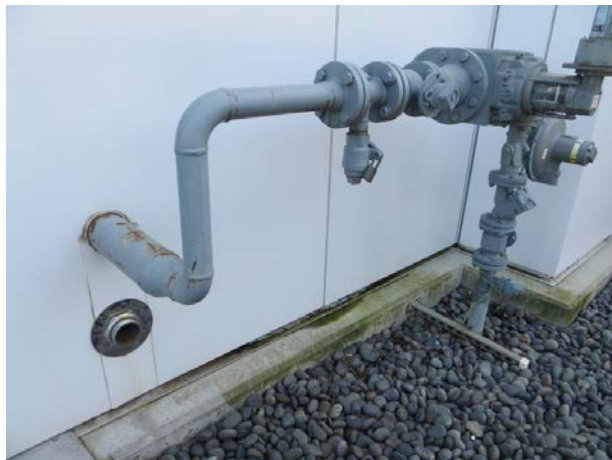
BW-01.355; 04/08/2014; Elevation Left / North

Issue	Inspect sealant joints for performance.
Investigation	Visual inspections.
Analysis	Sealant joints were noted to be in fair to good condition. Sealant joints are of commercial grade, with a backer rod system, adequately supporting them. Annual inspections required in order to assure performance and to identify a replacement time frame.
Conclusion	<ul style="list-style-type: none"><li>Isolated repair required at Building A - north elevation natural gas entry.</li><li>In general, the sealant joints observed are performing well in service</li><li>PFCS recommends inspections of sealant joints at windows, once a year.</li></ul>
Costs

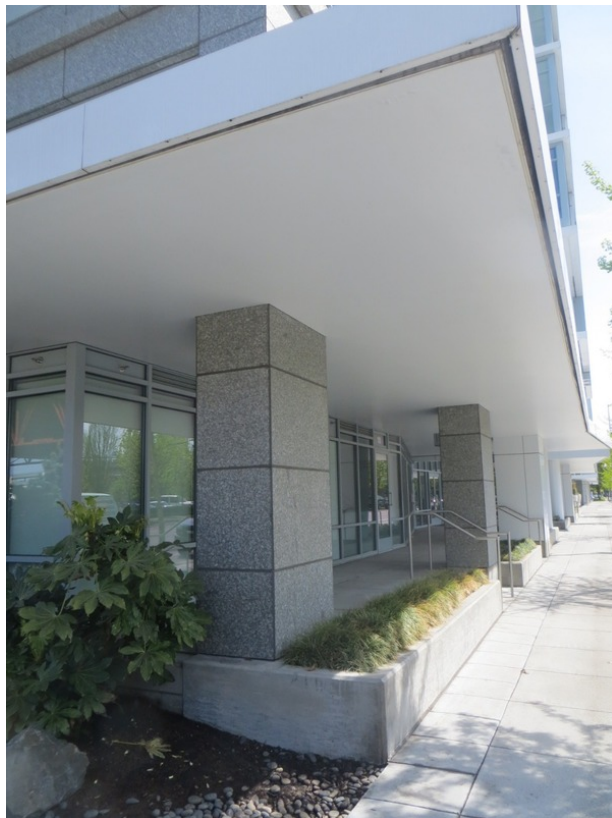
BW-01.294; 04/08/2014; Elevation Front / West,  
Elevation Left / North

Issue	Inspect exterior envelope and site components for corrosion or failing finish surfaces.
Investigation	Visual inspections.
Analysis	Most products delivered to the project, during the original construction were pre-finished in the factory. Current observations did not indicate any products experiencing corrosion or a failing finished surface condition. Bubbling paint was observed at Building A soffit area, see element B2010 for further details and repair recommendations.
Conclusion	No repairs required.
Costs

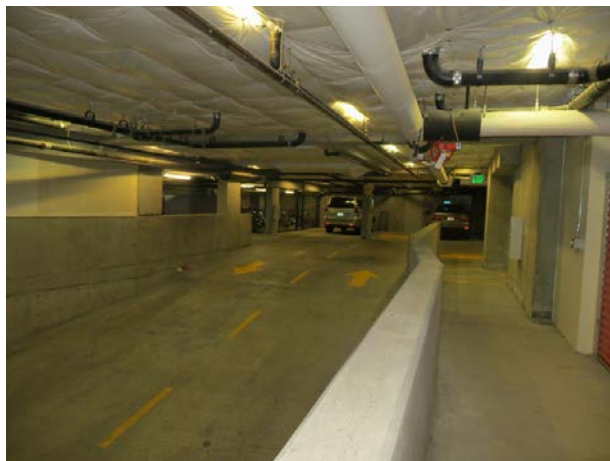
AP-01.523; 04/21/2014

Issue	Inspect signage and reflectivity of striping at concrete.
Investigation	Visual inspection
Analysis	Visual inspections.
Conclusion	PFCS performed a visual inspection of levels P1 and P2. Concrete paint striping was reflected and all parking stalls, directional paint, and in general was in good condition.
Costs	No repairs recommended.

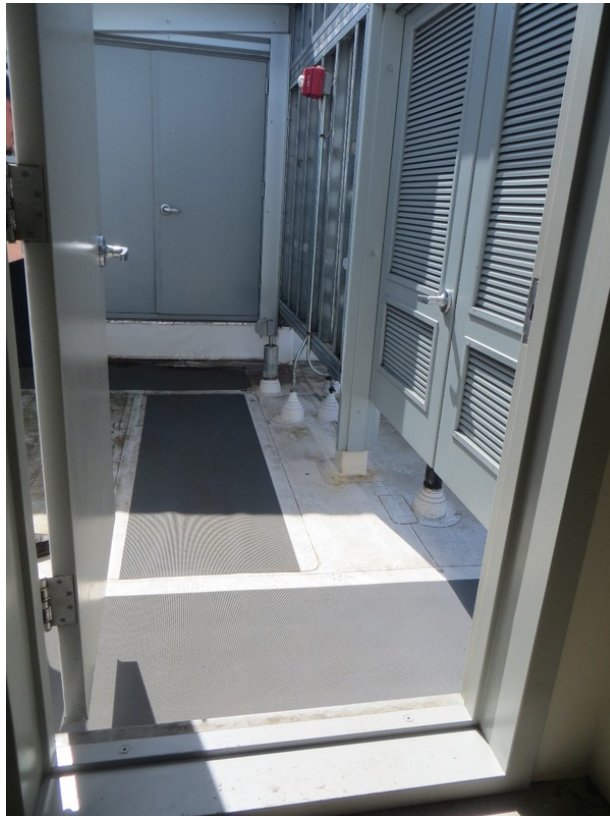
BW-01.373; 04/08/2014; Roof

Issue	Inspect for structural integrity, corrosion, and loose connections.
Investigation	Visual inspections.
Analysis	PFCS observed the wind screens to be in good condition. None were identified as in distress, loose, or any signs of corrosion. The main purpose of the panels is to block and enclose the mechanical equipment, located at the roof level of each building.  Product: Aluminum panels, attached to metal framing
Conclusion	No repairs required
Costs

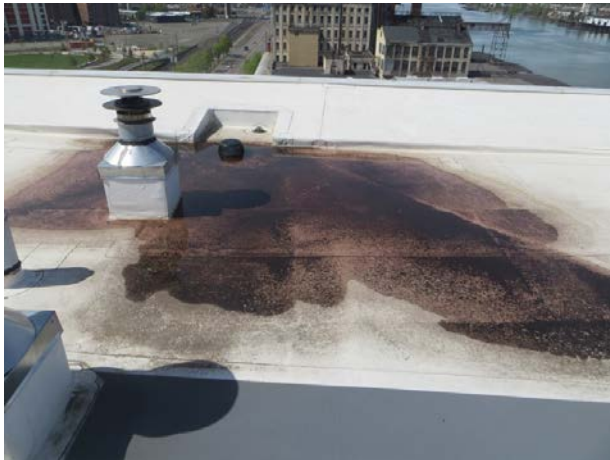
BW-01.381; 04/08/2014; Elevation Left / North

Issue	Visual inspection for standing water, seams, and overall condition of roof membrane.
Investigation	Visual inspection.
Analysis	<p>In general, the overall condition of the roof membrane is good. Seams and detailing at corners and penetrations are performing well, and none were observed to be loose nor are there signs of delamination. Some areas of standing water were noted at Building A. Although the manufacturer warranty is not impacted, standing water can lead to premature deterioration of the membrane. Per interviews conducted of Jason Cuninghame (on-site building engineer), the roof is being inspected twice per year, and therefore in compliance with the manufacturer warranty language.</p> <p>Product: Membrane roof system Manufacturer: Carlisle Coating &amp; Waterproofing</p> <p>Previous repairs were noted at the roof top mechanical room, where the pipe structural brackets were installed through the roof assembly and were not properly sealed. Stains at gypsum ceiling are not from an active leak, as repairs were completed, as per Jason. No action required.</p>

Conclusion	No repairs required. Continue semi annual inspections of the roof membrane.
Costs

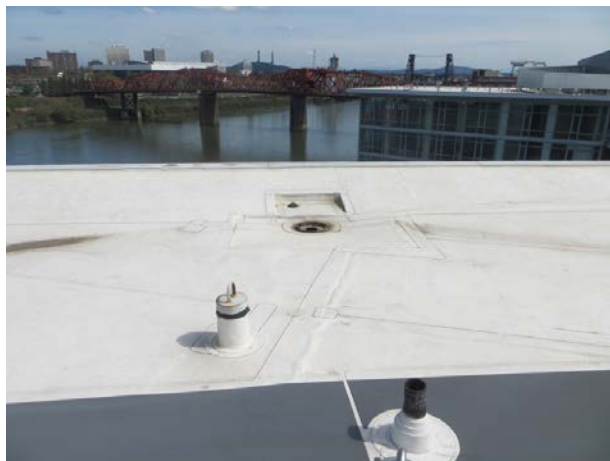
**BW-01.397; 04/08/2014; Elevation Back / East, Elevation Right / South**

Issue	Inspect roof drain covers / ponding conditions / debris
Investigation	Visual inspections.
Analysis	PFCS inspected both roof assemblies. In general the roofing membrane is performing as intended, however some ponding of water was observed at the roof drains. All drains were free of debris. Isolated roof drain cap was noted as missing at Building A.
Conclusion	Isolated repair required. Install a roof drain cap at Building A roof drain.
Costs

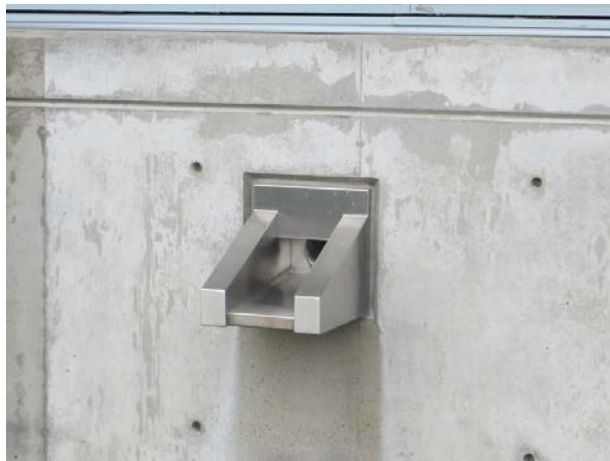
AP-01.056; 04/21/2014

Issue	Inspect downspout assemblies.
Investigation	Visual inspection from a distance.
Analysis	PFCS did not observe any downspout discharges to be in distress. The downspouts, which are integral and within the building cavity, were only inspected at the discharge locations, located at the exterior pond feature.
Conclusion	No repairs required.
Costs

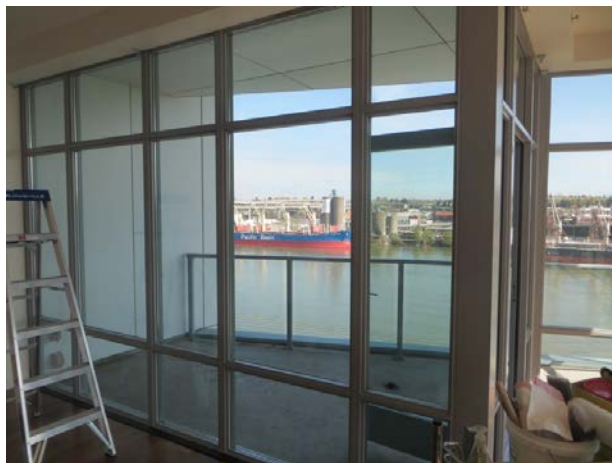
BW-01.073; 04/08/2014; Building Interiors

Issue	Inspect surface conditions, membrane conditions, slope, and outside edge condition.
Investigation	Visual inspections and review of Horizon Restoration balcony / deck review report.
Analysis	In general, the waterproof membrane assembly are in fair to good condition. Most balconies are well protected by the balcony above, therefore we anticipate overall good performance and life cycle of waterproof membrane. It is crucial that all pots placed onto the waterproofing surface have isolation pads and standing water is not promoted by excessive watering of plants. Elevated cantilever balconies are designed to drain to the exterior and it is crucial that the outside edge detail is maintained and kept debris free. The exterior aluminum panel detail, covering the outside edge of the balcony tends to promote moss growth and a constant wet condition, which sometimes allows moisture to migrate into the concrete edge and over time may cause damage. Maintenance of this condition is highly recommended.

Conclusion	Create a maintenance plan to keep the outside edge free from any debris and moss. Any future waterproofing efforts need to include the outside edge, and the underside of the outside edge detail.
Costs

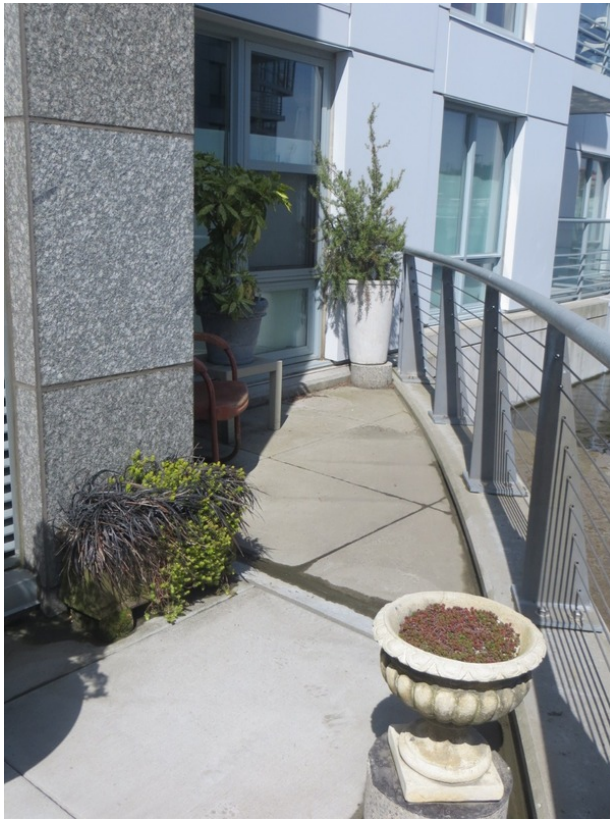
**BW-01.323; 04/08/2014; Elevation Front / West,  
Elevation Right / South**

Issue	Inspect waterproofing membrane and drainage at decks over livable space.
Investigation	Visual inspections.
Analysis	<p>PFCS has inspected numerous deck locations, that are directly over livable space below. In general, these areas are performing well. However, regular maintenance will be required. It is strongly recommended that all pots placed onto the waterproofing surface have isolation pads and standing water is avoided by excessive watering of plants. Some decks were noted with ponding water stains, and occupants should do their best to eliminate any standing water via maintenance. All drain assemblies must be maintained and unit owners need to keep them free of debris.</p> <p>Although elastomeric waterproof deck coating membrane manufacturers claim recoating is required every 2-5 years (pfcs.co/dq2u), they generally have a service life of between 5-12 years, depending on exposure and use. The HOA should maintain budgets to accommodate for an additional membrane, due at estimated time of replacement.</p> <p>There are 2 items that need to be addressed:</p> <ul style="list-style-type: none"> <li>Item 1: Building B - unit 905 has had previously identified excessive water ponding, and PFCS recommends that a reasonable repair approach to re-slope the finish coating should be planned and executed. It is not recommended that a more aggressive repair approach, that requiring concrete work, will be required.</li> <li>Item 2: Building A - Antique Store Patio, excessive moisture from above deck. Further investigation required. See photographs BW 1.323, BW1.325, and BW1.330.</li> </ul>

Conclusion	<ul style="list-style-type: none"> <li>Item 1: Building B - unit 905 has had previously identified excessive water ponding, and PFCS recommends that a reasonable repair approach to re-slope the finish coating should be planned and executed. It is not recommended that a more aggressive repair approach, that requiring concrete work, will be required.</li> <li>Item 2: Building A - Antique Store Patio, excessive moisture from above deck. Further investigation required. See photographs BW 1.323, BW1.325, and BW1.330.</li> </ul>
Costs

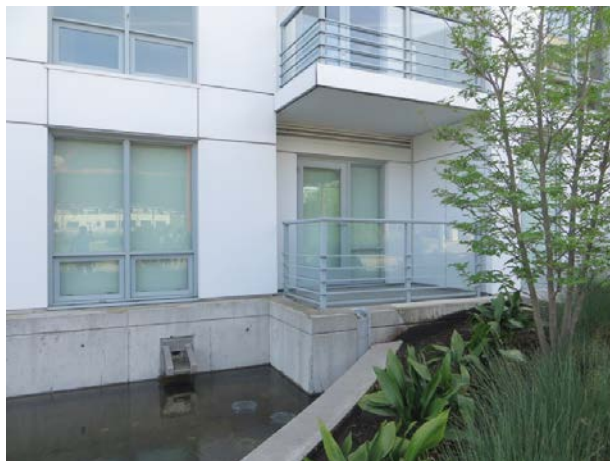
BW-01.363; 04/08/2014; Elevation Left / North

Issue	Investigate proper drainage at lower decks, at exterior pond level.
Investigation	Visual inspections.
Analysis	Lower decks, located at exterior pond feature are performing as intended. Drainage channels are located at the outside face, allowing the decks to drain directly into the water feature. No issues noted.
Conclusion	No repairs recommended.
Costs

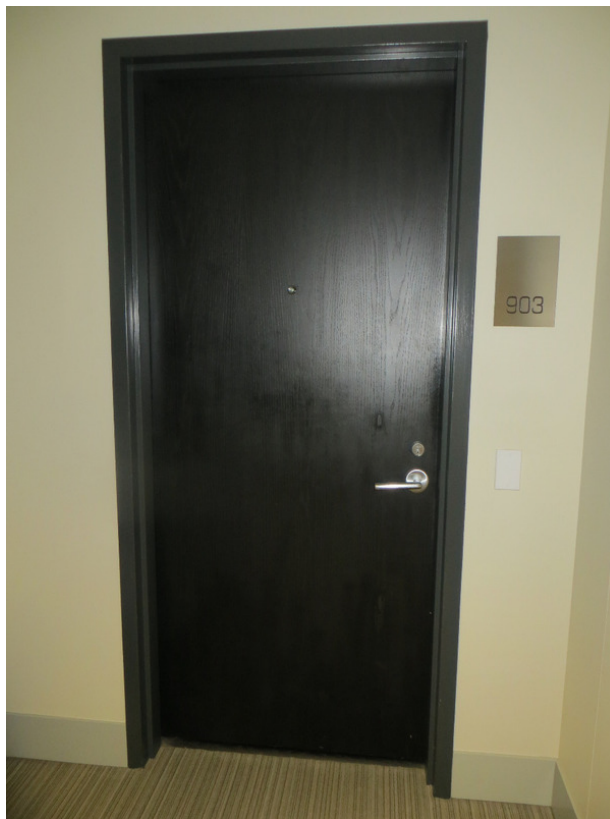
AP-01.308; 04/21/2014

Issue	Verify condition of interior doors.
Investigation	Visual inspections.
Analysis	PFCS noted numerous entry doors that did not have the drop-down smoke seal threshold in the correct location, thus needing to be adjusted.
Conclusion	Consider adjusting threshold drop down seals so that they function properly.
Costs

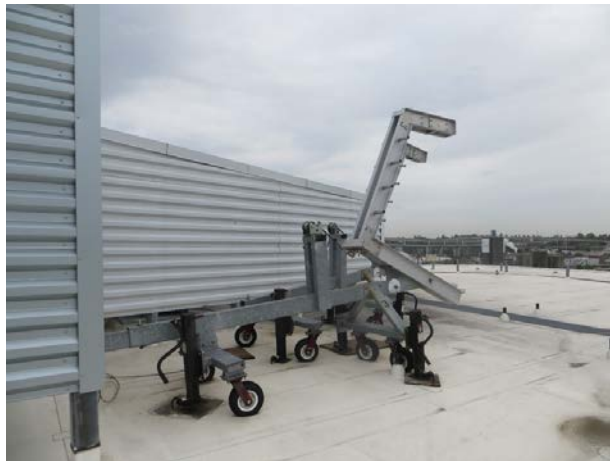
AP-01.239; 04/21/2014; Roof

Issue	Visual evaluation of the Window Cleaning Equipment.
Investigation	Visual inspections.
Analysis	Current window cleaning equipment is not being used, as contractor ties off on existing roof anchors. Maintain plywood or some isolation materials between equipment bases and roofing membrane in order to avoid damage to roof membrane.
Conclusion	Maintain isolation materials between equipment and roof membrane.
Costs
