Dry rot could be factor in Berkeley balcony collapse, engineers say

**LIBRARY GARDENS
APARTMENT**

**Fifth-floor balcony
collapses on
fourth-floor
balcony**

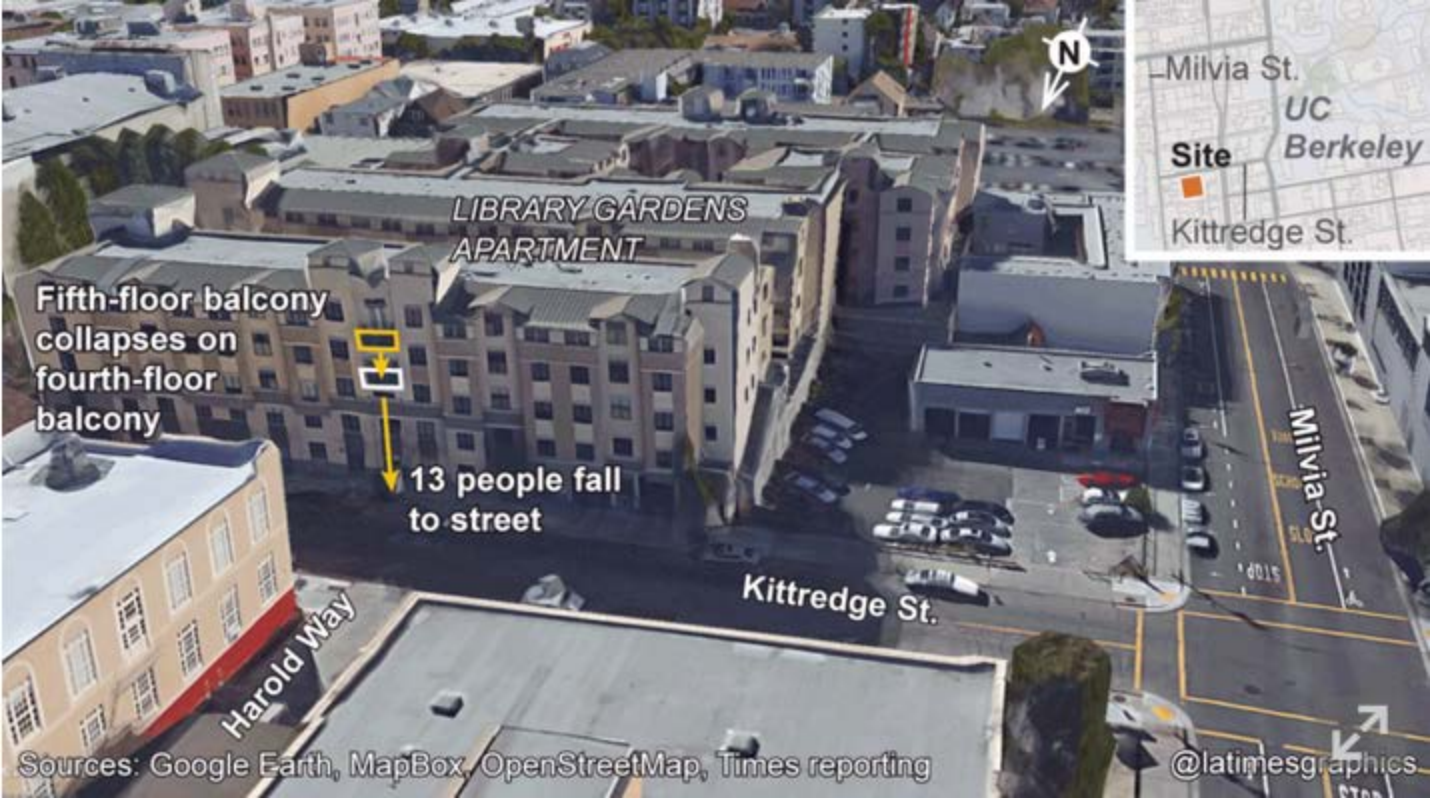
**13 people fall
to street**

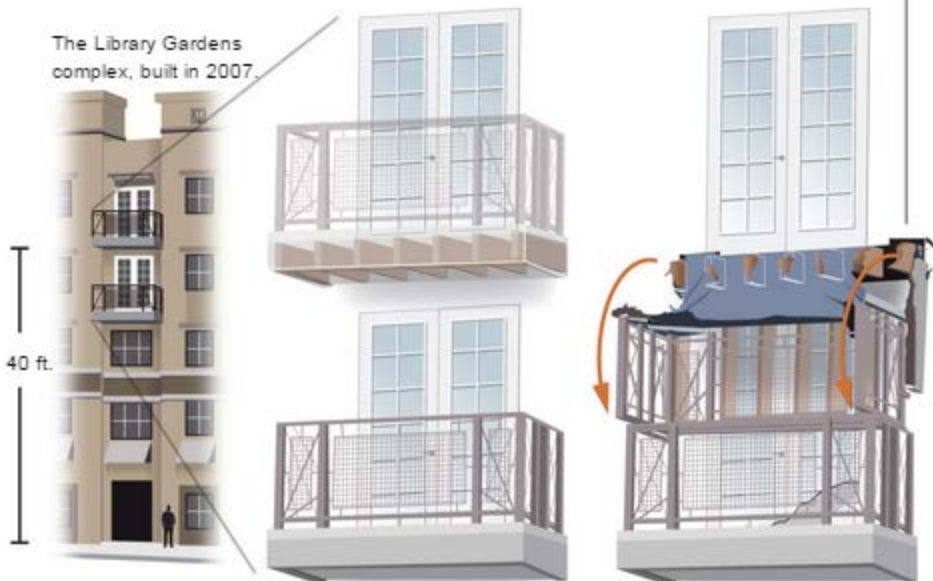
The balcony was supported by seven horizontal wood beams.

Broken wood beams protruding from the building showed signs of dry rot.
