State of the Construction Defect Industry: What's the Same & What's New

State of the Construction Defect Industry: What's the Same and What's New

Common Construction

A guided tour through some of the most common errors and omissions fueling the litigation frenzy in the California building industry

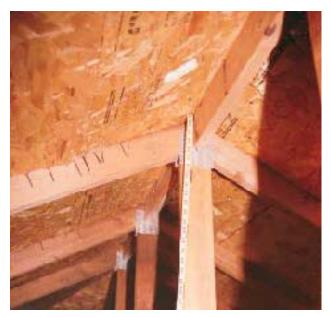
Figure 1. Nails that miss the truss — a result of sloppy work with a pneumatic nailer — void the strength of the roof diaphragm.

Failure to follow the nailing requirements for shear walls and diaphragms is a common defect. Many builders temporarily set the plywood in place with a few hand-driven nails, then return later to finish the nailing with a gun. Unfortunately, we sometimes find that the second step in the process has been forgotten and the finish materials are installed over inadequately attached plywood. Another typical mistake is the substitution of box nails or sinkers for the specified common nails, or use of a smaller size nail. Figure 1 shows an example of just plain sloppy nailing.

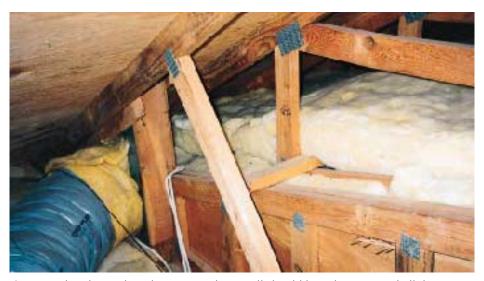
Figure 2. The plywood on this interior shear wall should have been carried all the way to the roof diaphragm.

A more subtle but common problem is failure to carry an interior shear wall all the way to the roof diaphragm (Figure 2). This vertical continuity is necessary for the shear wall to transfer lateral forces from the roof diaphragm down to the foundation.

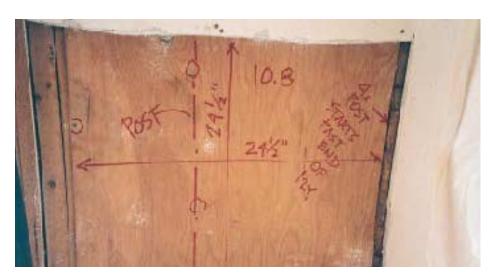
Figure 3. This shear plywood falls short of the shear wall posts on the right and left, and is attached with too few nails.

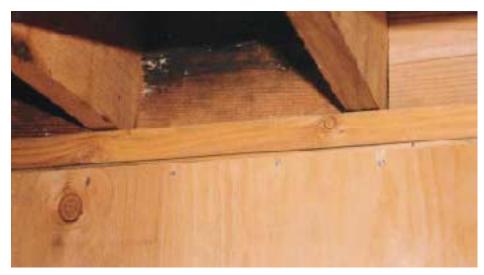
Figure 4. This shear plywood should have extended to the top of the double top plate — a mistake that can be remedied with the addition of metal connectors across the two plates.

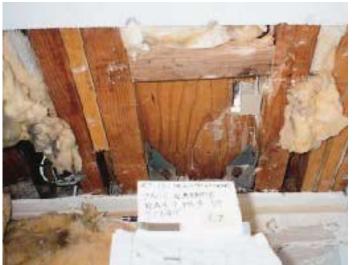
Figure 5. These shear wall hold-downs are too close together, making the shear wall practically useless in resisting overturning forces.

Another common mistake occurs when the hold-downs are attached to the wrong members, creating a shorter shear wall than the plans called for. This is important because the uplift load on the hold-downs increases exponentially as the hold-downs get closer together. When hold-downs are placed too close together, the uplift loads will exceed the hold-down's capacity, creating the potential for catastrophic failure in an earthquake or hurricane (Figure 5).

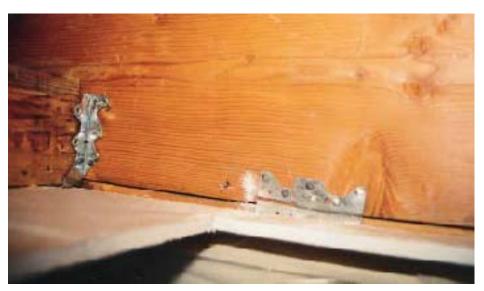
Figure 6. An inspection made through a hole cut in the ceiling reveals that the joist hanger at left is bent and missing nails.

Improper installation of joist and beam hangers is also quite common (Figure 6). These metal connectors frequently have missing nails and are often found mangled and twisted out of shape, having been cut or bent to fit an application never intended by the manufacturer or structural designer.

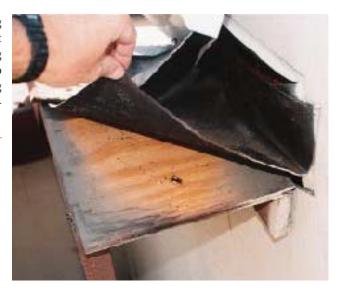
Figure 7. Instead of folding down over the edge, the felt paper on this rake overhang was cut flush with the top of the sheathing, allowing rain water to wet the surface of the roof deck.

One of the most common mistakes I see is the failure of the roofer to turn down the 30-lb. felt underlayment to cover the edge of the decking at the rake. Instead, the felt is cut flush with the top edge of the roof sheathing or barge rafter. Any water that makes its way past the rake tiles has an easy path onto the wood deck (Figure 7). Unfortunately, like most roofing defects, this cannot be readily inspected on a completed roof because the rake tiles cover the edge of the roof.

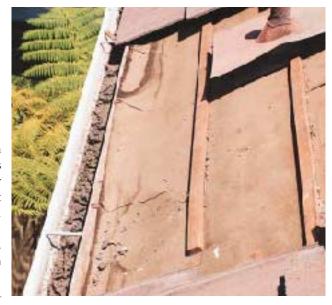
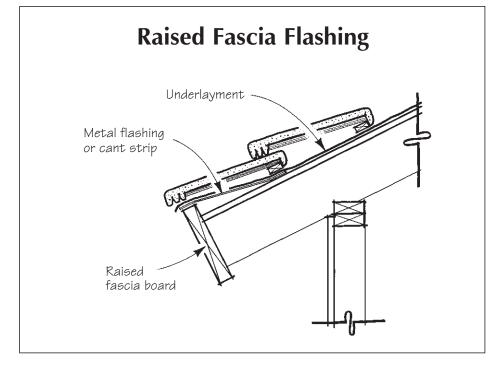
Figure 8. A raised fascia board (illustration) requires a heavy metal flashing or cant strip to ensure that runoff passes over the edge. Otherwise, water will pond, as in the photo, resulting in leaks and rot in the eaves.

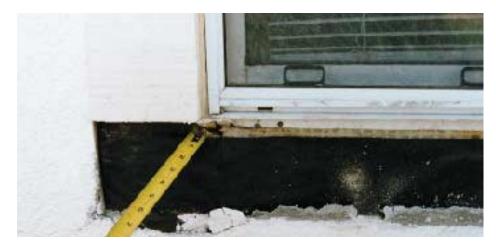
Figure 9. The building paper below a window must be tucked below the flashing paper — a detail often botched, as in the top photo. Above is a reverse lap seen from the inside of the wall cavity.

A classic problem is the "reverse lap" at the sill flashing paper, which should lap over the building paper below. The kraft flashing paper is put on first and the building paper is then lapped over (Figure 9). This allows water to easily enter the interior of the building envelope once it passes the exterior finish. Occasionally I'll see an instance where a worker made an effort to get the building paper under the sill flashing paper but failed to detail the corner junction correctly (Figure 10). These mistakes can be repaired only by removing the exterior finish and reinstalling the building paper to properly integrate with the window flashing paper.

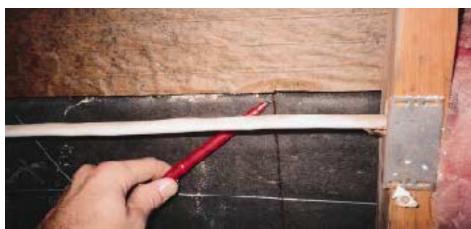
Figure 10. Here, the building paper is installed under the flashing paper at the bottom of the window, but not on the side — leaving a vulnerable corner where the flashing paper has been cut.

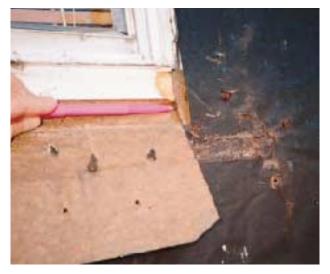
Figure 11. Wood windows should be painted on all raw wood surfaces. Otherwise, they will pick up excessive moisture (as the moisture meter reading in the photo at right shows), causing them to swell or even rot.

Wood windows are the exception in Southern California construction (most are aluminum), which may be the reason they are often not protected adequately from the harmful effects of moisture and temperature extremes. Although most wood windows come with an exterior primer from the factory, all components and all edges should be painted as soon as possible. When wood windows are not properly painted on all surfaces, the unfinished surfaces will take on moisture at a higher rate than the painted areas, creating uneven expansion and contraction and the possibility of rot (Figure 11). A common manifestation of damage is when the windows fail to operate properly, especially after swift changes in the weather.

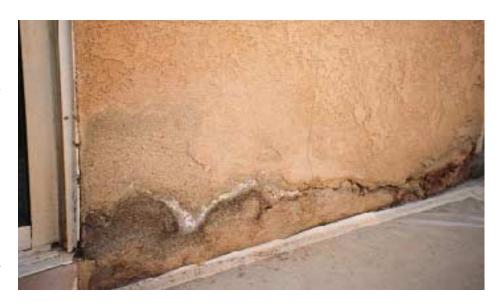
Figure 13. The stucco at the bottom of this wall (photo, top) should have terminated with a weep screed above grade rather than being buried behind an outdoor patio slab.

Because a traditional stucco exterior is not "waterproof," some accommodation must be made to allow moisture to escape. The *Uniform Building Code* mandates the installation of a galvanized steel weep screed at the base of the wall (Figure 13). The screed is nailed to the sill plate, and its upper leg is covered by the building paper. This creates a neat and clean termination for the plaster in addition to allowing the escape of moisture that has found its way behind the stucco.

Unfortunately, all too often the screed is buried behind a patio slab or concrete walk that gets installed after the stucco contractor has left — again, a problem in coordination and planning. When this happens, moisture can't escape, causing the stucco to deteriorate and frequently leading to rot in the sheathing and framing.

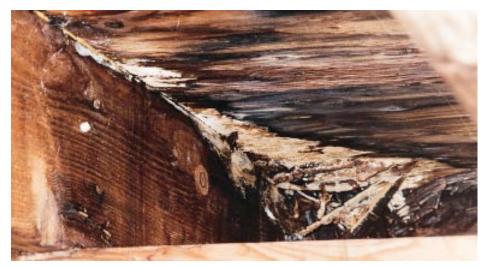
Figure 15. Because waterproof decks are difficult to detail properly, rotting substructure is a common defect.

Waterproof decks are only eighth on the list of defects, probably because they're not found in every residence. But whenever I find them on 1980s mass-produced housing that's involved in litigation (including condos and single-family tracts), these decks seem to always have problems. Many builders have realized the practical difficulty of waterproofing this type of construction, and are now avoiding it altogether. If you continue to build waterproof decks, include as few penetrations as possible and strictly follow the decking manufacturer's installation directions.

The photo on shows a poorly flashed post penetration. The unsealed flashing acted more like a funnel, sending the water right into the framing and keeping it there, where it could do the kind of damage evident in Figure 15. Ponding of water on waterproof decks is another common problem (Figure 16), which can also lead to rot in the structure below.

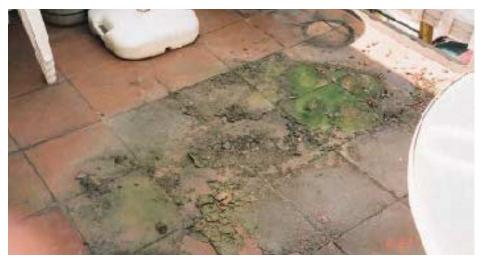
Figure 16. Besides ruining the finish surface, ponding on waterproof decks also leads to deterioration of the framing below.

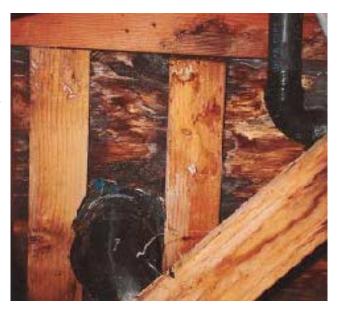
Figure 17. If hidden by finish surfaces, a leaky toilet connection can go undetected until structural decay sets in.

A common source for a plumbing leak is a poorly installed toilet (Figure 17). The connection to the closet flange is important because the toilet receives so much use, which includes supporting the entire body weight of the user. If the toilet has not been set level, or if the flange is too high or low in relation to the finish floor, it's only a matter of time before a leak develops. A leaky toilet often goes unnoticed for some time, since the water may leak under the finish flooring directly into the framing.

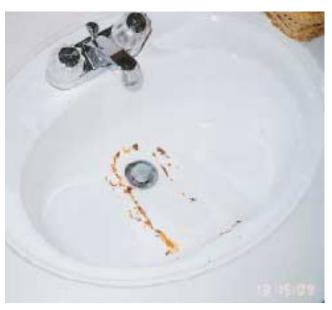
Figure 18. The chipped enamel in this cheap lavatory sink is the kind of defect that will send condo or tract homeowners ballistic — especially when they see it in every home on the block.

This is a manufacturing defect plain and simple — and one that tends to be highly visible and irritating to owners (Figure 18). Although it's not a structural concern, if condo owners or tract house dwellers notice this in one another's homes, it can help start the defect litigation ball rolling. The chipping is normally located at the spot welds in the sinks. The enamel doesn't stick well to the welds and easily chips away, sometimes in a pattern. The solution is not to buy cheap sinks from manufacturers you have not heard of.

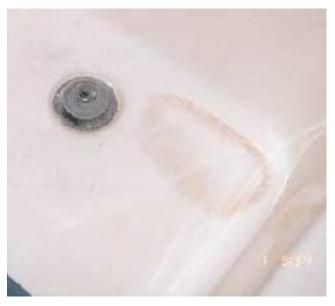
Figure 19. Ponding in the bottom of a tub unit — the result of an out-of-level installation — is not structurally serious but is obvious to any homeowner.

Ponding in a tub may be a manufacturing problem but more often stems from improper installation (Figure 19). The builder needs to take the time to check the framing, and shim and level the tub as necessary. Otherwise, water will collect and may stain the unit. Again, this is not a life or death issue, but it's one that homeowners will easily see. The cure for this defect, some might argue, is more painful than the disease:

Remove the tub and reinstall it correctly — which usually involves removal and replacement of ceramic tile surrounds.

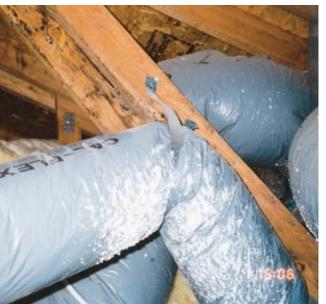
Figure 20. A pinched duct can result in uneven temperatures. It's easy to fix if it's accessible, but easier still to avoid.

As with plumbing, many of the hvac defects cited in a typical defect case are nuisance and code issues that are easy to correct, like construction debris in the return air plenum, unsecured units, and no trap vent on the condensate drain. These issues rarely cause serious owner dissatisfaction. Pinched or crushed ducts are another common problem (Figure 20), which can cause uneven heating or cooling and result in owner discomfort. The cause may be sloppy installation or damage by a subsequent trade. The repair is as simple as unpinching the duct or replacing any short sections that have been permanently damaged.

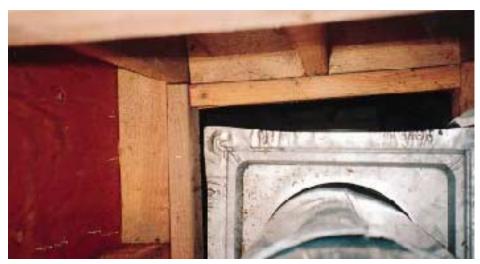
Figure 22. Firestops are an important safety requirement. Unfortunately, if a gap is missed by the inspector, all too often it will be permanently concealed from view.

Figure 23. The pipe penetration into a gas fireplace must be properly sealed with a firestop material — a defect that's easy to spot and easy to fix with fireproof grout.

Mechanical fireboxes are very common in moderately priced Southern California residential construction. An unsealed gas line penetration at the mechanical firebox is one of the most common construction defects we see (Figure 23). It's a problem because fire that is supposed to be contained within the mechanical firebox could spread to the wood framing behind the box. Lucky for builders, it's also easy to recognize and easy to fix.

There's no removal of expensive finishes needed. The repair is a simple application of fireproof grout to seal around the penetration.
