## Introduction

# Random Selection and Extrapolation of Construction Defects

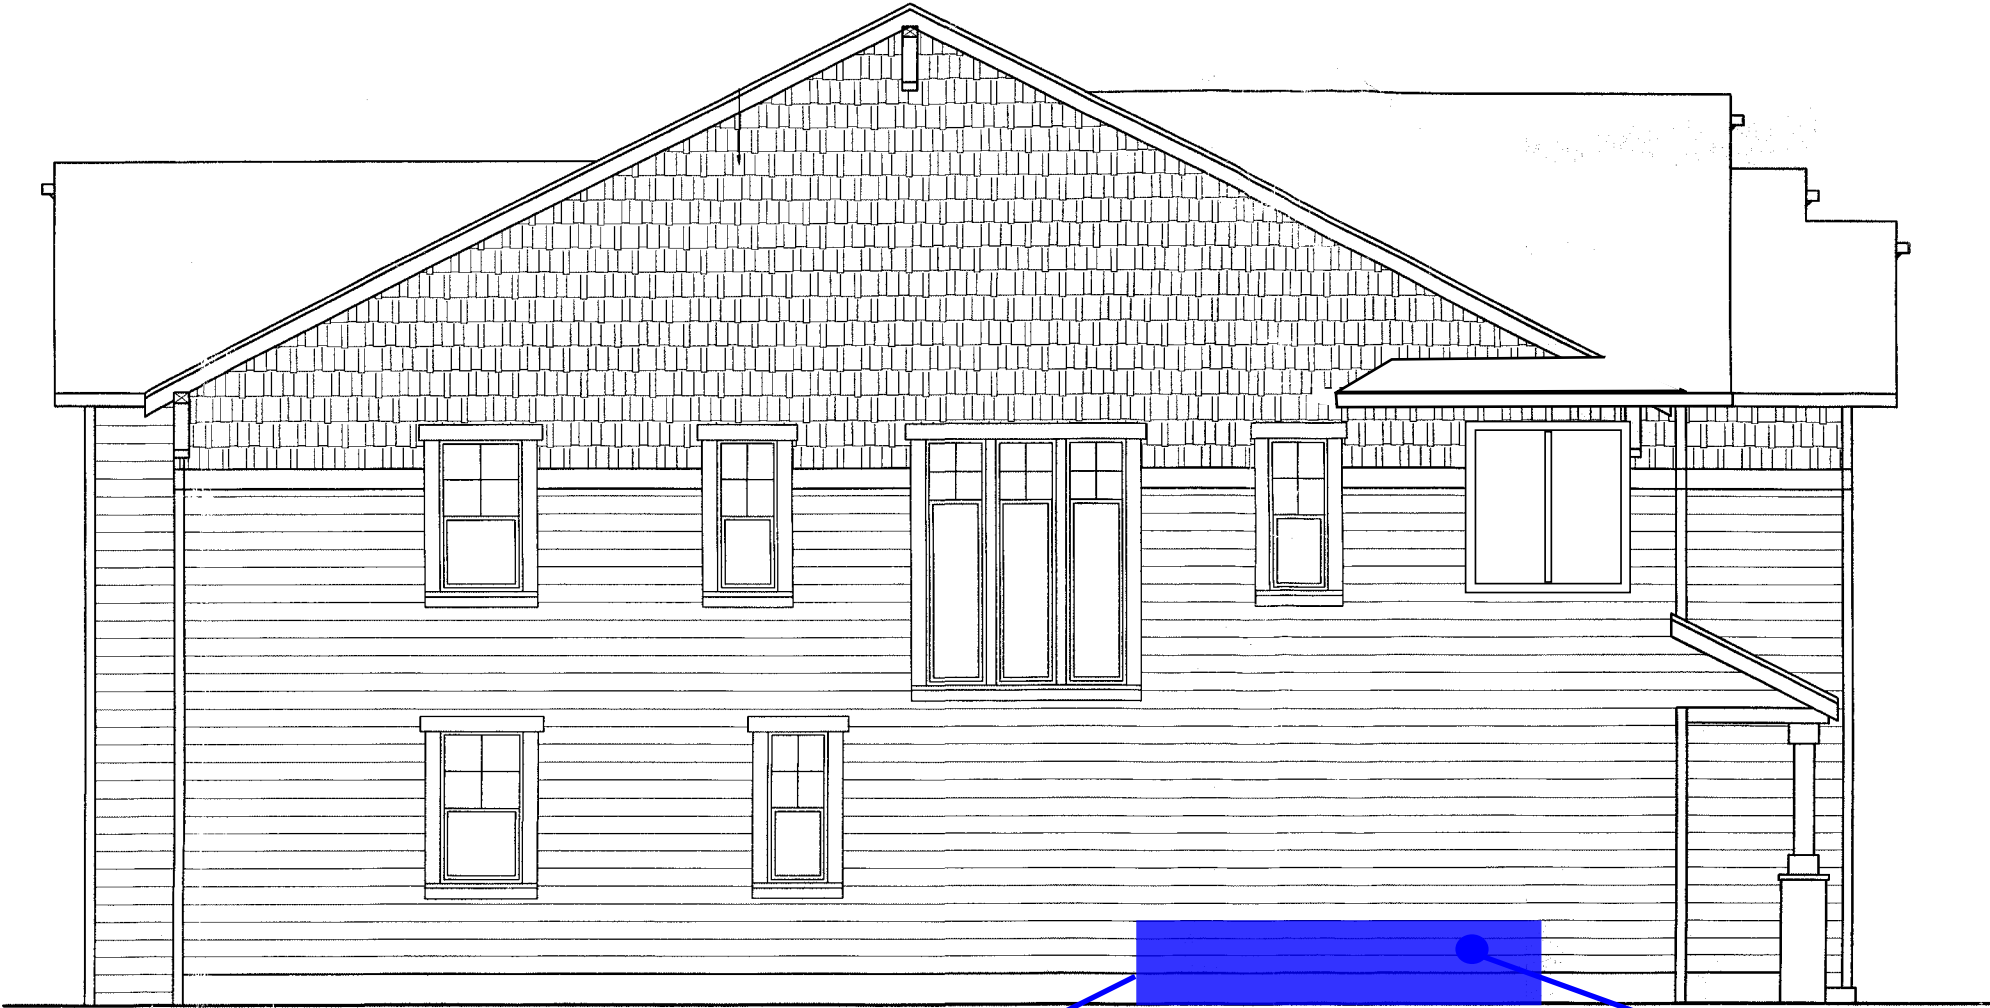
LEFT ELEVATION

Remove and replace  
damaged OSB.
