# The Art of Water Testing

by Francesco J. Spagna, PE

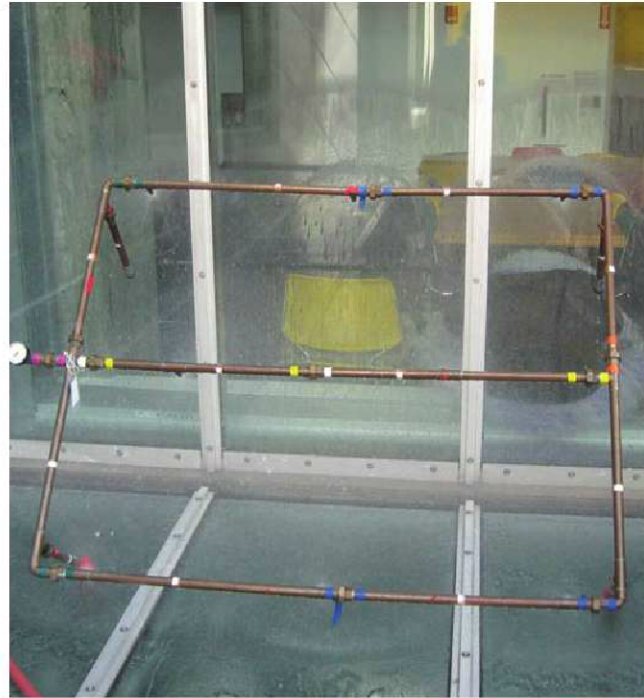
Figure 1

This photo shows a water test at the intersection of sloped glazing and seven-story curtain wall. The spray rack consists of copper pipes with nozzles in a uniform grid pattern.

Seven stories of curtain wall rose above the low-sloped glazing. A spray rack, calibrated in accordance with industry standards, was used for this project (Figure 1). The equipment consisted of copper pipes with nozzles spaced in a grid to deliver a uniform spray to the test area. The vertical curtain wall was water-tested above the leakage area for approximately three hours without replicating the leaks.

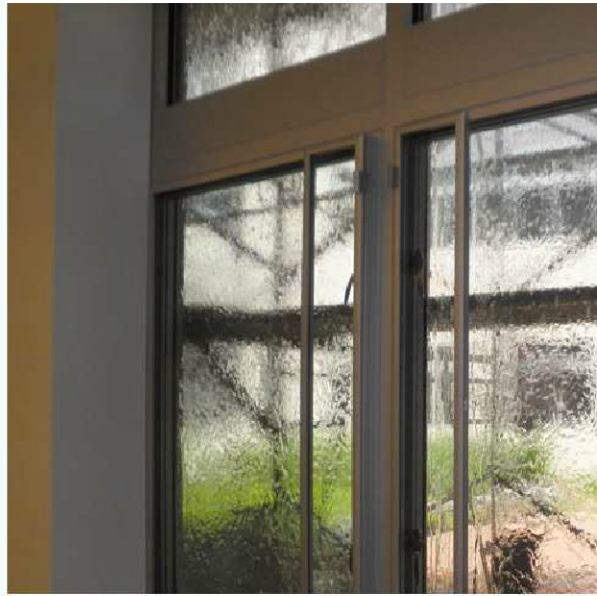
Figure 3

A spray rack set up on the exterior of this window delivers a consistent film of water over the test area.

Both ASTM E 1105 and E 2128 refer to a testing apparatus that delivers a water flow rate of approximately 3.4 L/m<sup>2</sup>/min (5 gal/sf/hour) to the test area. A spray rack set at this rate using standard, commercially available nozzles, and placed about 0.3 m (1 ft) in front of the test area produces a consistent film of water (Figure 4, page 57).

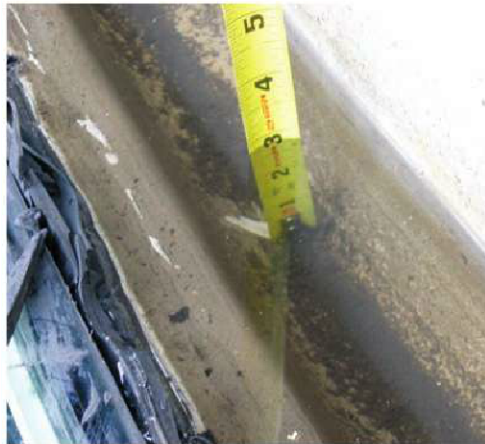
Figure 4

A close-up of the troughs in the silicone sheet between rafters, which held as much as 76 mm (3 in.) of water.

The brake metal was intended to be the first line of defense in stopping water from entering the building between the curtain wall and sloped glazing, while the underlying sheet was the second. The silicone sheet was unsupported between sloped glazing rafters and, as a result, sagged between them. This created numerous troughs that held as much as 76 mm (3 in.) of water at the end of the testing (Figure 3, page 56). Since the system was already primed and most of the water in the troughs remained overnight, the leakage was replicated

The water had to follow a convoluted path measuring more than 15 m (50 ft) from the point of entry into the silicone sheet gutter to the point of leakage into the building. Leakage occurred only after all the troughs in the silicone sheet upstream of the point of leakage into the building had filled. Replicating this leakage required a substantial volume of water and hours of testing with a spray rack.
