Slip, Trip & Fall Analysis

Pete Fowler
CONSTRUCTION
Services, Inc.

Slip, Trip and Fall Analysis is a 1-hour walk through Pete Fowler Construction Services' (PFCS) Construction Claims Analysis Method applied to personal injury claims that occur as a result of a hazard in the built environment. No two claims are the same, but our analytical method walks us through a professional investigation and analysis, similar to how the scientific method aids in discovery of the workings of our natural world, regardless of the specifics of the claim.

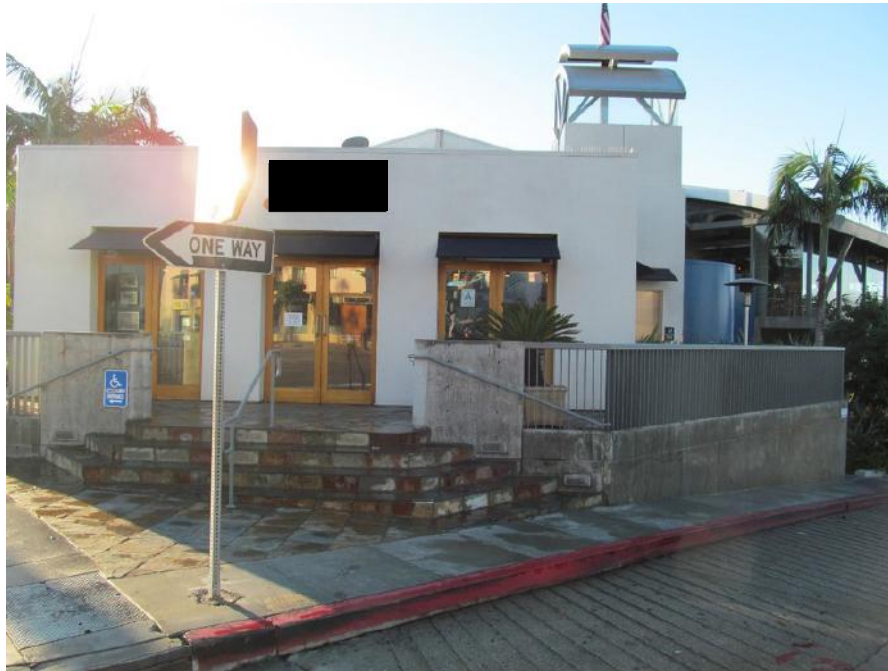
PK-01.002; 12/17/2014; Elevation Front; Overview shot with 4 total risers.

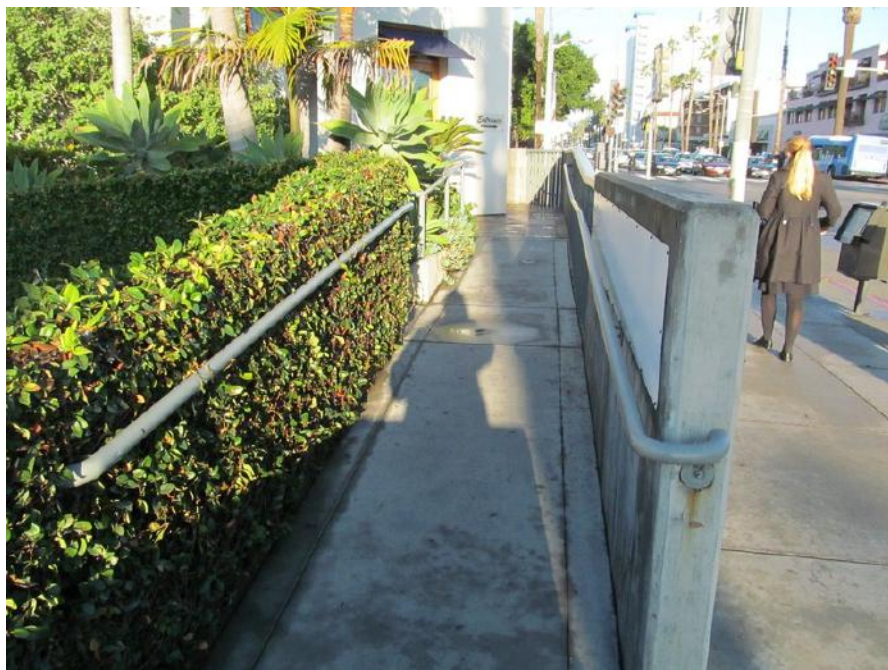
PK-01.010; 12/17/2014; Elevation Left; Overview shot with handicapped ramp.

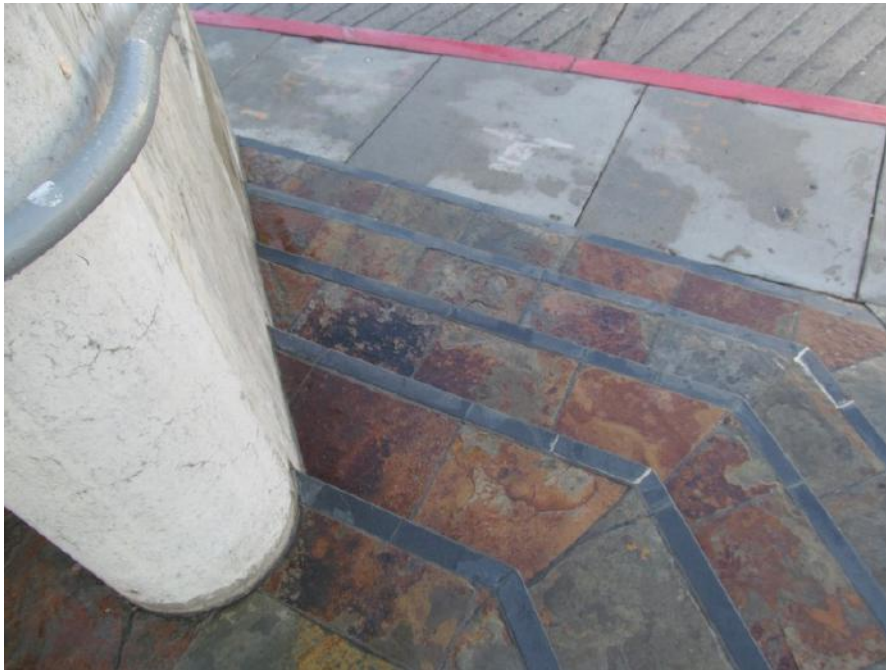
PK-01.015; 12/17/2014; Stairway; From landing looking down towards the intersection of the sidewalk on [REDACTED] and the [REDACTED] driveway off Colorado Street. See A/3. Looking North. See page 2 for general stair widths.

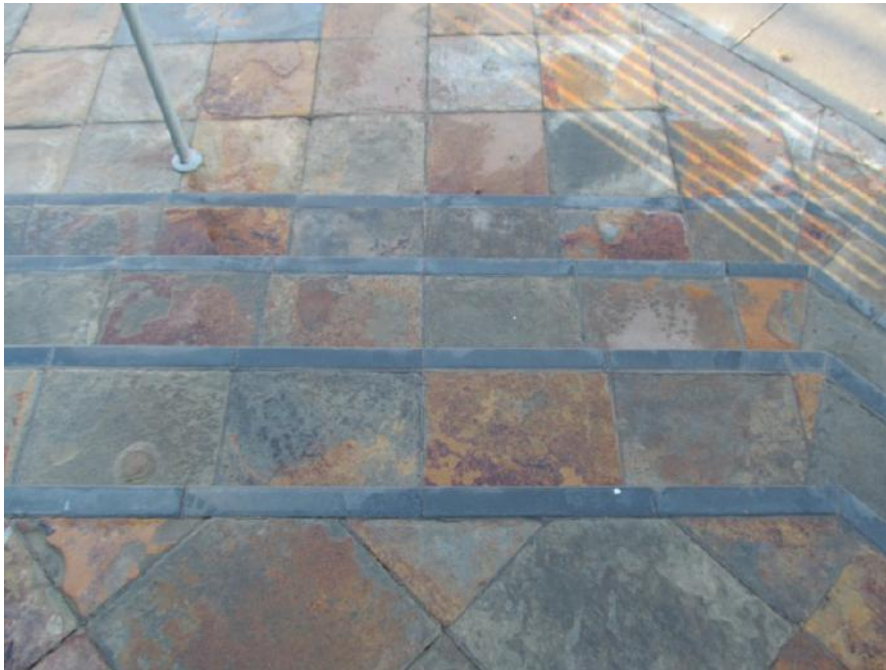
PK-01.021; 12/17/2014; Stairway; From landing looking down towards the intersection of the sidewalk on [REDACTED] and the [REDACTED] driveway off Colorado Street. See A/3. Looking North. See page 2 for general stair widths.

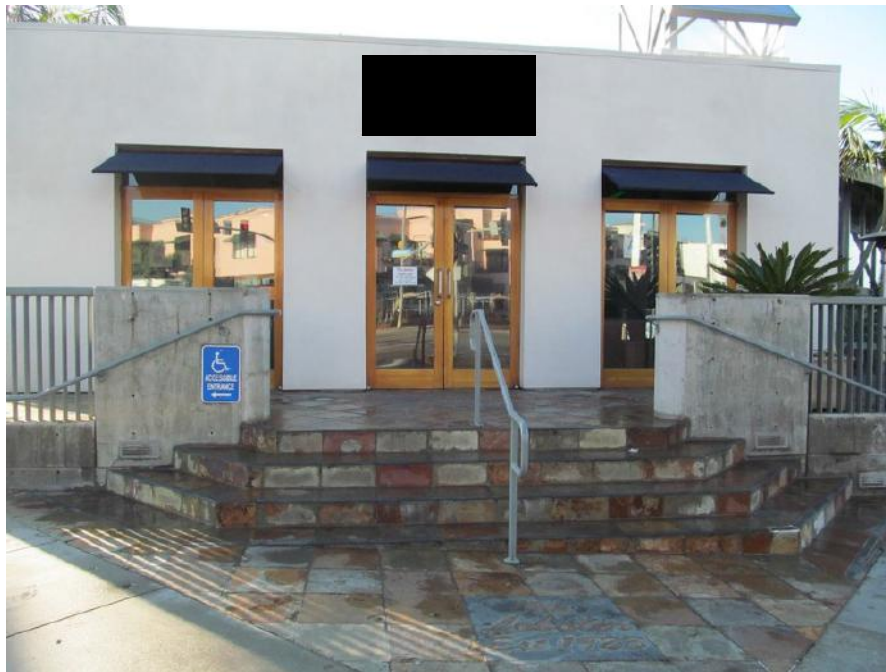
PK-01.029; 12/17/2014; Stairway; Front elevation of stairway looking South, fan shaped stairway with middle section of stairway with 4 risers with bisecting handrail and 2 angled stairway to the East and West. Right hand side (west side) with 5 risers to sloping pathway. Left hand side (east) parallel to Colorado with 3 risers, level with Colorado.

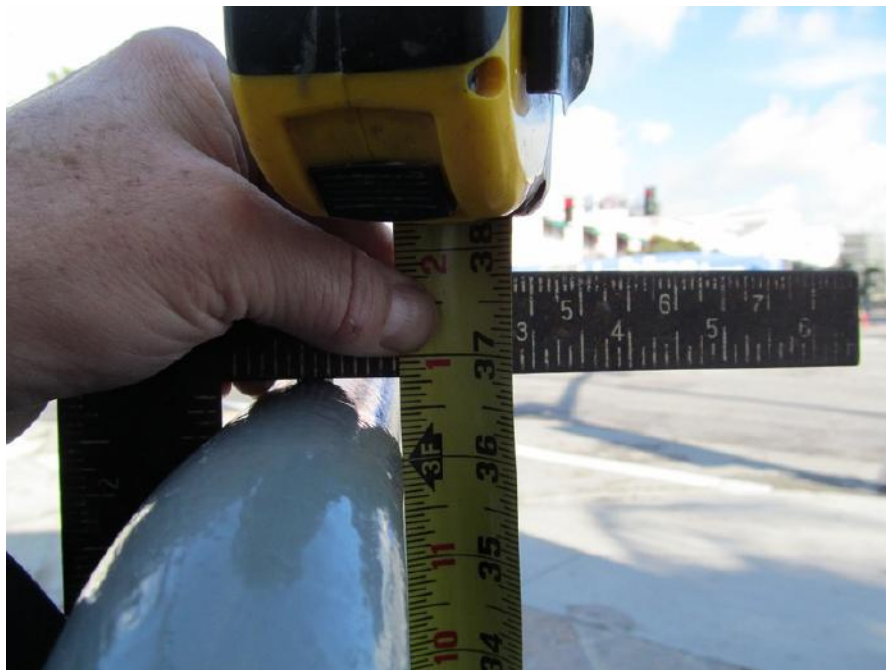
PK-01.049; 12/17/2014; Stairway; Middle section top is +/- 36 13/16" above finished floor at top.

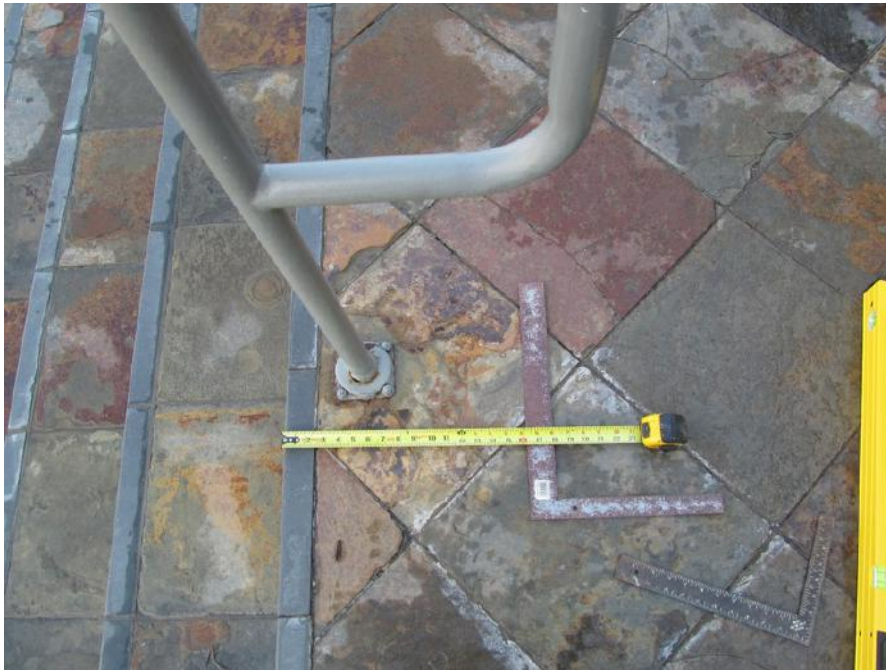
PK-01.053; 12/17/2014; Stairway; Stairway extension is +/- 17 15/16". See A/3 at top.

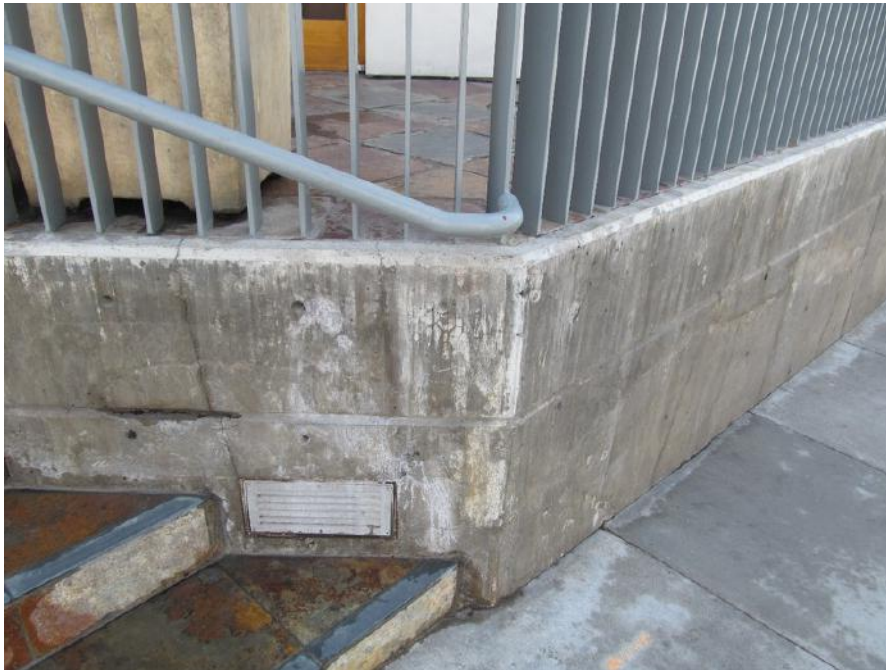
PK-01.094; 12/17/2014; Stairway; West riser section bottom of handrail extension $\pm 2 \frac{3}{4}$ " beyond last riser, handrail is $\pm 33 \frac{15}{16}$ " above the last nosing.

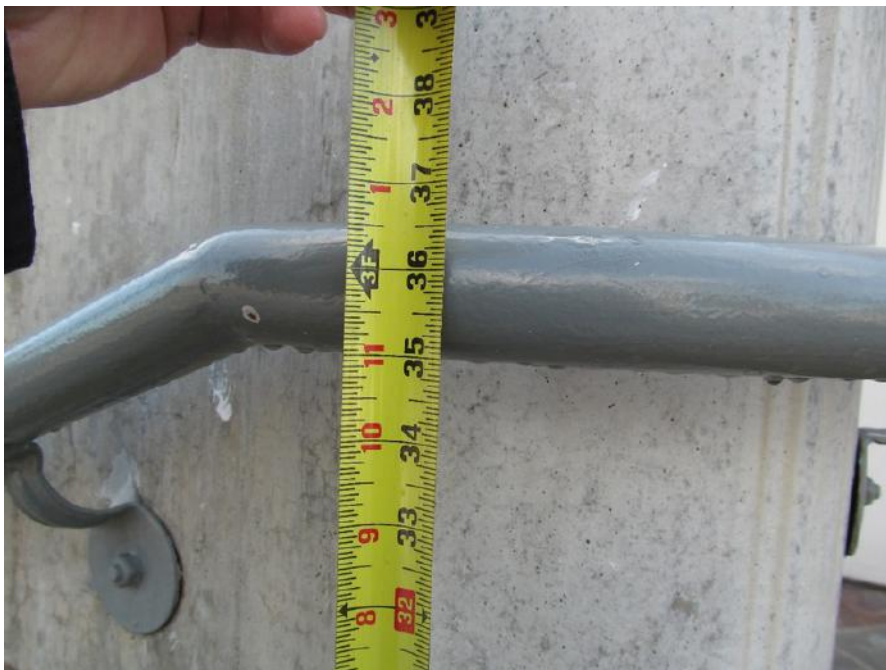
PK-01.100; 12/17/2014; Stairway; East riser section with handrail $\pm 36 \frac{1}{2}$ " above top of nosing.

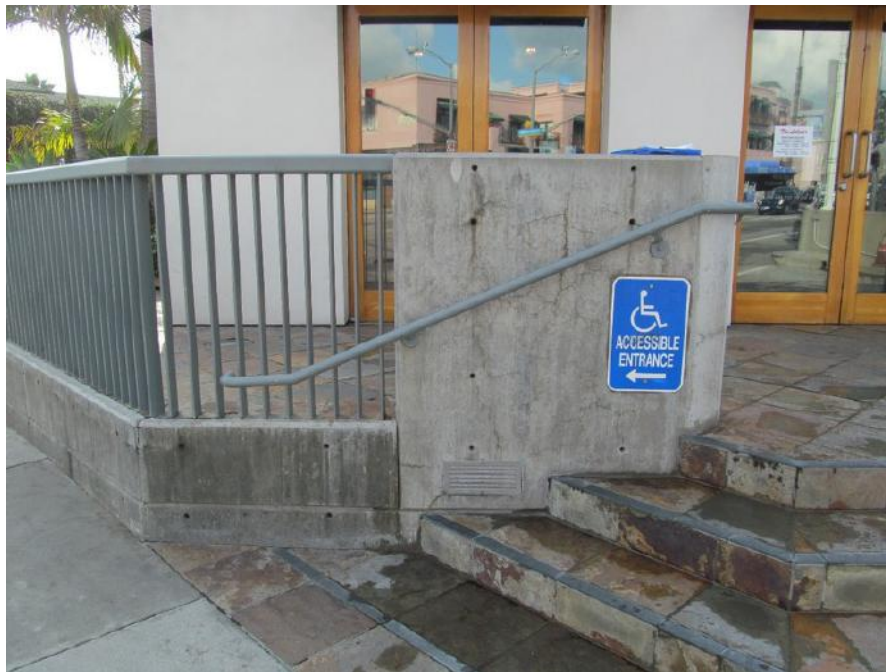
PK-01.101; 12/17/2014; Stairway; East riser section with handrail +/- 34 1/2" above the bottom nosing with +/- 31" extension.

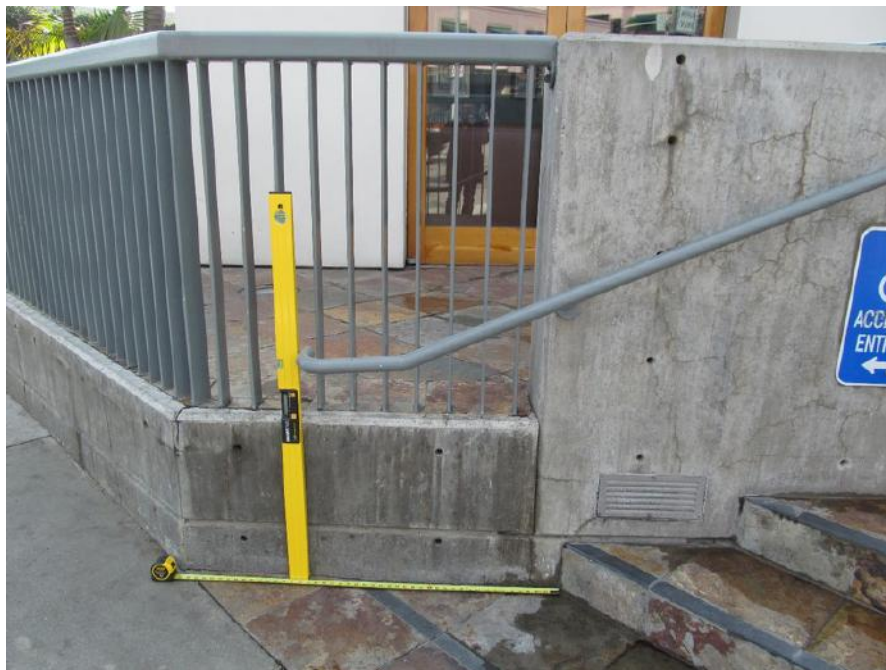
PK-01.104; 12/17/2014; Stairway; East riser section with handrail +/- 34 1/2" above the bottom nosing with +/- 31" extension.

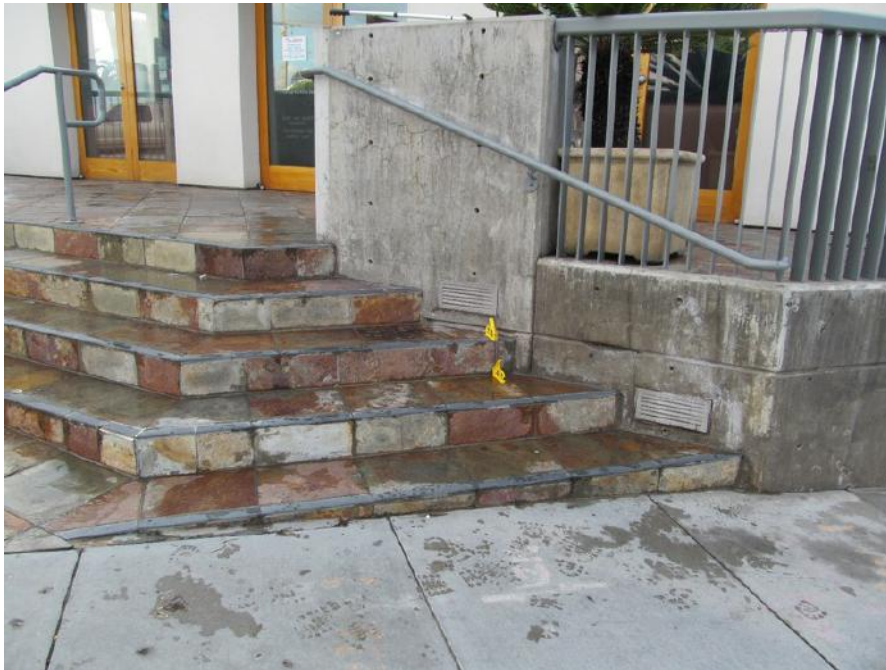
PK-01.107; 12/17/2014; Stairway; West section with riser height along concrete wall/pilaster. See A/5.

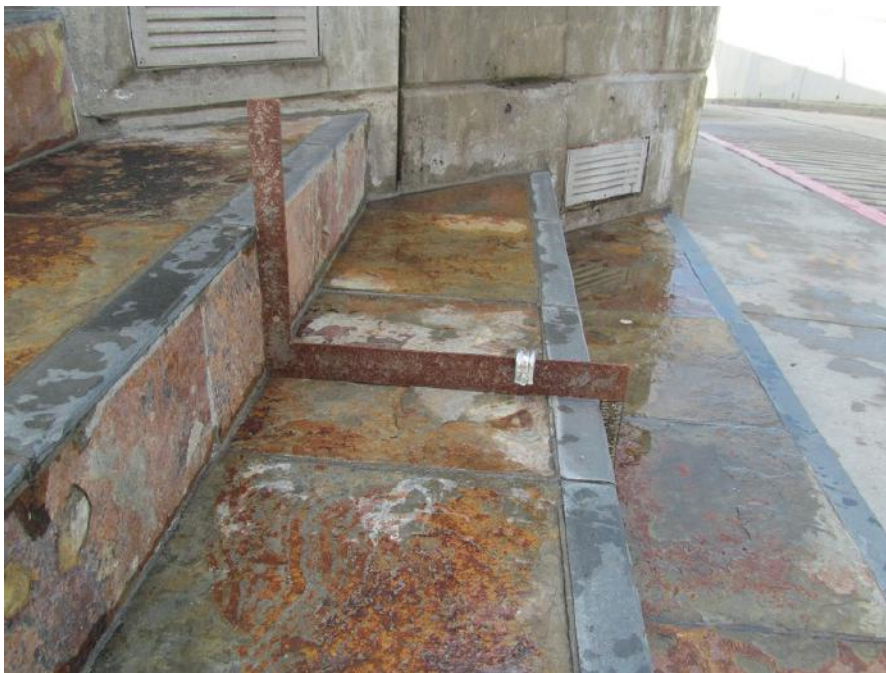
PK-01.113; 12/17/2014; Stairway; West section tread measurements. See A/5.

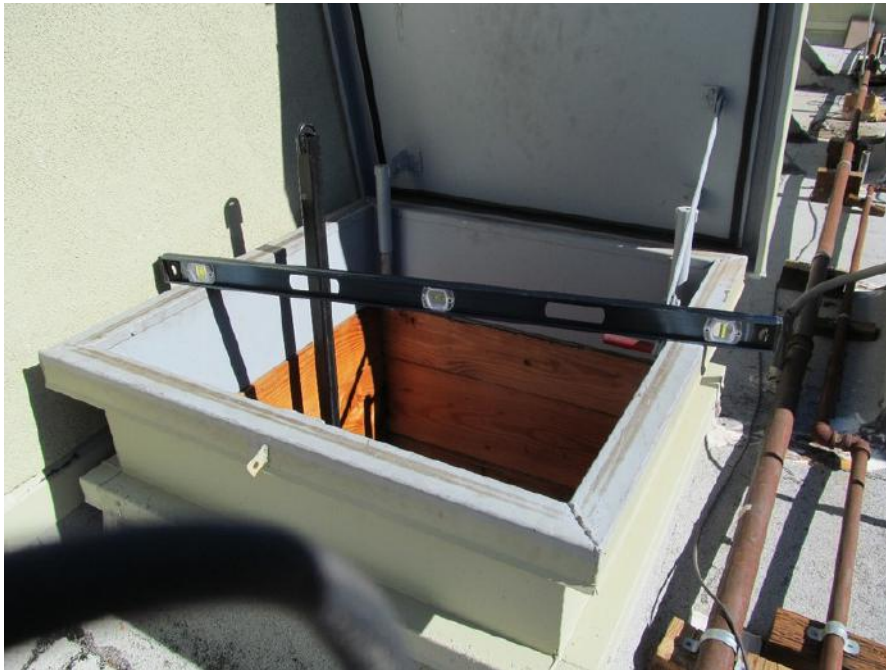
PK-01.016; 11/04/2014; Building 6; Roof; Top edge of the roof hatch is 13 -15 3/4" from the slab on grade concrete floor below. See A/2.

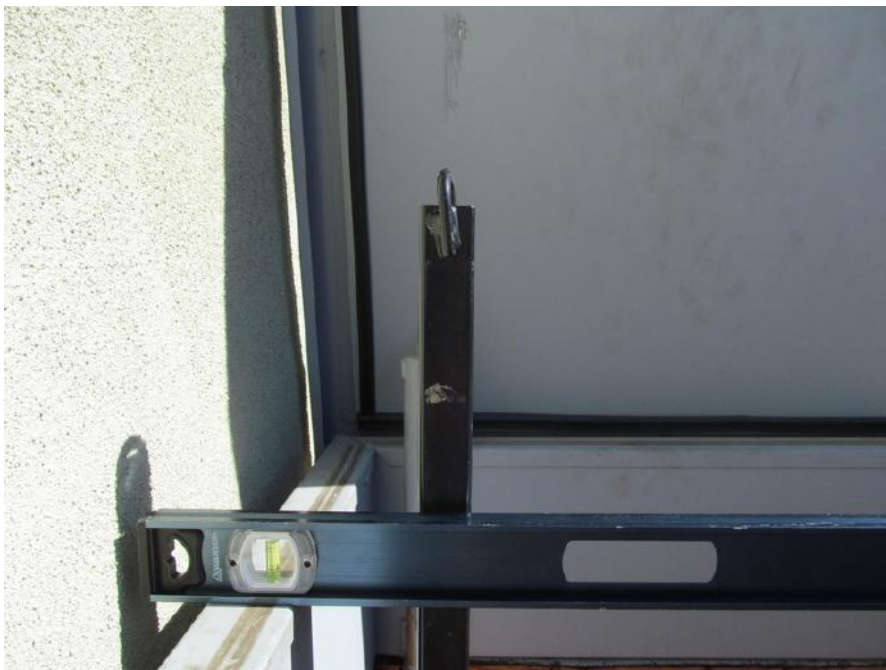
PK-01.019; 11/04/2014; Building 6; Roof; Top of safety pole extends 8 1/2" above the top edge of the roof hatch.

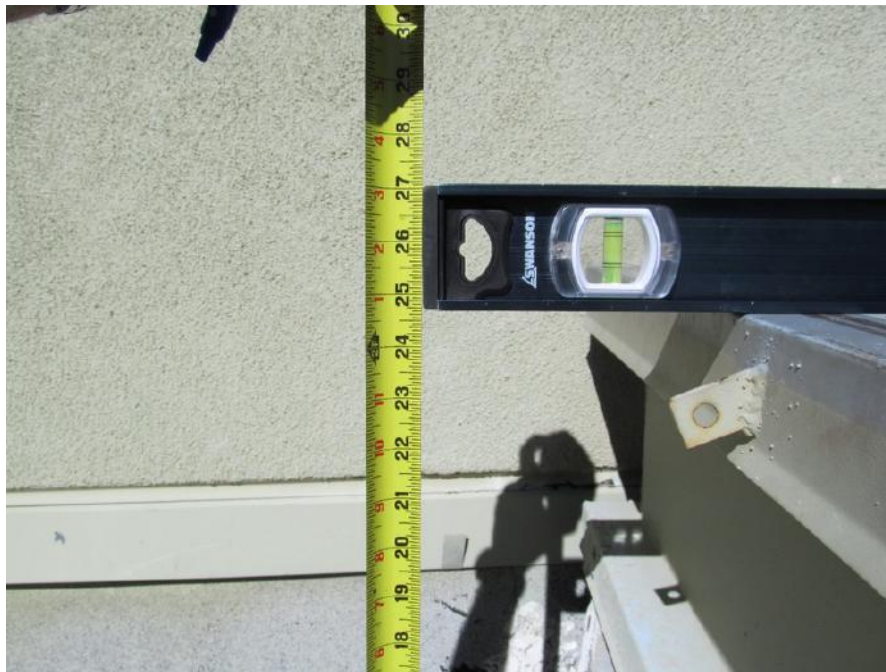
PK-01.085; 11/04/2014; Building 6; Roof; The cap sheet is $\pm 24 \frac{3}{4}$ " from the roof hatch level ± 6 " from the edge over the latching mechanism / receiving bolt.

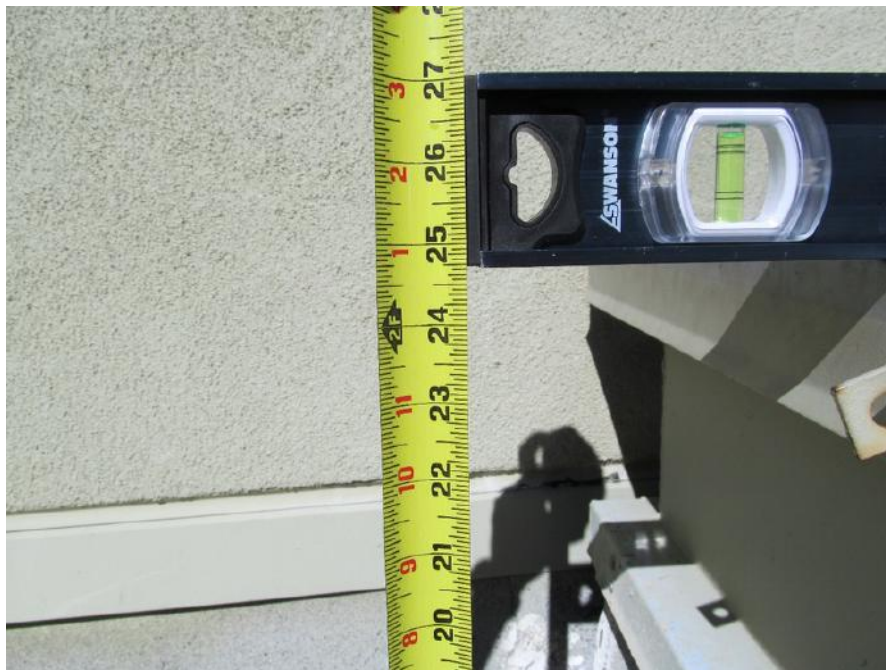
PK-01.087; 11/04/2014; Building 6; Roof; The cap sheet is $\pm 24 \frac{3}{4}$ " from the roof hatch level ± 6 " from the edge over the latching mechanism / receiving bolt.

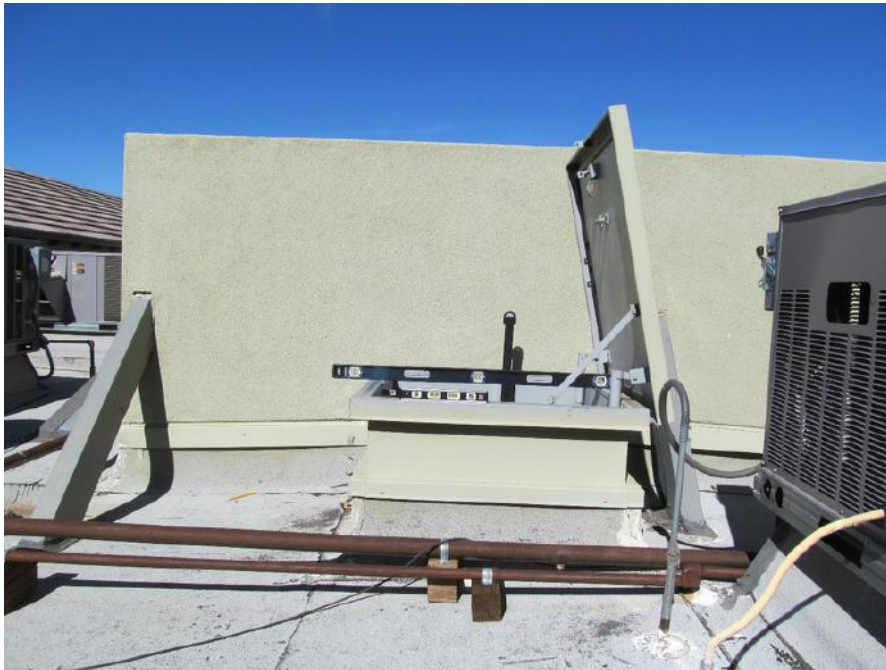
PK-01.091; 11/04/2014; Building 6; Roof; Elevation view with hinge side to the right-hand side.

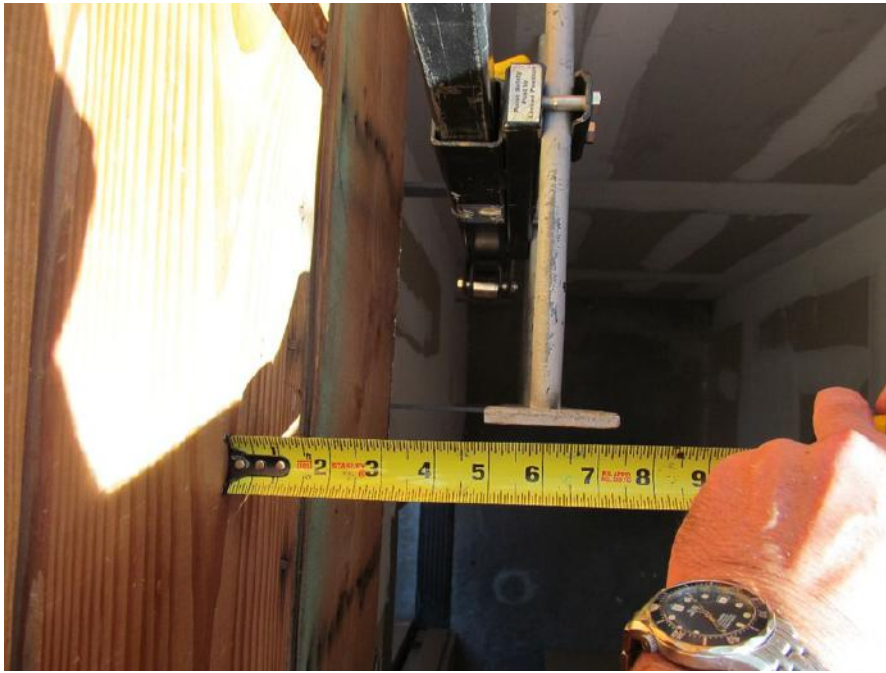
PK-01.108; 11/04/2014; Building 6; Roof; 13 " wide step ladder side rail is 4 3/4" from the well framing.

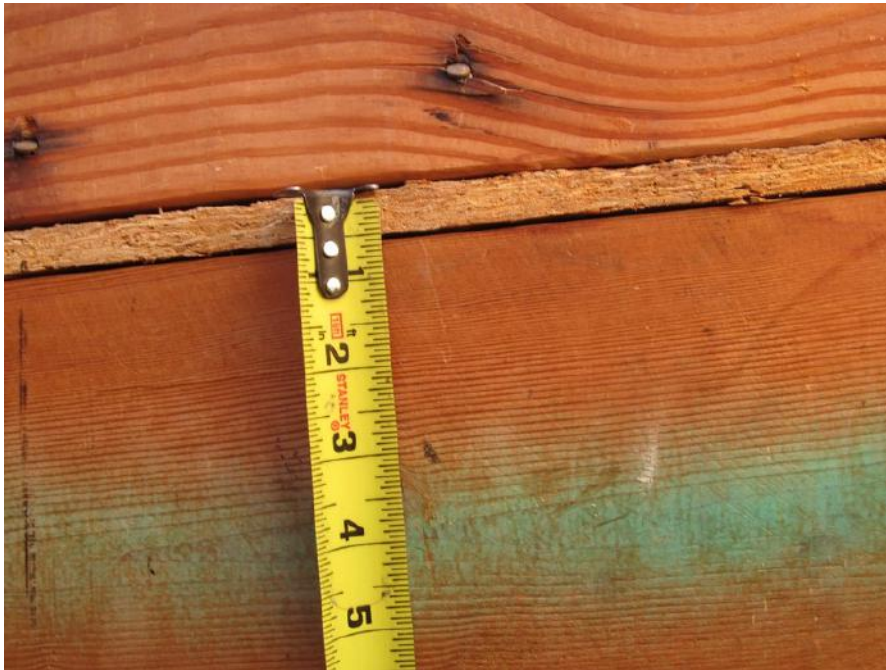
PK-01.032; 11/04/2014; Building 6; Roof Access; Structural sheathing $\pm 1/2$ " thick. See A/2.

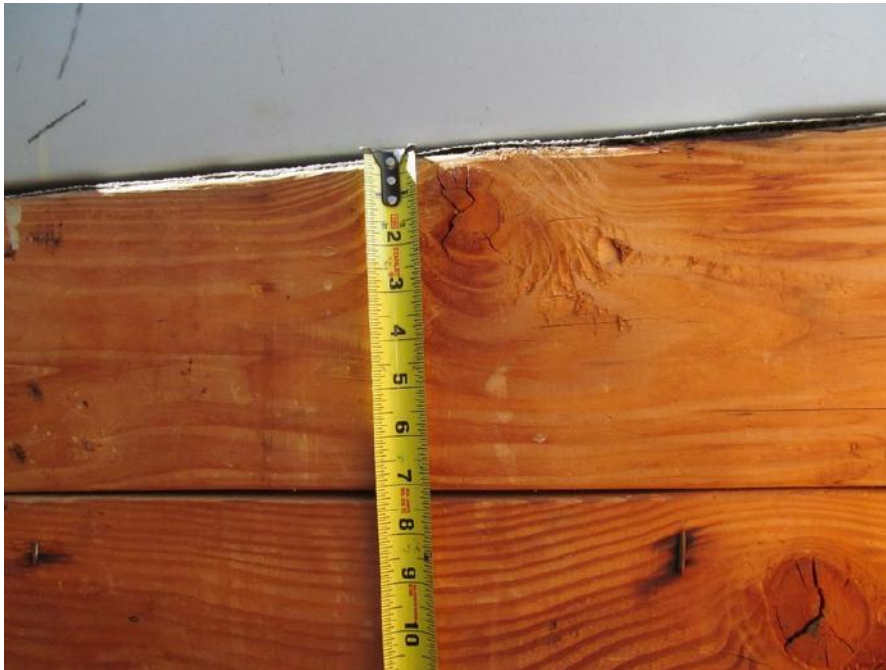
PK-01.036; 11/04/2014; Building 6; Roof Access; Curb \pm 7" deep. See A/2.

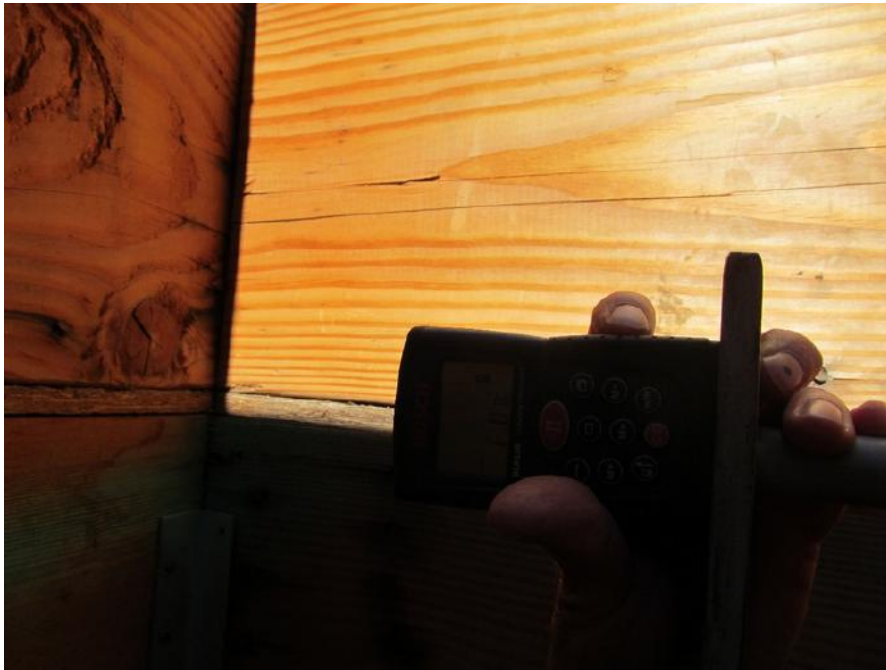
PK-01.050; 11/04/2014; Building 6; Roof Access; Distance of the metal step ladder outside edge to adjacent framing at the top $\pm 12 \frac{1}{16}$ ". See A/2 and A/1.

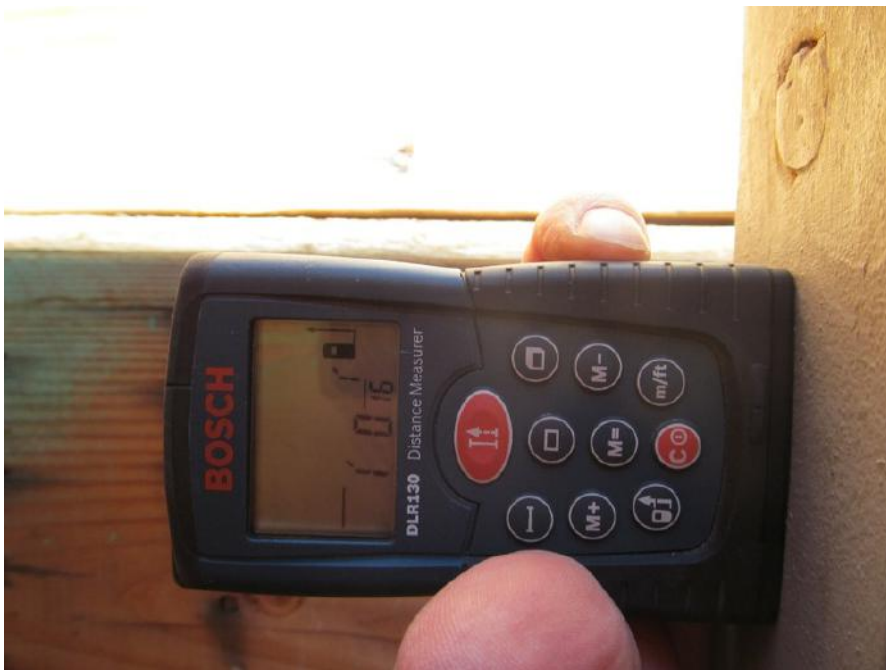
PK-01.051; 11/04/2014; Building 6; Roof Access; Distance of the metal step ladder outside edge to adjacent framing at the top $\pm 12 \frac{1}{16}$ ". See A/2 and A/1.

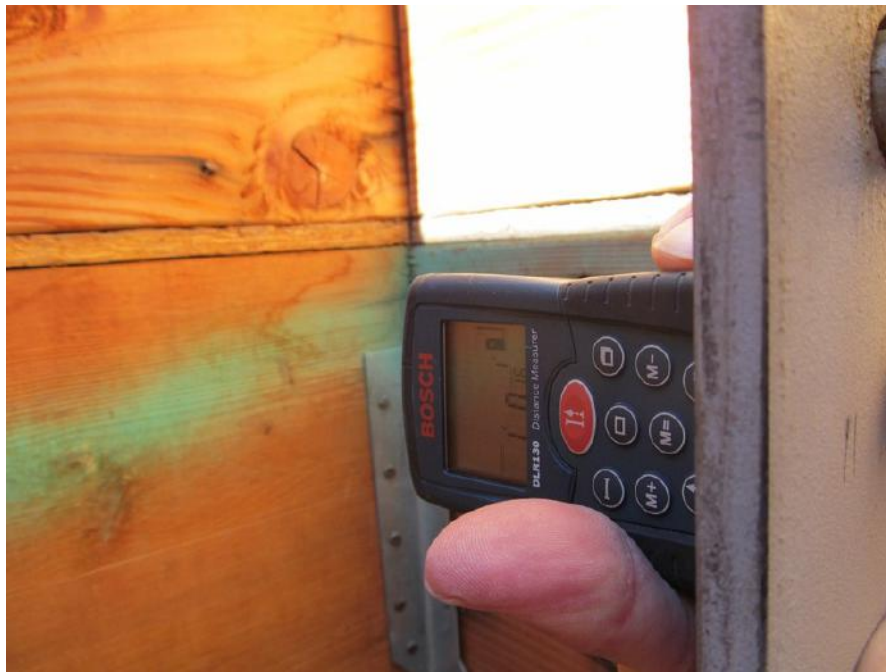
PK-01.052; 11/04/2014; Building 6; Roof Access; Distance of the metal step ladder outside edge to adjacent framing at the top $\pm 12 \frac{1}{16}$ ". See A/2 and A/1.

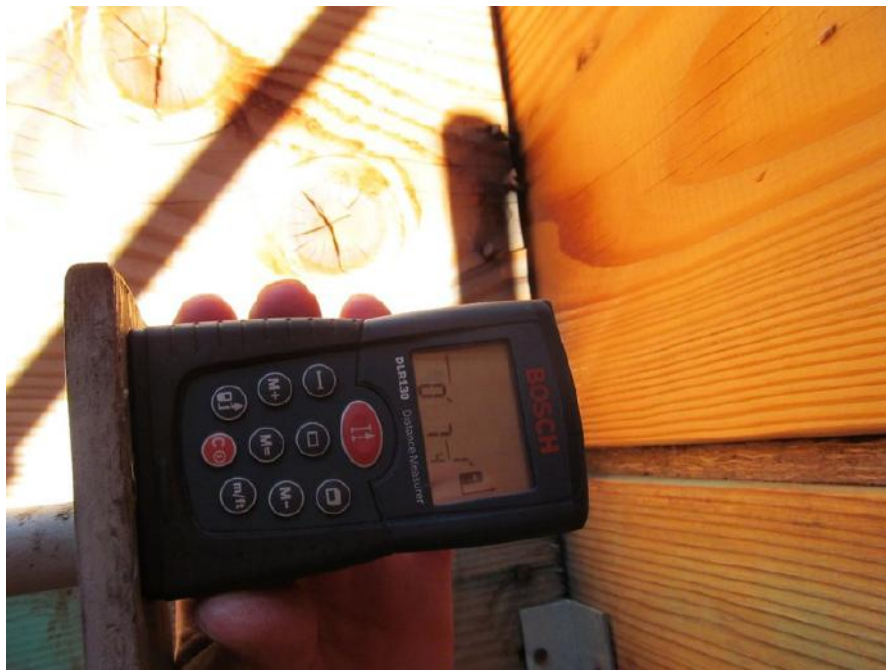
PK-01.053; 11/04/2014; Building 6; Roof Access; Opposite side / hinge side with $\pm 7 \frac{1}{4}$ " from outside edge to the adjacent framing.

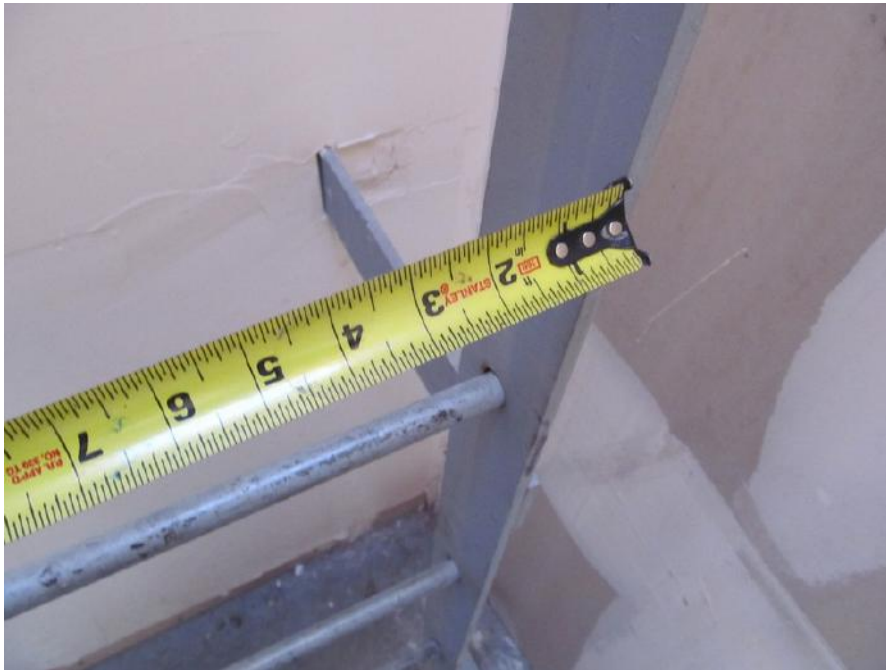
PK-01.061; 11/04/2014; Building 6; Roof Access; Step ladder inside dimension is $\pm 15 \frac{7}{8}$ ".

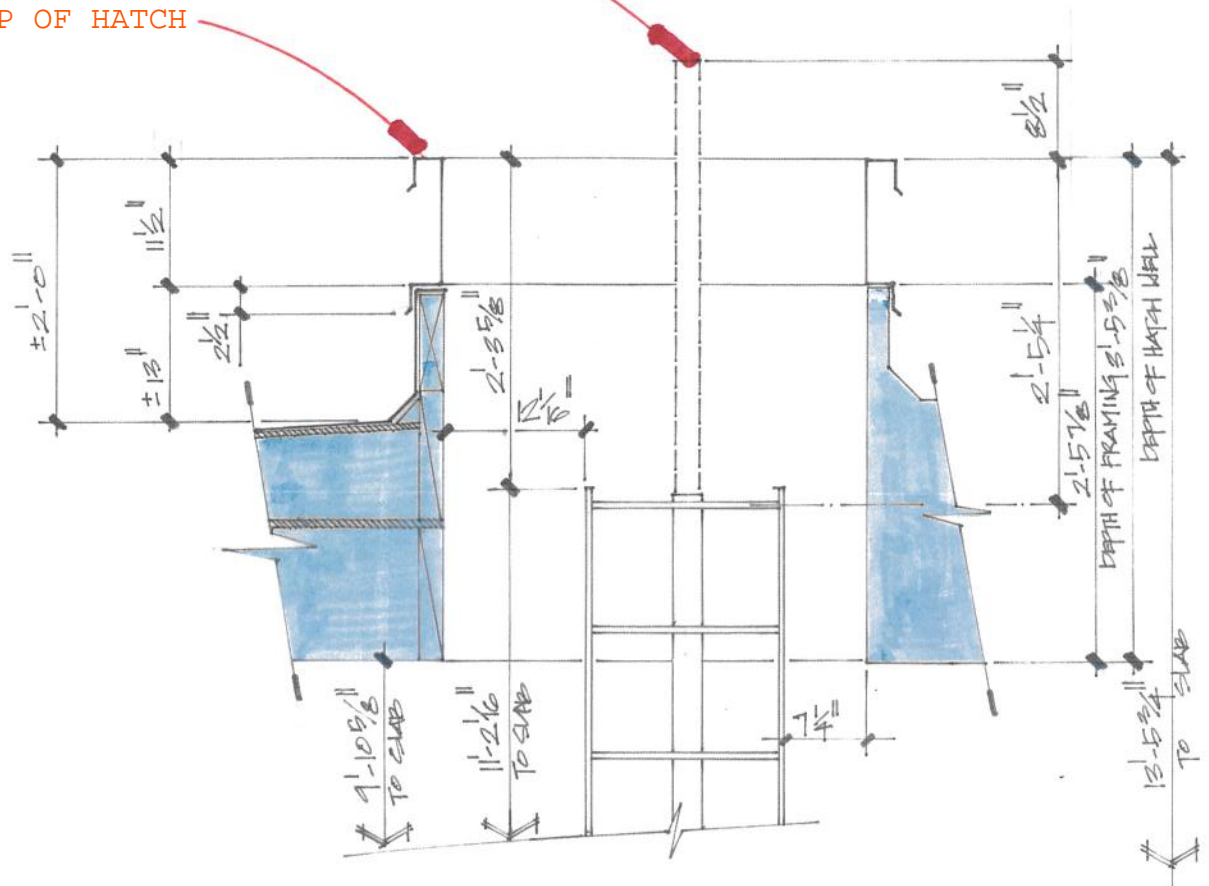
STEP LADDER ANCHOR PLATE

ROOF ACCESS LADDER
SCALE $\frac{3}{4}" = 1'-0"$.

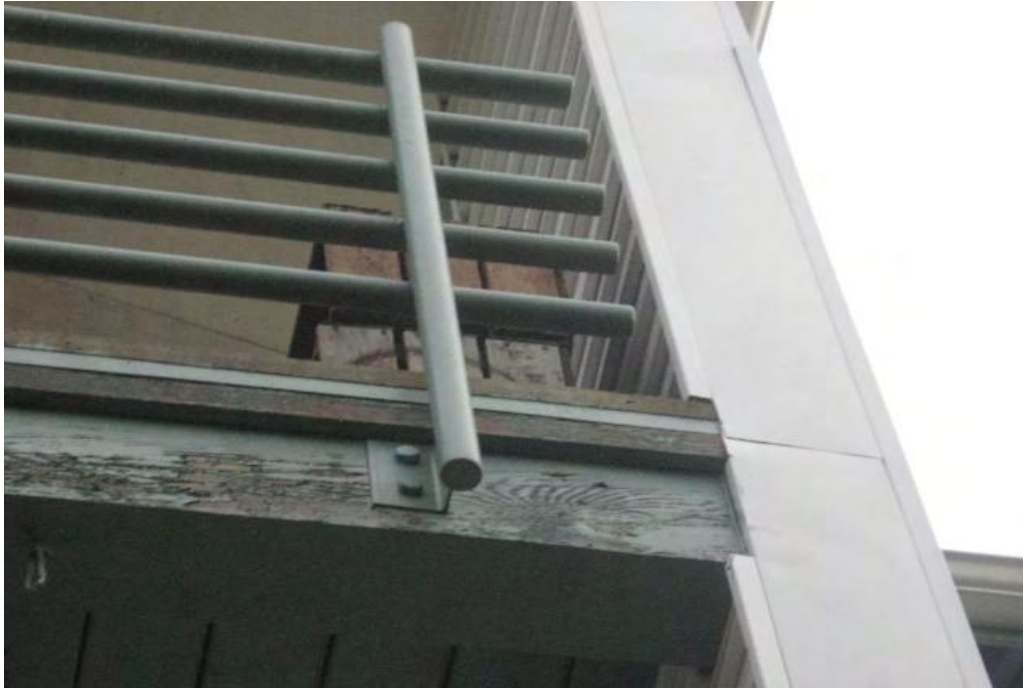
SM 01.038 Unit #49; Back elevation; Deck. Main guardrail fastened to beam with large lag bolts.

A separate issue unrelated to code requirements is the lack of lateral support at either end of the main guardrail. While this is not a code violation, we did observe leaning guardrails at various units. The leaning could be prevented by an attachment similar to that found at the top of the side guardrail.

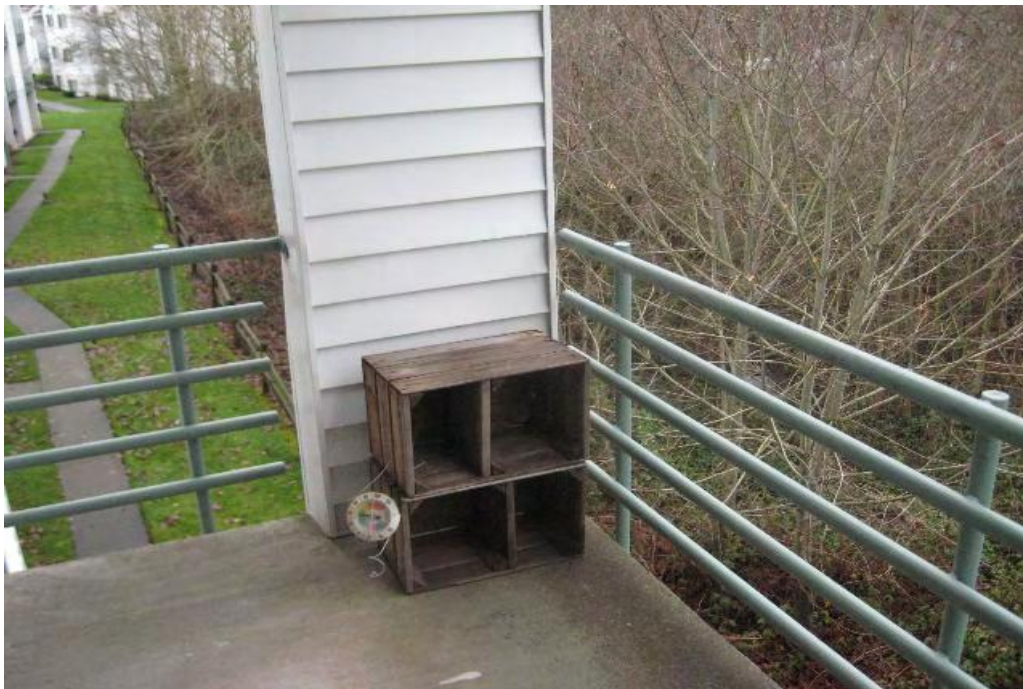
SM 01.043 Unit #49; Back elevation; Deck railing. Side guardrail at left, main guardrail at right. Note attachment to wall at right side of left guardrail.

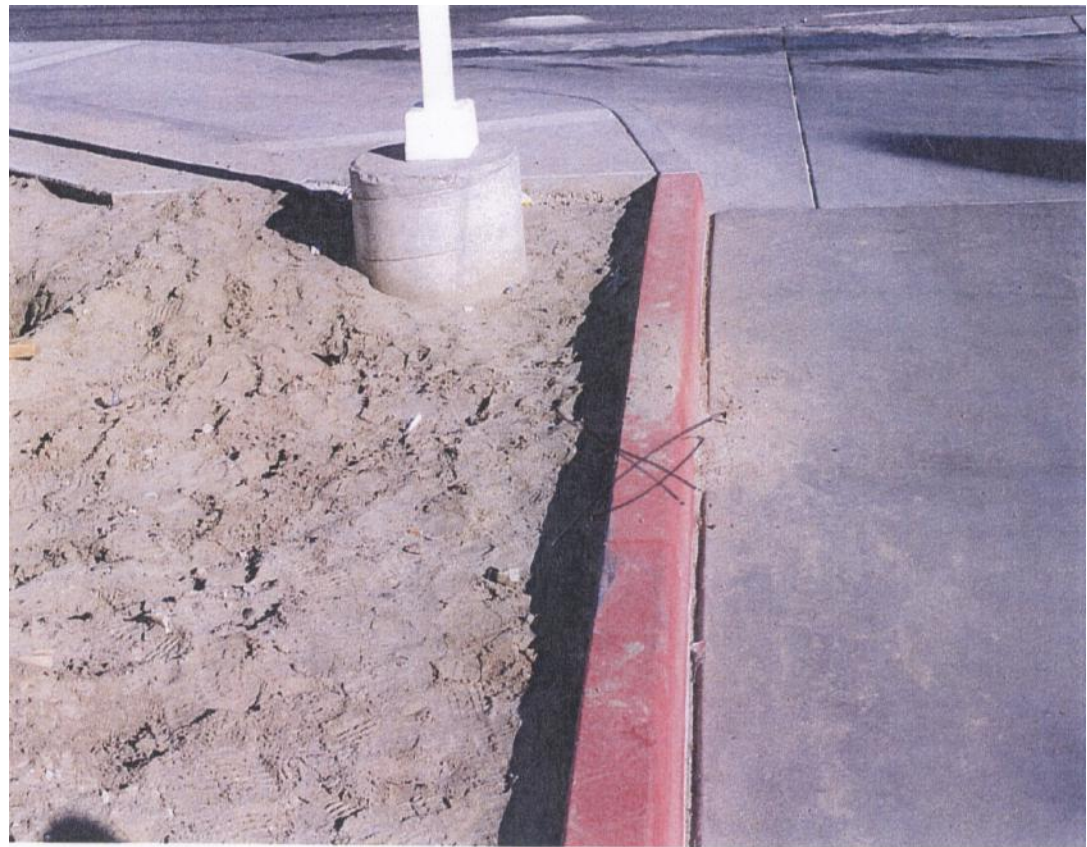
At his deposition plaintiff marked with an 'X' the location of the incident. Notice condition of red curb and planter.

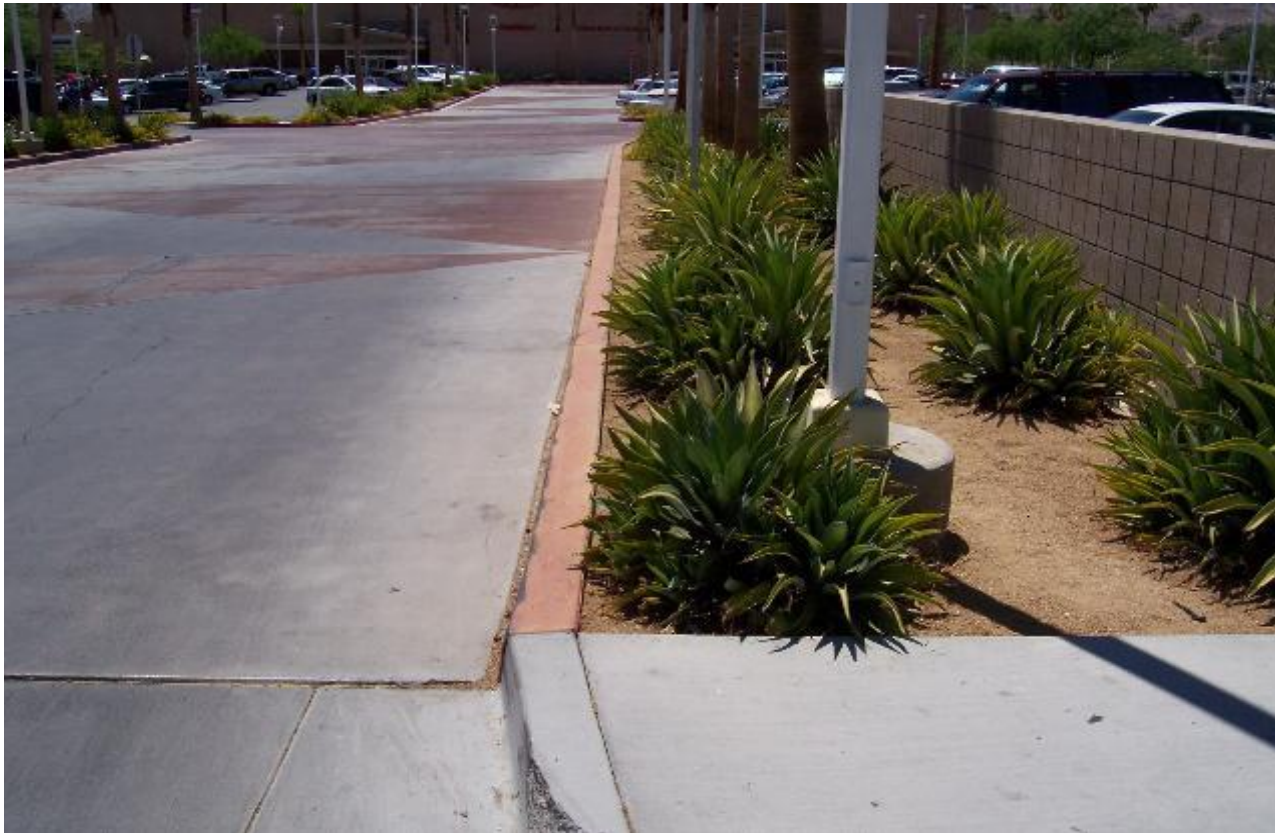
MP 01.006 6/5/06 Note footprints/ path in planter

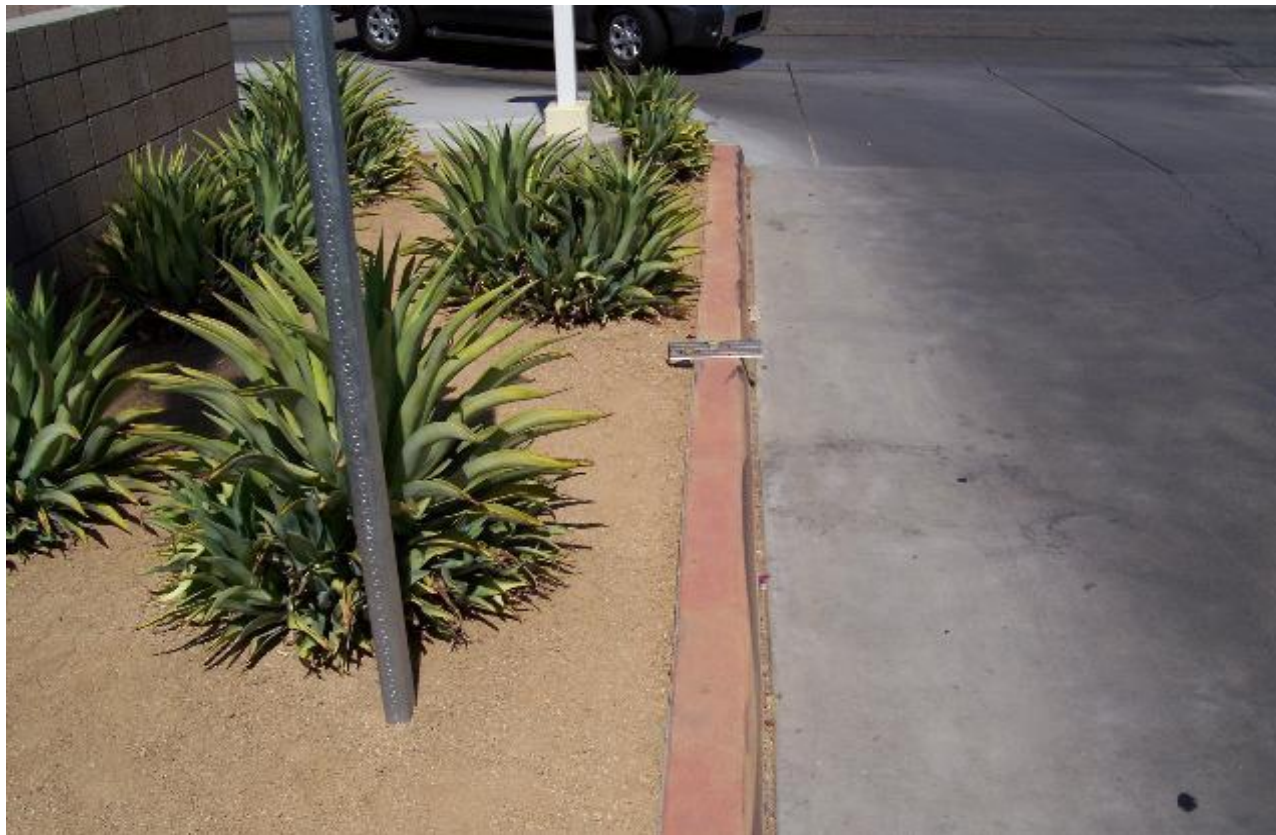
MP 01.034 6/5/06 Note footprints/path in planter.
