# River Front Living

*100 Main St, Seattle, WA*

Date: May 12, 2014  
To: PFCS - PDX  
PFCS - PDX  
T: (503) 246-3744 E: pdxstaff@petefowler.com  
From: Pete Fowler Construction Services, Inc.  
Project: River Front Living (PFCS 14-000)  
Regarding: Property Condition Assessment  
Note: Confidential Attorney-Client and Attorney Work Product. Protected under all applicable evidence codes.

The following report conforms to ASTM (American Society for Testing and Materials) E-2018, Standard Guide for Property Condition Assessments, with the primary goal being to identify and communicate physical deficiencies for the property located at 100 Main St, Seattle, WA.

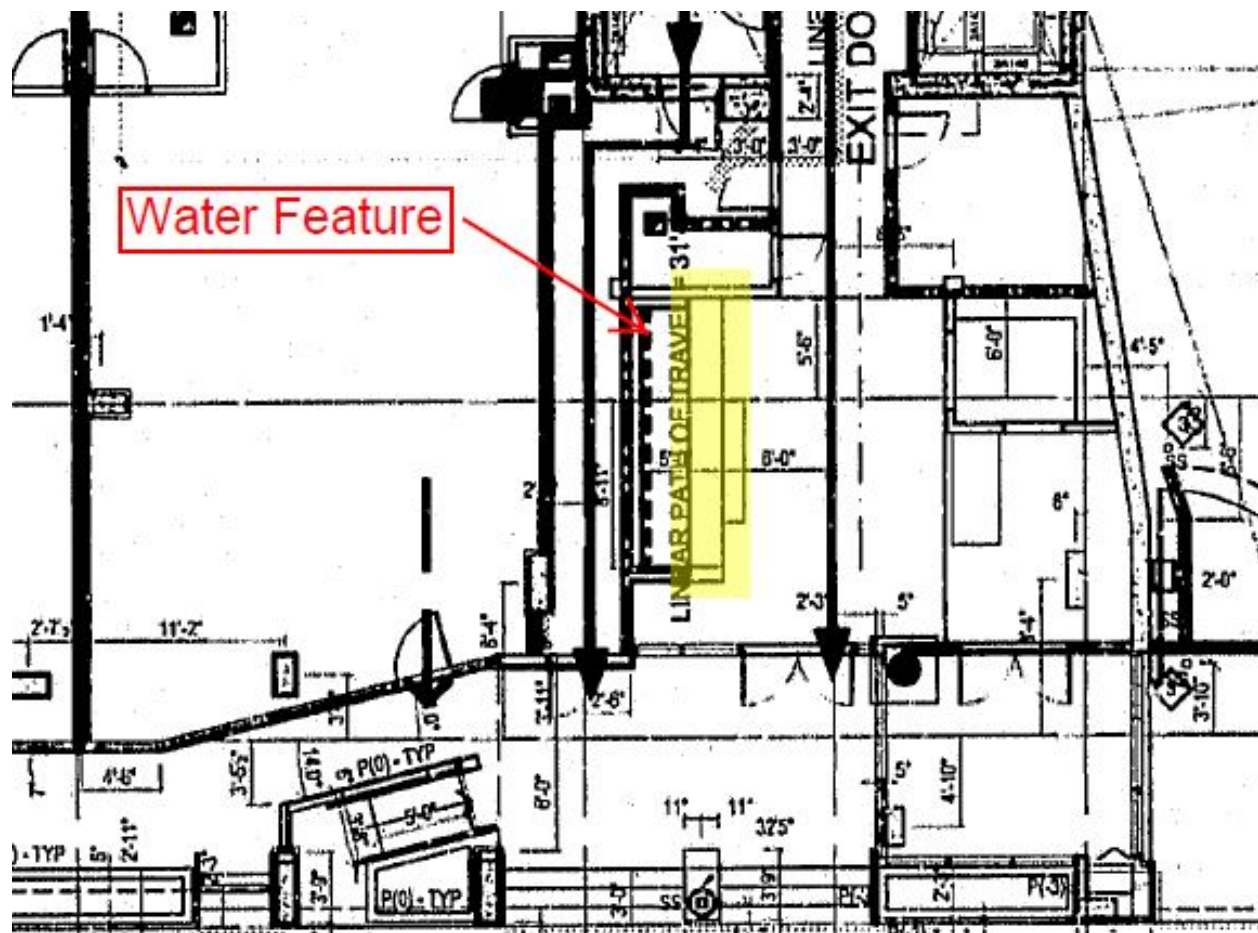
### Area - Building B Water Feature Location

Issue	Inspect below grade walls for cracks and moisture.
Investigation	Visual inspections performed at P1 and P2.
Analysis	<p>Visual inspections performed of P1 and P2 levels. In general, below grade concrete assemblies are performing as intended. PFCS did not note any excessive cracks, beyond 1/8th of an inch throughout the subterranean parking levels. All concrete columns were observed to be in good condition. See conclusions for isolated conditions noted.</p> <p>PFCS Identified 3 items requiring analysis:</p> <ul style="list-style-type: none"> <li>• Item 1. Moisture intrusion at Building A - Level P2 - North Elevation</li> <li>• Item 2. Grease migration at Building A - Level P2 - West Elevation</li> <li>• Item 3. Moisture intrusion at Building B - Level P1 below interior water feature</li> </ul>
Conclusion	<p>PFCS recommends that all water intrusion conditions are considered as immediate repairs, as these become significantly more expensive, if not addressed.</p> <ul style="list-style-type: none"> <li>• Item 1. Moisture intrusion at Building A - Level P2 - North Elevation.</li> <li>• ** PFCS noted excessive saturation of soils along North elevation of building A due to excessive irrigation, and lack of drying cycles.</li> <li>• ** RECOMMENDATION: Turn down or completely turn off irrigation along North elevation of building A. This area does not have any dry time, due to its exposure and significant shading provided by the structure. Clean and eliminate efflorescence along moisture intrusion area and monitor for future performance. Once irrigation is adjusted, moisture intrusion may stop. If moisture intrusion continues, repairs may be required, such as exposing waterproofing system and termination bar at exterior, and or concrete repairs from the interior of the structure.</li> <li>• Item 2. Grease migration at Building A - Level P2 - West Elevation.</li> <li>• ** Grease migrating into concrete structure from tieback assemblies. Aesthetic condition only.</li> <li>• *** RECOMMENDATION: Clean off grease that has migrated into the concrete structure.</li> <li>• Item 3. Moisture intrusion at Building B - Level P1 below interior water feature.</li> <li>• ** Also see G2043B. Water migration through concrete directly below interior entry water feature.</li> </ul>

Conclusion (continued)	<ul style="list-style-type: none"><li><b>** RECOMMENDATION:</b> Turn off water feature and clean area of water intrusion, located within P1. Monitor condition while water feature is turned off in order to positively determine that the source is the water feature. It is likely that the water feature is the source and waterproofing repairs will be required.</li></ul>
Costs

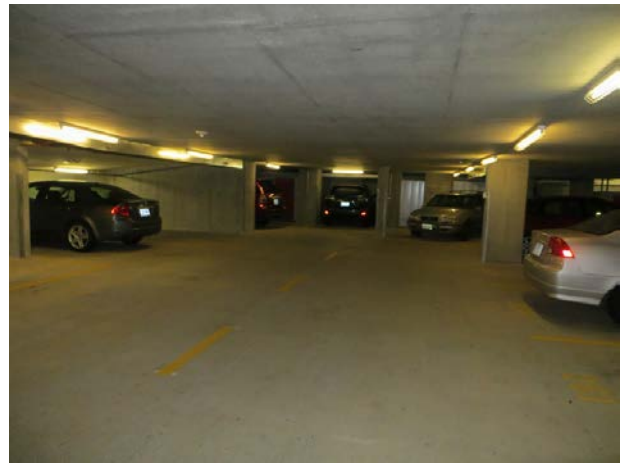
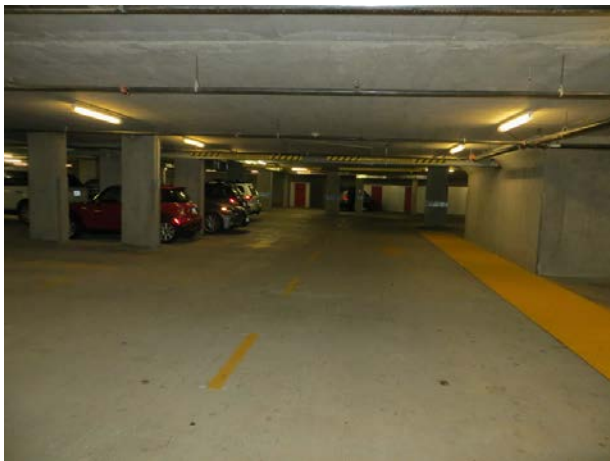
Issue	Inspect concrete structure for excessive cracks and or moisture intrusion conditions.
Investigation	Visual inspections of P1 and P2 levels.
Analysis	PFCS has performed a visual inspection of parking levels P1 and P2 at both structures. In general, the overall condition of the concrete subterranean structure is in very good condition. Vehicular pathways are well marked, signage is adequate, all parking stalls are marked, and concrete appears to be free from significant cracks.
Conclusion	No repairs recommended.
Costs

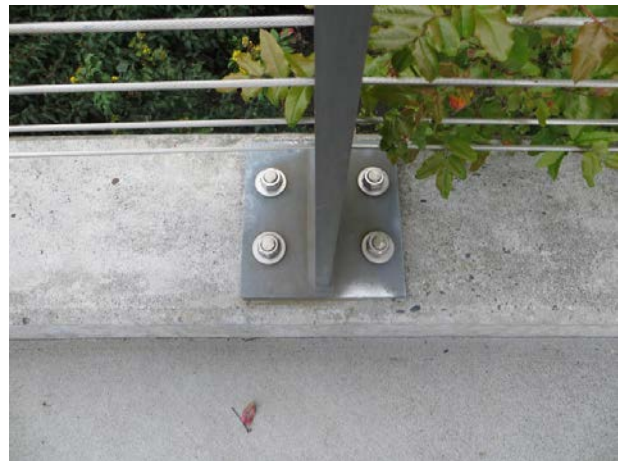
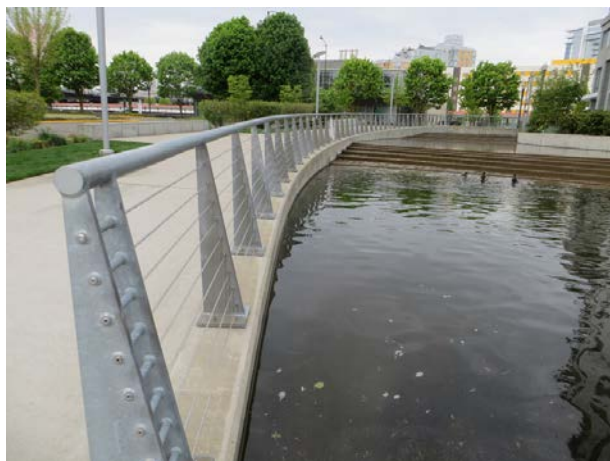
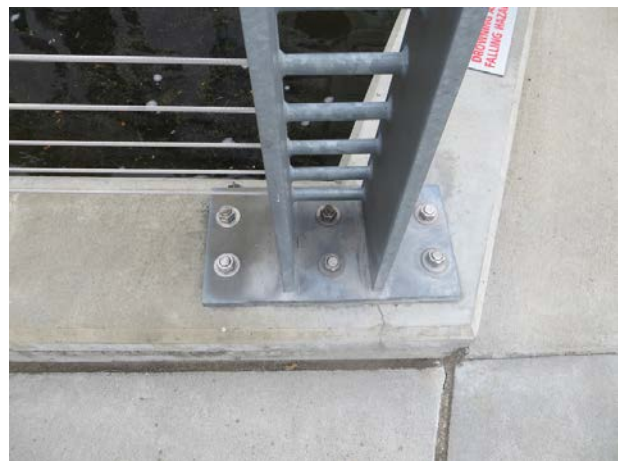
Issue	Investigate finishes and structural integrity.
Investigation	Visual inspections.
Analysis	Handrails at river-walk area, eastern elevations. All handrails were noted to be in good condition. Metal handrail system with cables. All cables were noted to be present and tight. None of the finishes were noted to be in distress. All handrails were solid with adequate structural integrity.
Conclusion	No repairs recommended.
Costs

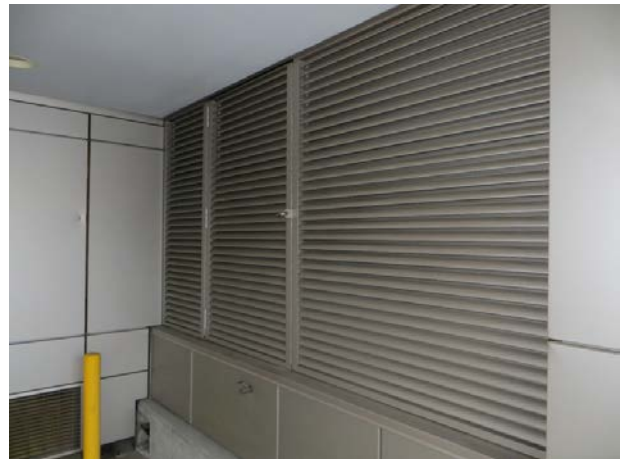
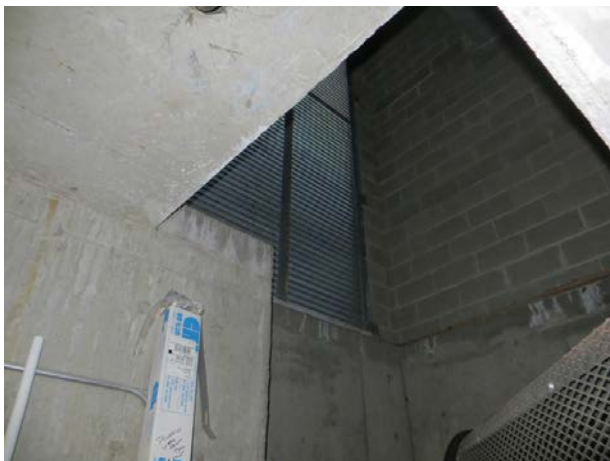
Issue	Inspect finishes for corrosion or any distress.
Investigation	Visual inspections.
Analysis	Metal louvers were observed at numerous locations, mainly associated with garage venting and mechanical rooms. All louvers were observed to be in good condition, with no corrosion noted.
Conclusion	No repairs recommended.
Costs

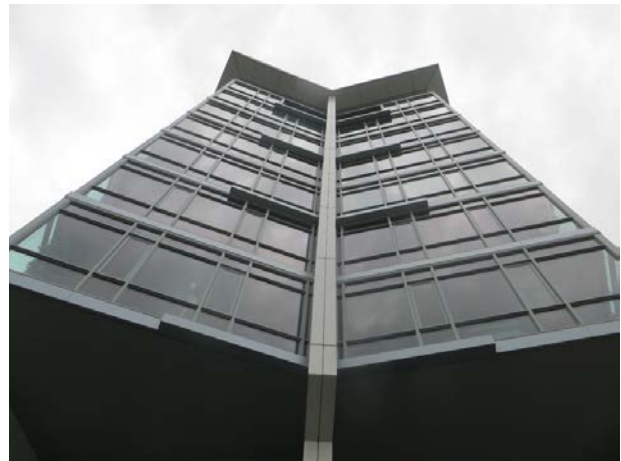
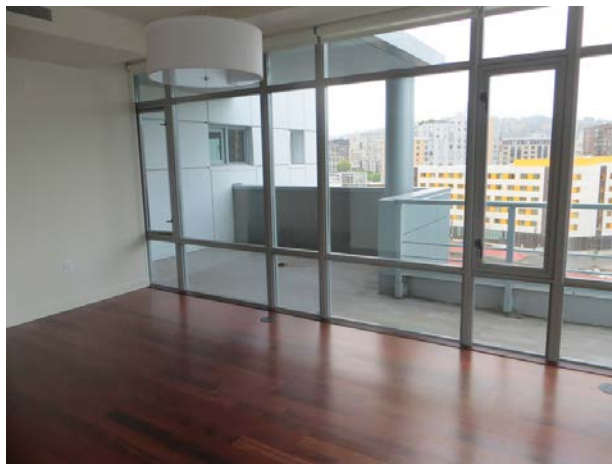
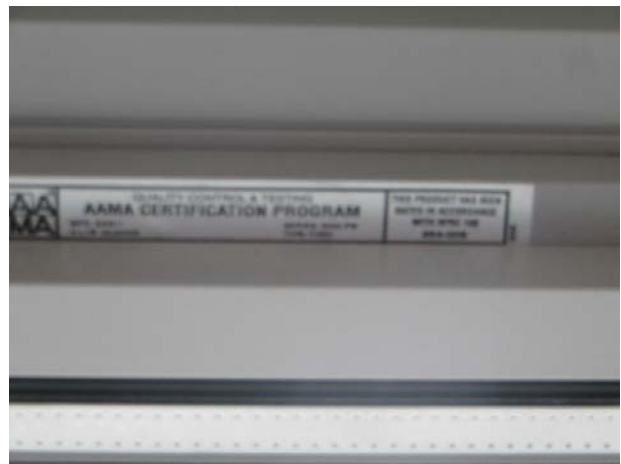
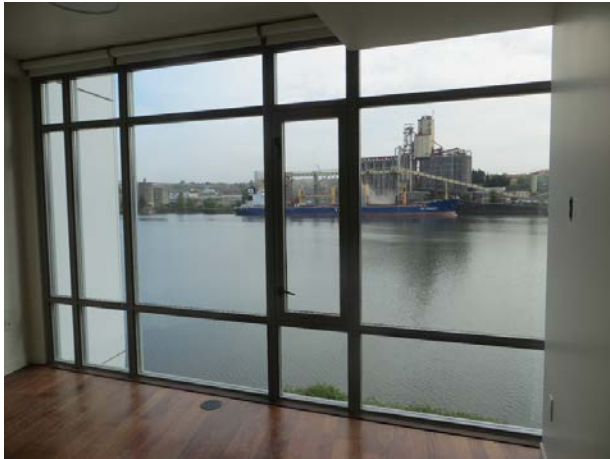
Issue	Inspect for sealant failures or glazing failures.
Investigation	Visual inspections.
Analysis	<p>PFCS performed visual inspections of the common and residential units, where accessible throughout our inspections. The windows are AAMA certified (see inspection photographs), and manufactured in Canada by Starline Windows. All caulking around windows was observed to be in good condition. All glazing seals were observed to be performing with no failed units noted throughout. Per interview with Jason Cunningham (on-site building engineer) and Sean Rogers (property manager), there have been no reported leaks at windows throughout the history of the project.</p> <p>Product Manufacturer: Starline Architectural Windows  Series 9000 - Double Glazed Window Wall  Series 9502 - Double Glazed Swing Door  Series 9503 - Triple Glazed Swing Door  Product Description: Thermally broken 4 1/2" aluminum casement / fixed window with seismic jambs</p>

Conclusion	No repairs recommended. PFCS recommends inspections of sealant joints at windows, once a year.
Costs

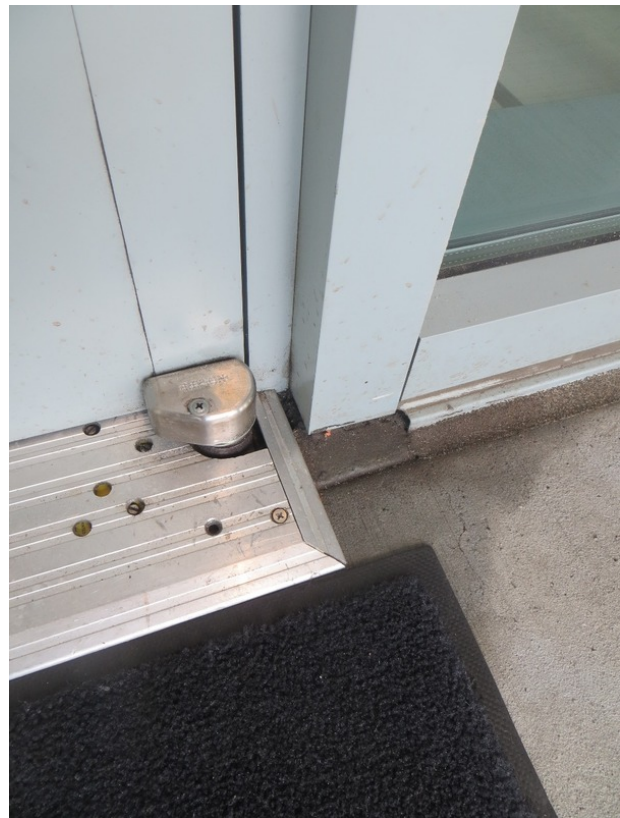
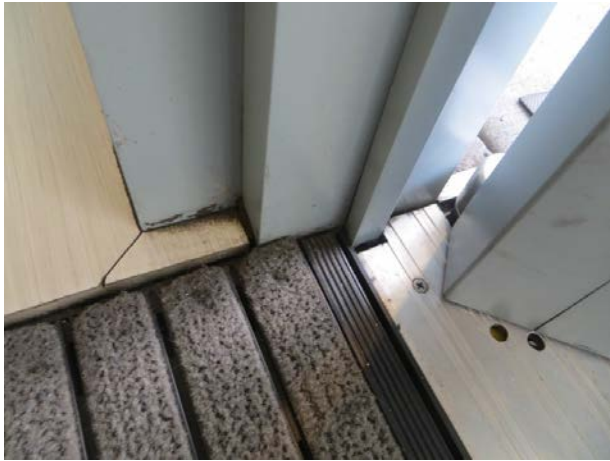
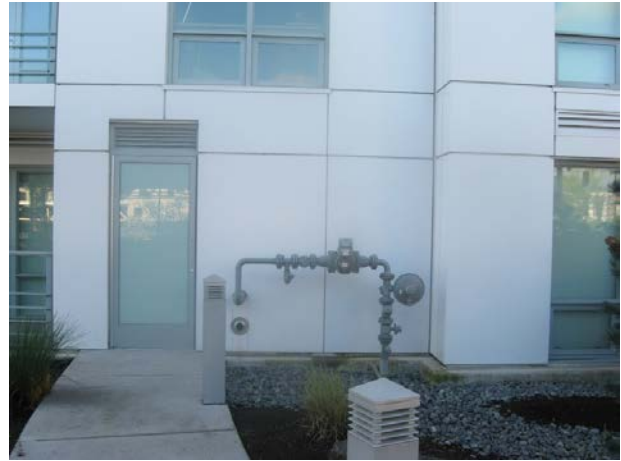
Issue	Inspect for sealant failures and operational status.
Investigation	Visual inspections.
Analysis	PFCS performed visual inspections of common area doors throughout the buildings. The main entry doors were observed to be well covered, where the building was providing good protection of the main entries. All doors and hardware were noted as operational with no issues. All finishes were noted as in good condition with no immediate maintenance required.
Conclusion	No repairs recommended.
Costs

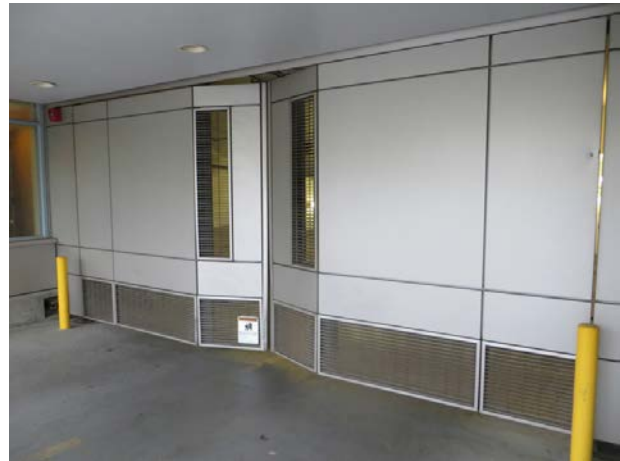
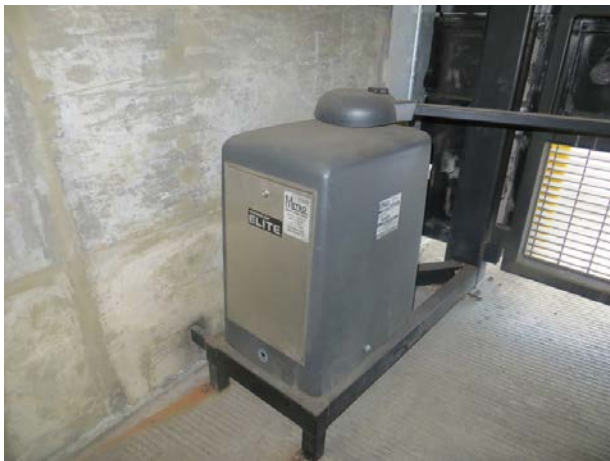
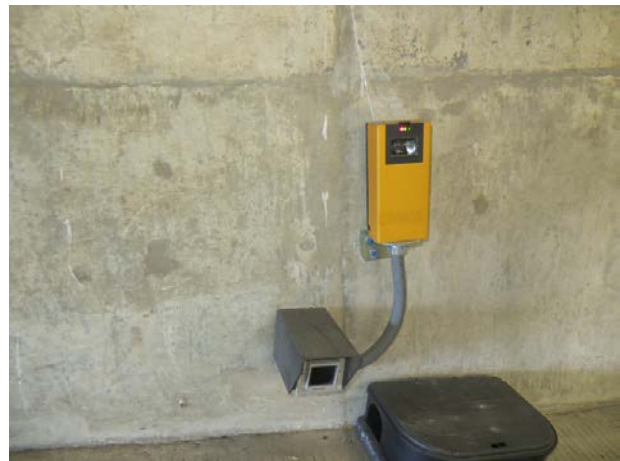
Issue	Inspect operational status and finishes.
Investigation	Visual inspection.
Analysis	Garage doors were observed to be functioning as intended, with frequent use, due to only one entrance into subterranean garage structure. Door was observed to open with ease, once activated by an approaching car. A dent was noted from the exterior (aesthetic item), with no immediate need for repairs. Opener motor was noted to be by Chamberlain Elite and serviced by Metro Security Access Control Company.
Conclusion	No repairs required.
Costs

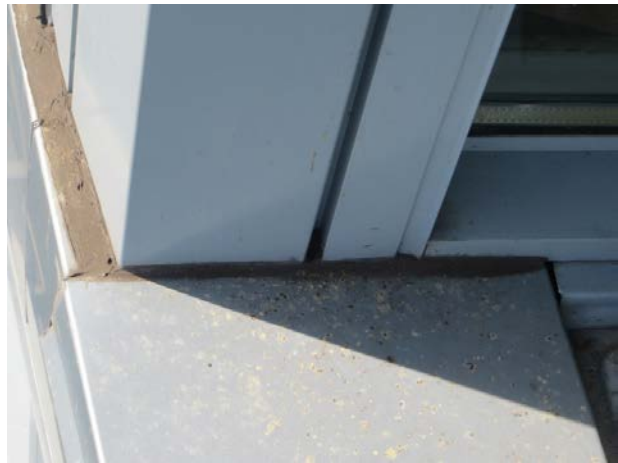
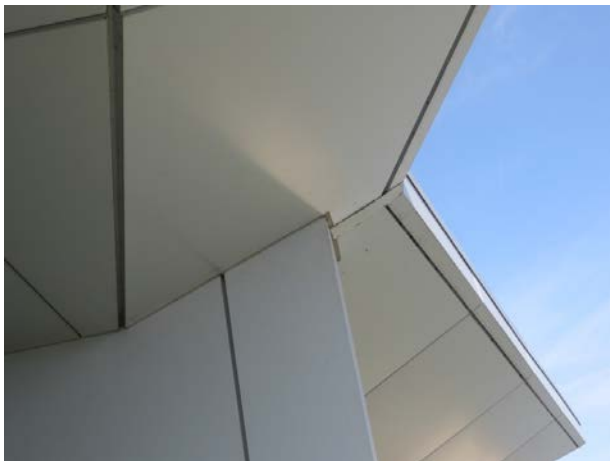
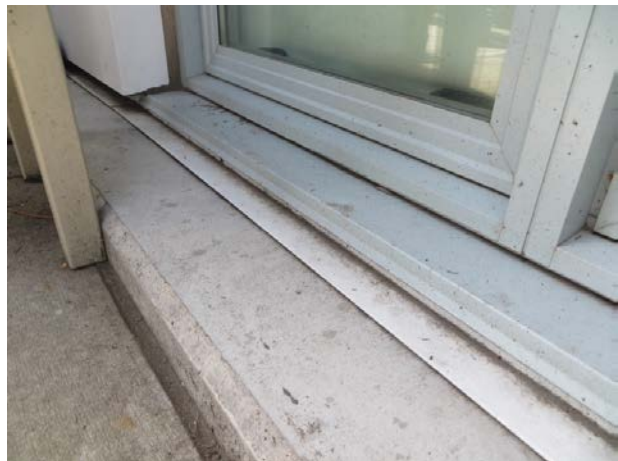
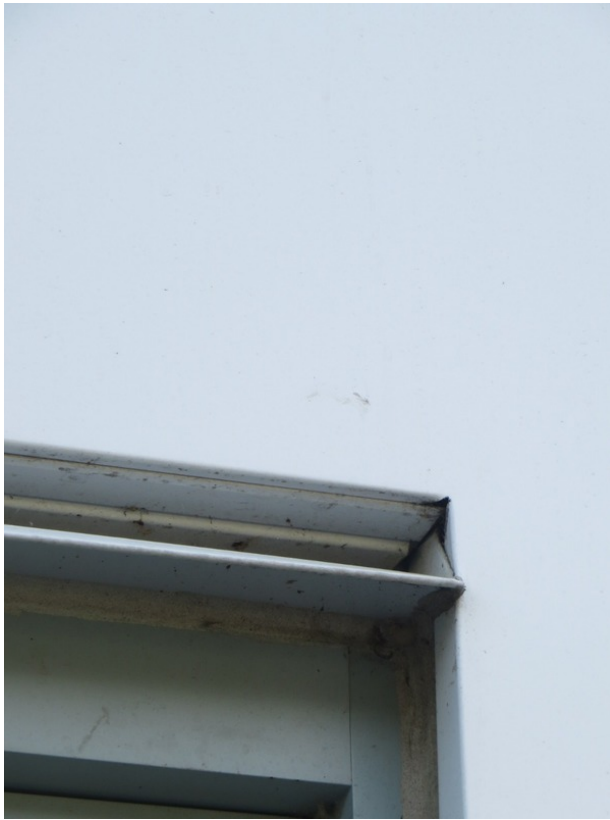
Issue	Identify and inspect product transitions and associated sealant joints.
Investigation	Visual inspections.
Analysis	PFCS inspected wall flashing details, as available throughout numerous inspections. Flashing details were observed at product transitions and generally observed in areas where required by code and industry standards. Based on interviews, no water intrusion events have been noted throughout the buildings.
Conclusion	No repairs required.
Costs

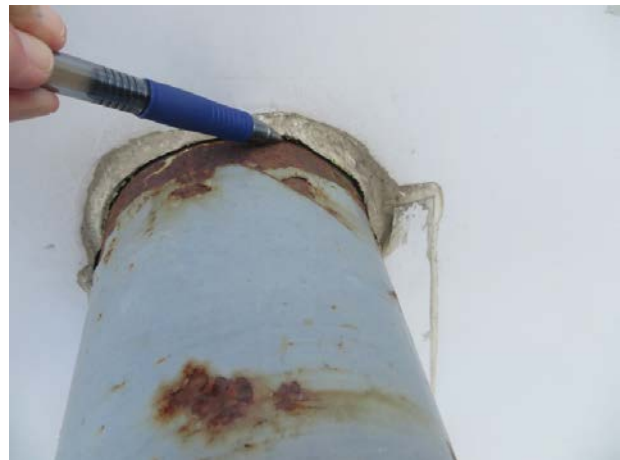
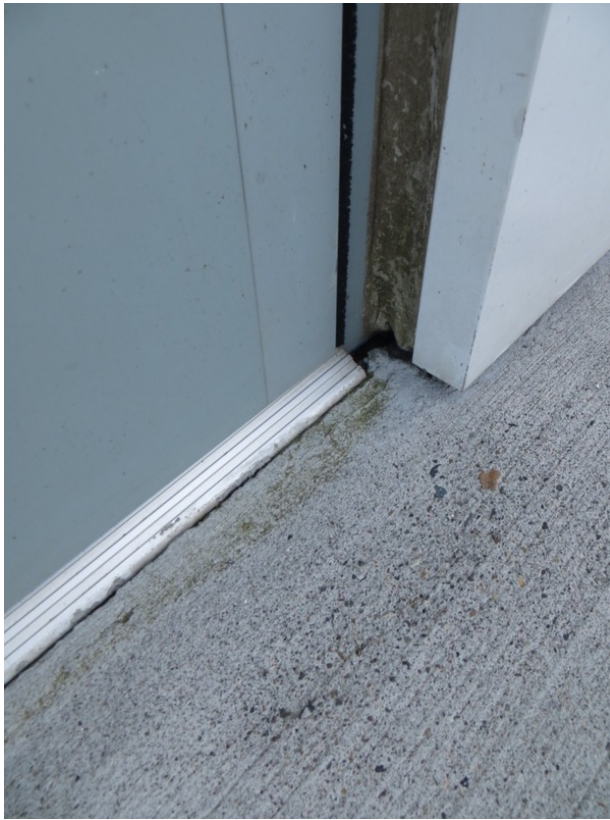
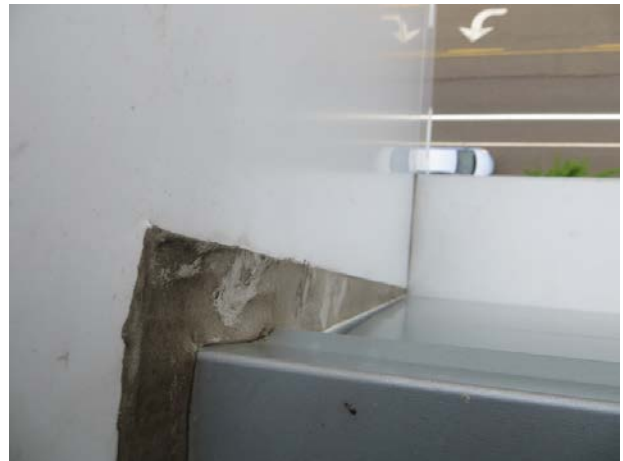
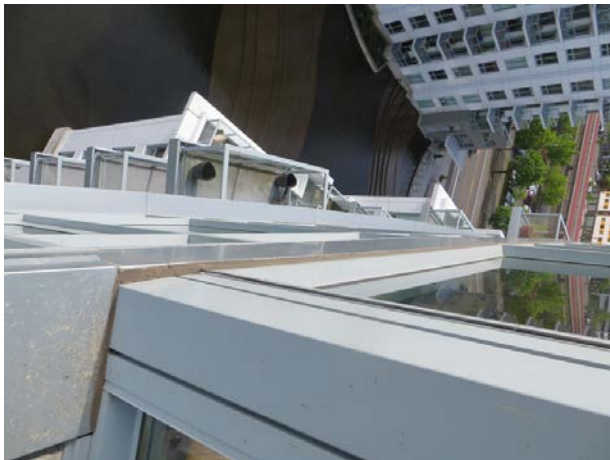
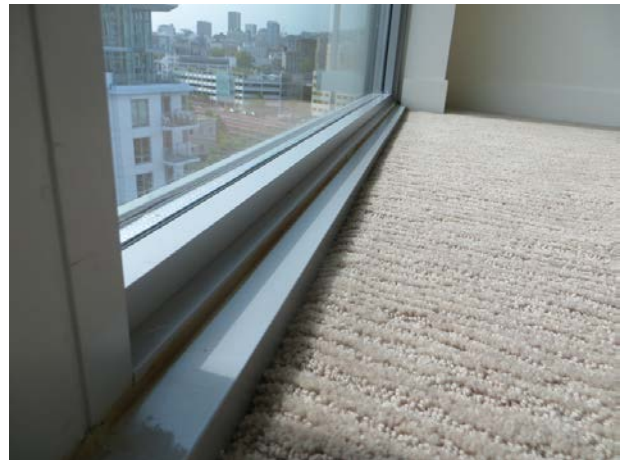
Issue	Inspect sealant joints for performance.
Investigation	Visual inspections.
Analysis	Sealant joints were noted to be in fair to good condition. Sealant joints are of commercial grade, with a backer rod system, adequately supporting them. Annual inspections required in order to assure performance and to identify a replacement time frame.
Conclusion	<ul style="list-style-type: none"><li>Isolated repair required at Building A - north elevation natural gas entry.</li><li>In general, the sealant joints observed are performing well in service</li><li>PFCS recommends inspections of sealant joints at windows, once a year.</li></ul>
Costs

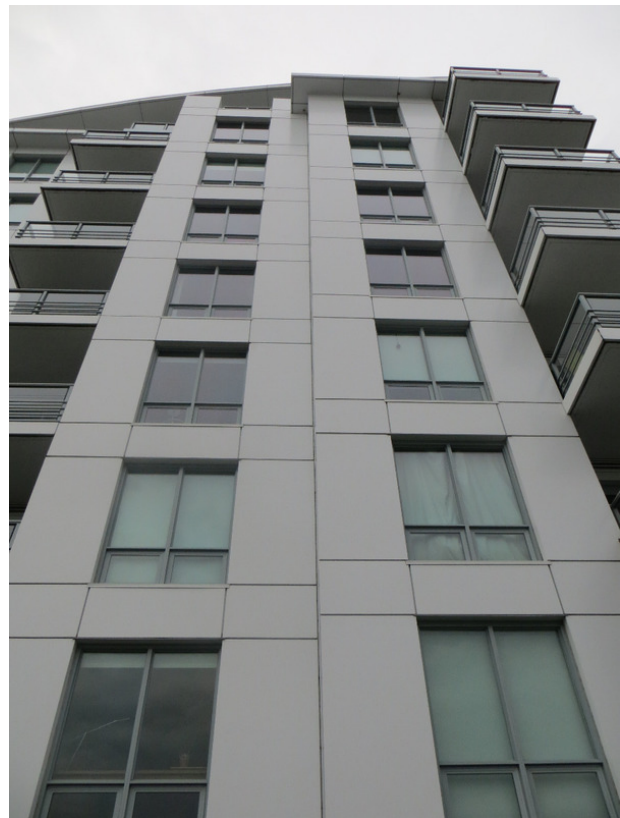
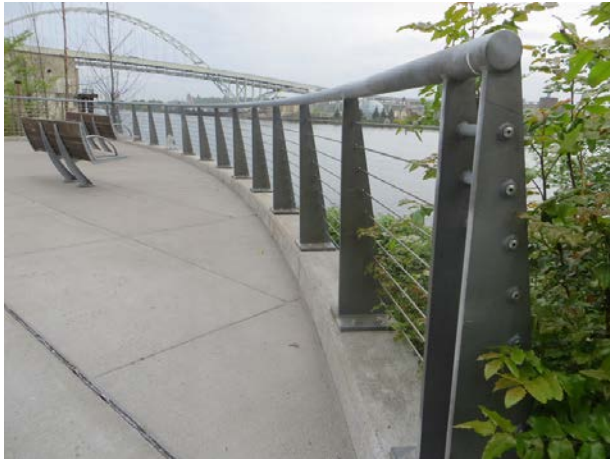
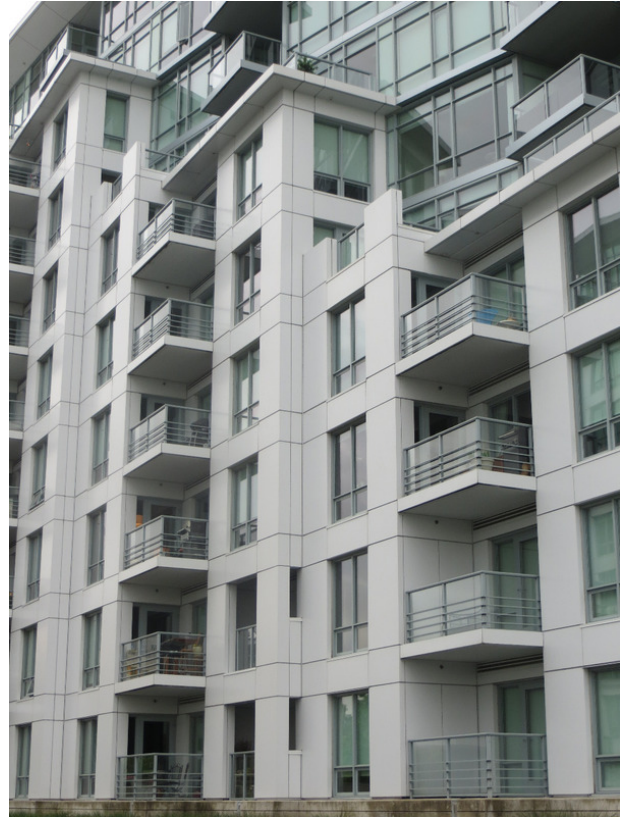
Issue	Inspect exterior envelope and site components for corrosion or failing finish surfaces.
Investigation	Visual inspections.
Analysis	Most products delivered to the project, during the original construction were pre-finished in the factory. Current observations did not indicate any products experiencing corrosion or a failing finished surface condition. Bubbling paint was observed at Building A soffit area, see element B2010 for further details and repair recommendations.
Conclusion	No repairs required.
Costs

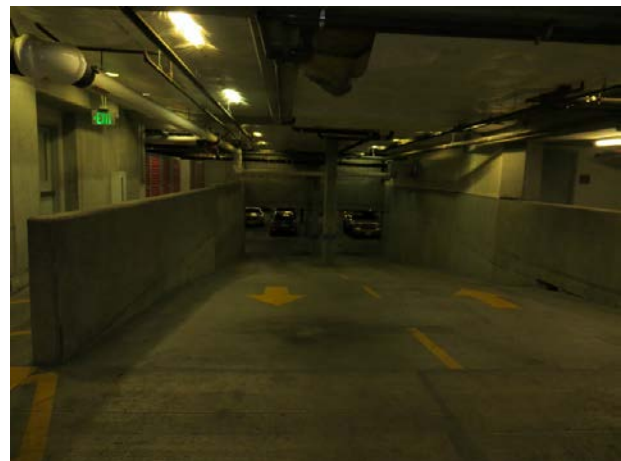
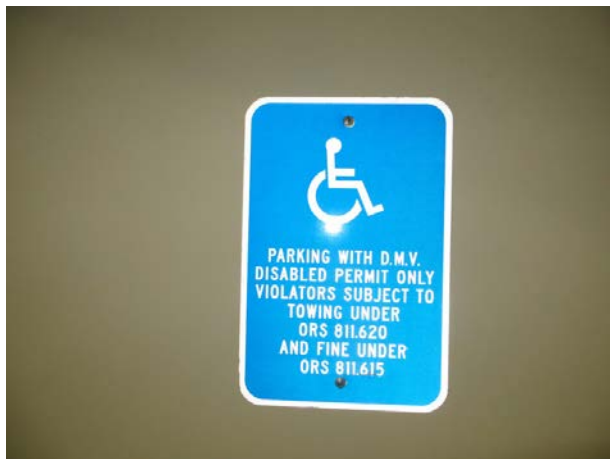
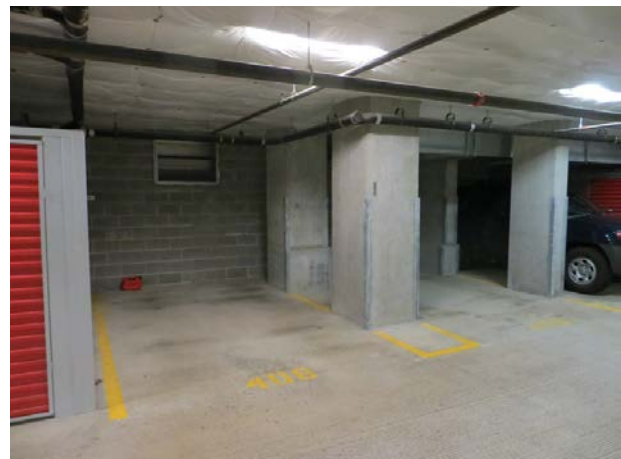
Issue	Inspect signage and reflectivity of striping at concrete.
Investigation	Visual inspection
Analysis	Visual inspections.
Conclusion	PFCS performed a visual inspection of levels P1 and P2. Concrete paint striping was reflected and all parking stalls, directional paint, and in general was in good condition.
Costs	No repairs recommended.

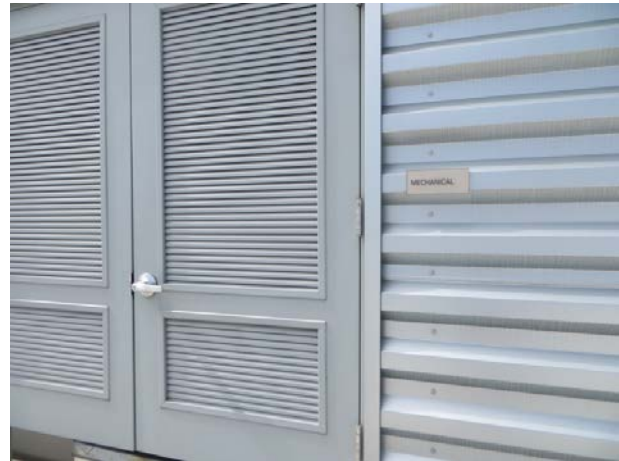
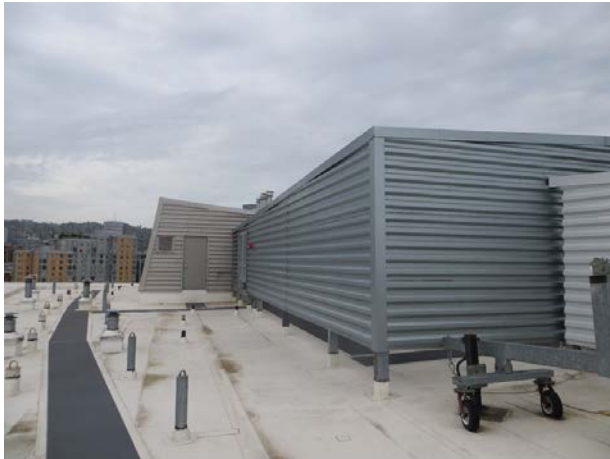
Issue	Inspect for structural integrity, corrosion, and loose connections.
Investigation	Visual inspections.
Analysis	PFCS observed the wind screens to be in good condition. None were identified as in distress, loose, or any signs of corrosion. The main purpose of the panels is to block and enclose the mechanical equipment, located at the roof level of each building.  Product: Aluminum panels, attached to metal framing
Conclusion	No repairs required
Costs

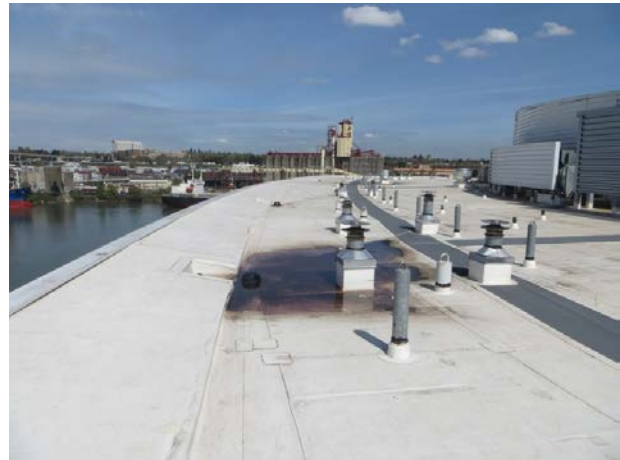
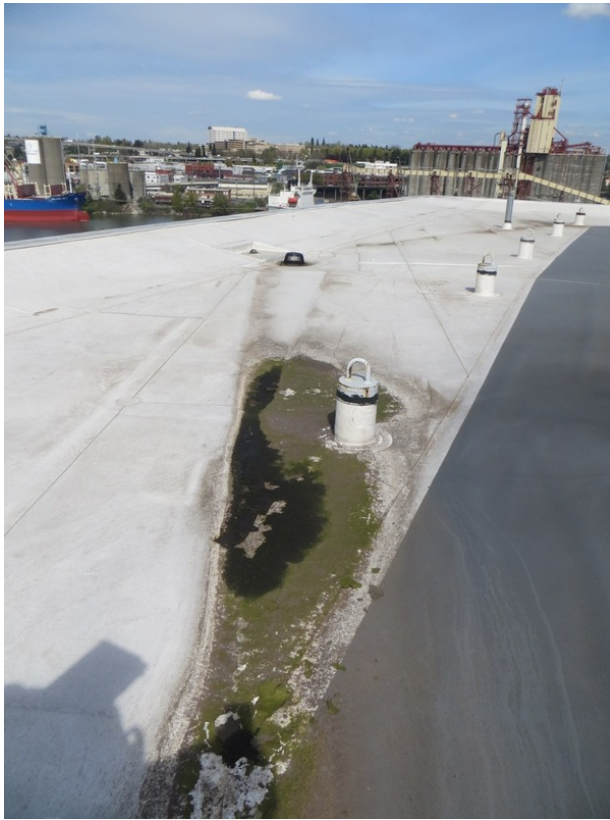
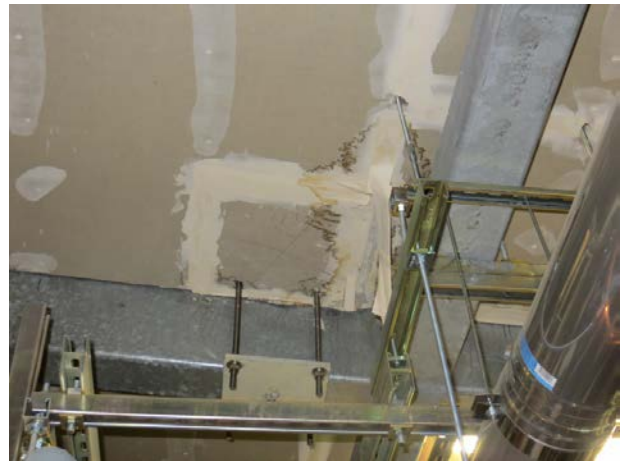
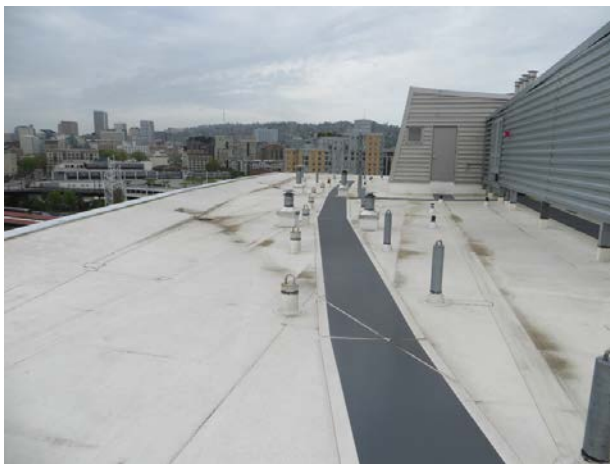
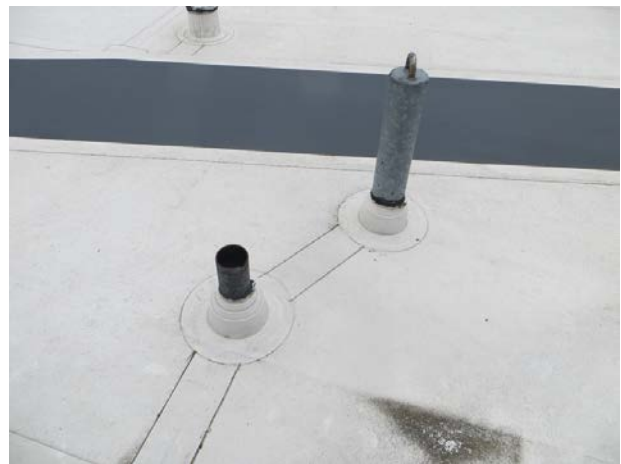
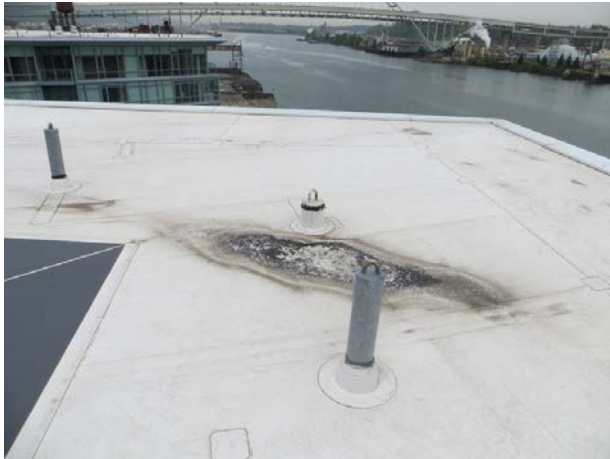
Issue	Visual inspection for standing water, seams, and overall condition of roof membrane.
Investigation	Visual inspection.
Analysis	<p>In general, the overall condition of the roof membrane is good. Seams and detailing at corners and penetrations are performing well, and none were observed to be loose nor are there signs of delamination. Some areas of standing water were noted at Building A. Although the manufacturer warranty is not impacted, standing water can lead to premature deterioration of the membrane. Per interviews conducted of Jason Cuninghame (on-site building engineer), the roof is being inspected twice per year, and therefore in compliance with the manufacturer warranty language.</p> <p>Product: Membrane roof system Manufacturer: Carlisle Coating &amp; Waterproofing</p> <p>Previous repairs were noted at the roof top mechanical room, where the pipe structural brackets were installed through the roof assembly and were not properly sealed. Stains at gypsum ceiling are not from an active leak, as repairs were completed, as per Jason. No action required.</p>

Conclusion	No repairs required. Continue semi annual inspections of the roof membrane.
Costs

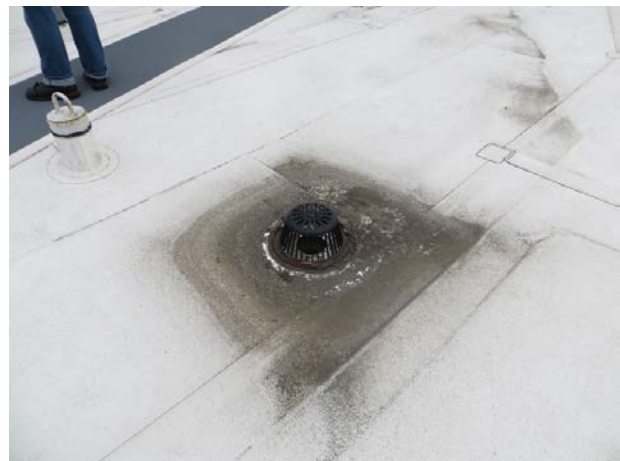
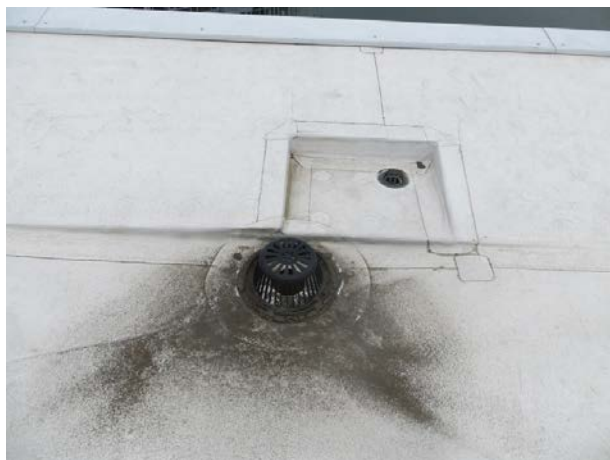
Issue	Inspect roof drain covers / ponding conditions / debris
Investigation	Visual inspections.
Analysis	PFCS inspected both roof assemblies. In general the roofing membrane is performing as intended, however some ponding of water was observed at the roof drains. All drains were free of debris. Isolated roof drain cap was noted as missing at Building A.
Conclusion	Isolated repair required. Install a roof drain cap at Building A roof drain.
Costs

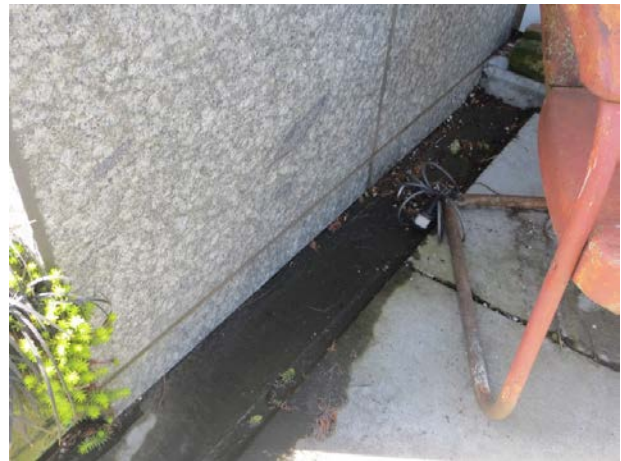
**BW-01.325; 04/08/2014; Elevation Front / West,  
Elevation Right / South**

Issue	Inspect waterproofing membrane and drainage at decks over livable space.
Investigation	Visual inspections.
Analysis	<p>PFCS has inspected numerous deck locations, that are directly over livable space below. In general, these areas are performing well. However, regular maintenance will be required. It is strongly recommended that all pots placed onto the waterproofing surface have isolation pads and standing water is avoided by excessive watering of plants. Some decks were noted with ponding water stains, and occupants should do their best to eliminate any standing water via maintenance. All drain assemblies must be maintained and unit owners need to keep them free of debris.</p> <p>Although elastomeric waterproof deck coating membrane manufacturers claim recoating is required every 2-5 years (pfcs.co/dq2u), they generally have a service life of between 5-12 years, depending on exposure and use. The HOA should maintain budgets to accommodate for an additional membrane, due at estimated time of replacement.</p> <p>There are 2 items that need to be addressed:</p> <ul style="list-style-type: none"> <li>Item 1: Building B - unit 905 has had previously identified excessive water ponding, and PFCS recommends that a reasonable repair approach to re-slope the finish coating should be planned and executed. It is not recommended that a more aggressive repair approach, that requiring concrete work, will be required.</li> <li>Item 2: Building A - Antique Store Patio, excessive moisture from above deck. Further investigation required. See photographs BW 1.323, BW1.325, and BW1.330.</li> </ul>

Conclusion	<ul style="list-style-type: none"> <li>Item 1: Building B - unit 905 has had previously identified excessive water ponding, and PFCS recommends that a reasonable repair approach to re-slope the finish coating should be planned and executed. It is not recommended that a more aggressive repair approach, that requiring concrete work, will be required.</li> <li>Item 2: Building A - Antique Store Patio, excessive moisture from above deck. Further investigation required. See photographs BW 1.323, BW1.325, and BW1.330.</li> </ul>
Costs

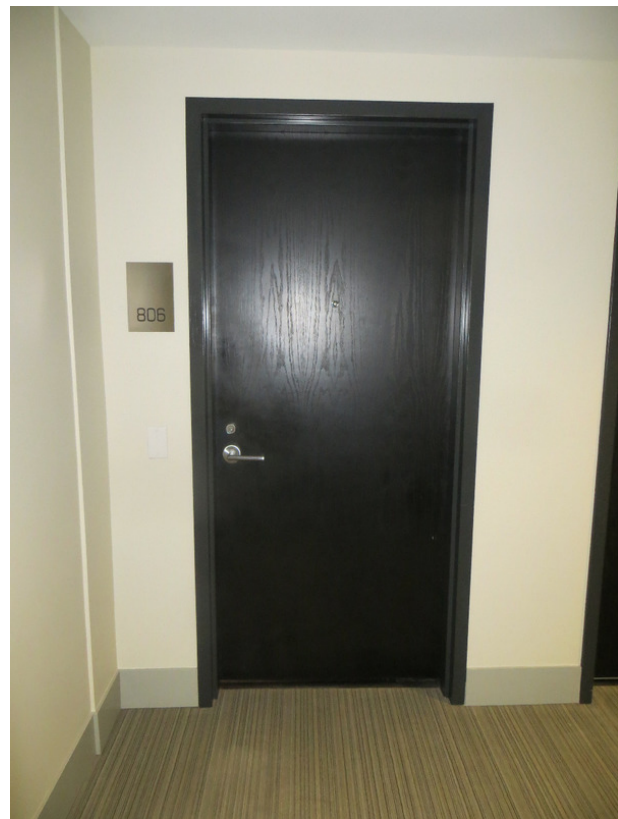
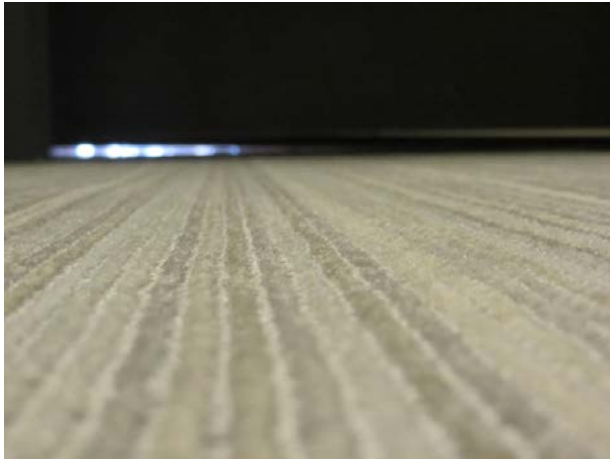
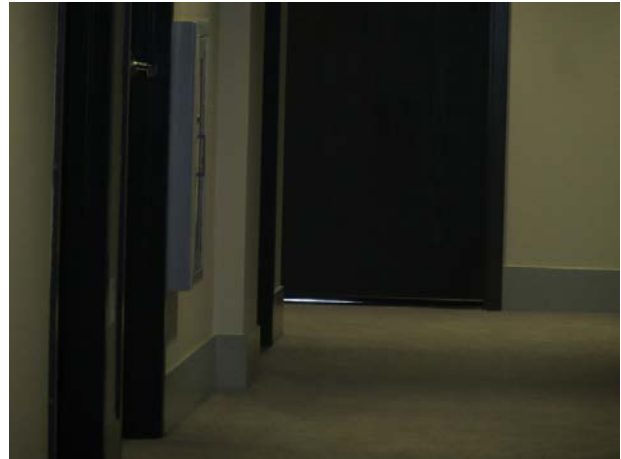
Issue	Verify condition of interior doors.
Investigation	Visual inspections.
Analysis	PFCS noted numerous entry doors that did not have the drop-down smoke seal threshold in the correct location, thus needing to be adjusted.
Conclusion	Consider adjusting threshold drop down seals so that they function properly.
Costs

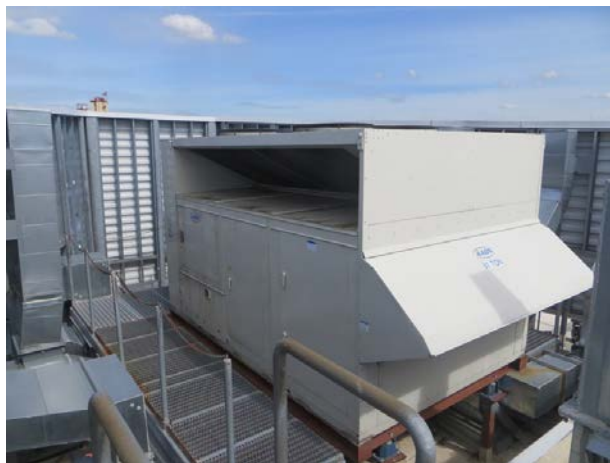
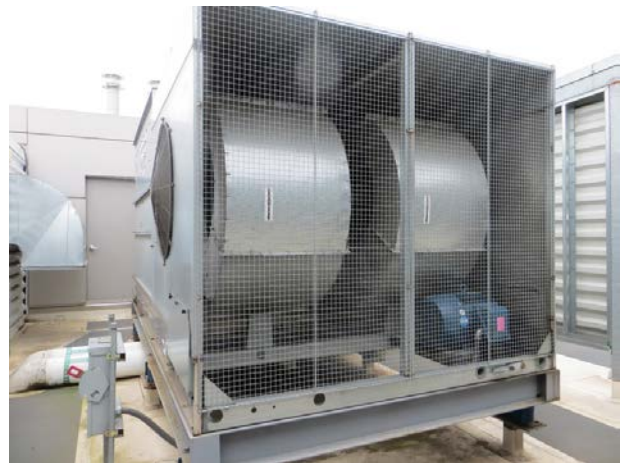
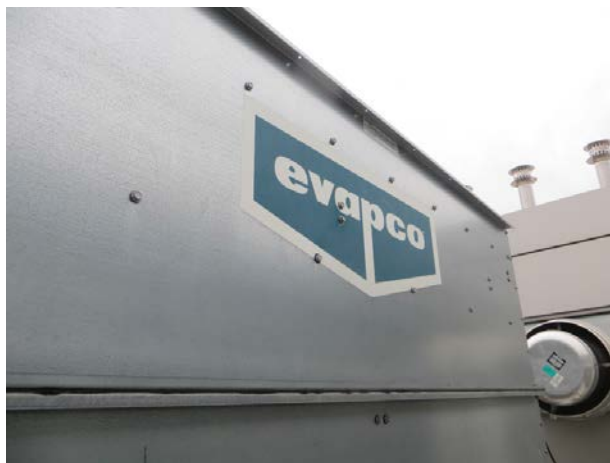
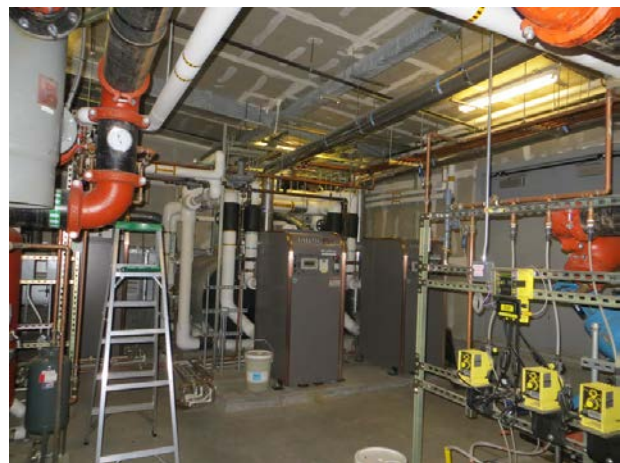
Issue	Inspect for regular maintenance schedule and for potential leaks.
Investigation	Visual inspections.
Analysis	PFCS did not observe any leaks associated with the cooling tower equipment.  Manufacturers: AAON and Evapco Cooling towers are on a regular maintenance schedule.
Conclusion	No repairs recommended. Continue maintenance schedule.
Costs

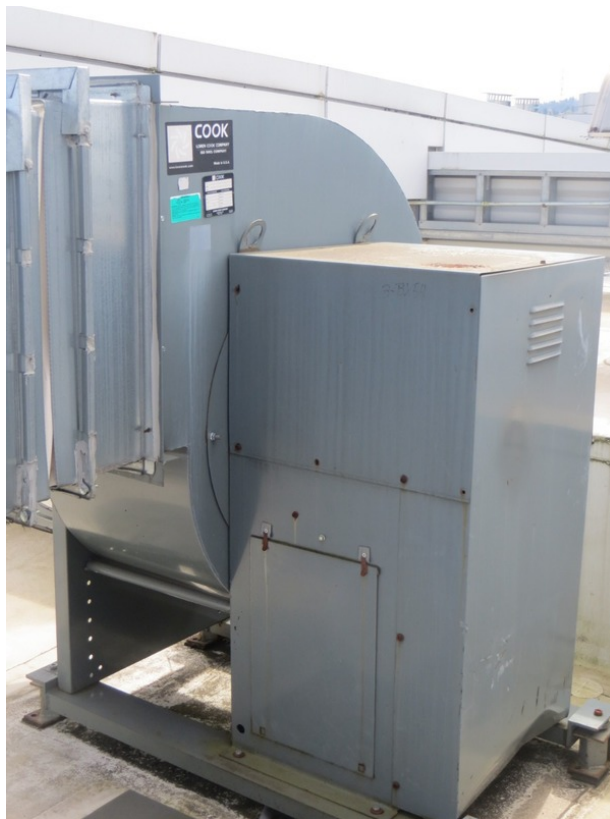
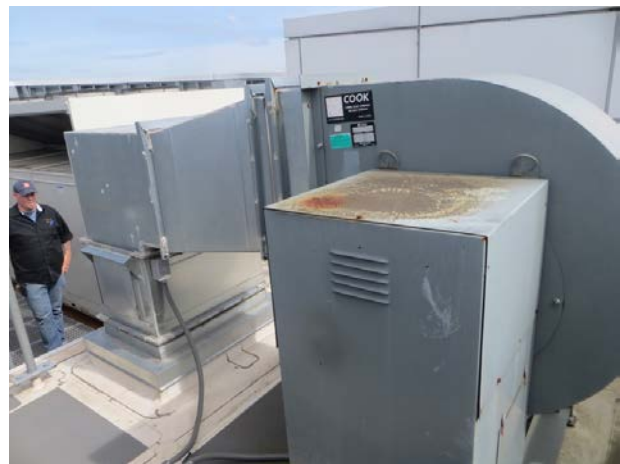
Issue	Verify maintenance schedule and check for equipment related leaks.
Investigation	Visual inspections.
Analysis	PFCS did not observe any leaks, associated with the elevator cooling equipment. Cooling equipment units are on a regular maintenance schedule.
Conclusion	No repair recommendations. Continue maintenance schedule.
Costs

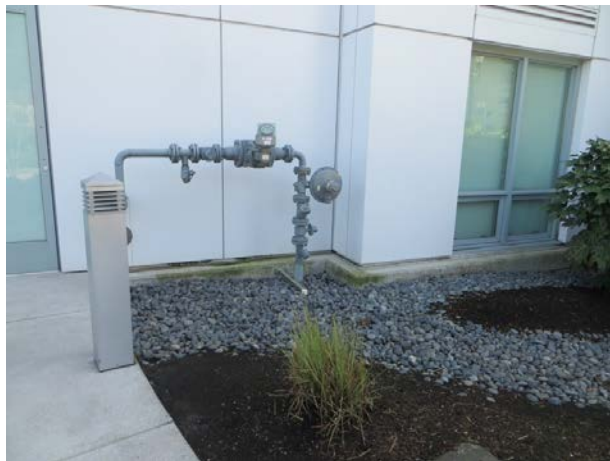
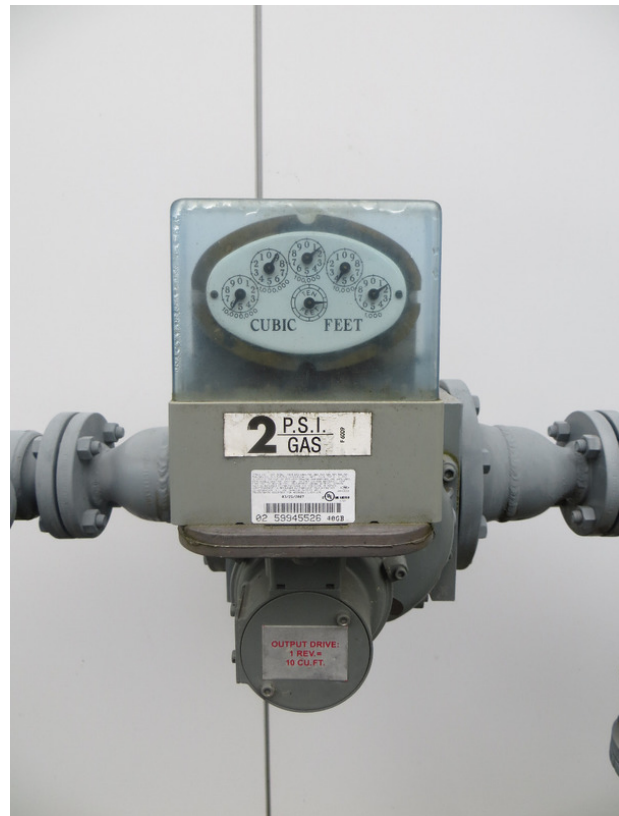
Issue	Inspect for component leaks and element finishes.
Investigation	Visual inspections.
Analysis	Equipment was noted as operating normally and as intended. Based on interviews, element has a good working history. PFCS did not see any components in distress. PFCS did not see finishes in need of immediate maintenance. No repairs recommended at this time.
Conclusion	No repairs recommended.
Costs
