# River Front Living

*100 Main St, Seattle, WA*

Date: May 12, 2014  
To: PFCS - PDX  
PFCS - PDX  
T: (503) 246-3744 E: pdxstaff@petefowler.com  
From: Pete Fowler Construction Services, Inc.  
Project: River Front Living (PFCS 14-000)  
Regarding: Property Condition Assessment  
Note: Confidential Attorney-Client and Attorney Work Product. Protected under all applicable evidence codes.

The following report conforms to ASTM (American Society for Testing and Materials) E-2018, Standard Guide for Property Condition Assessments, with the primary goal being to identify and communicate physical deficiencies for the property located at 100 Main St, Seattle, WA.

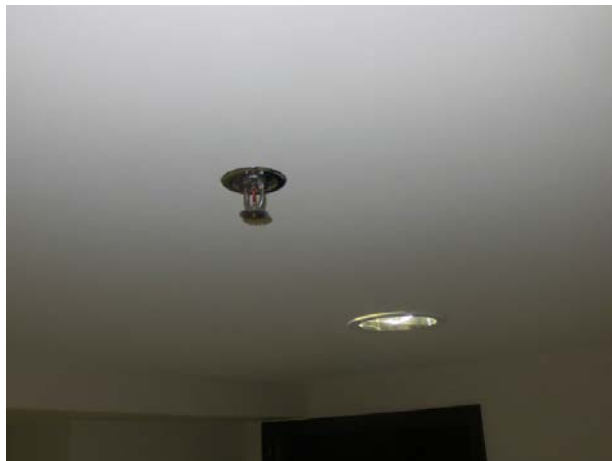
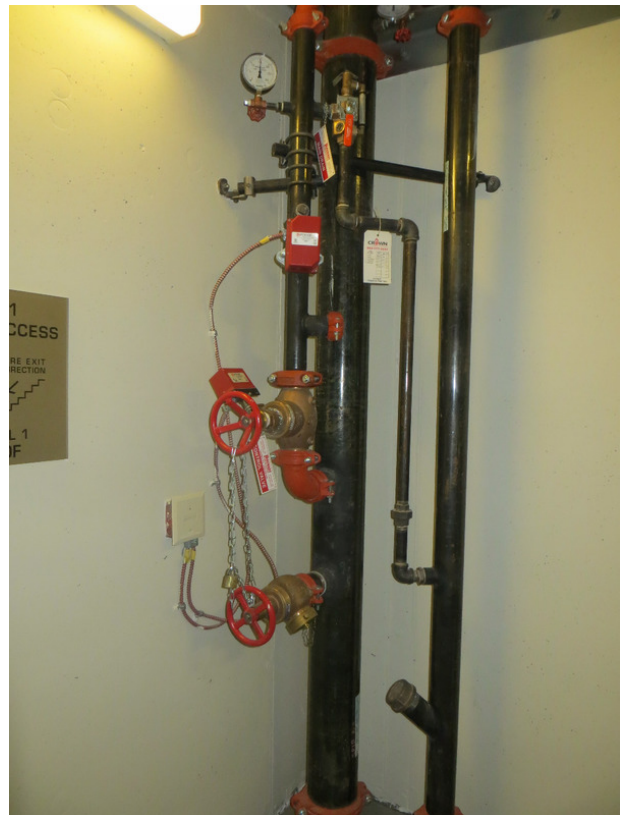
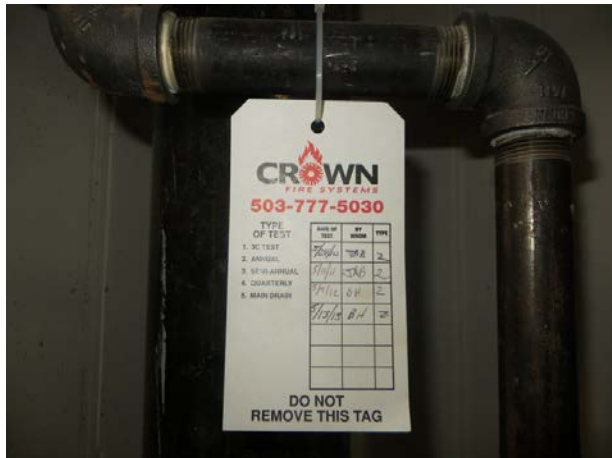
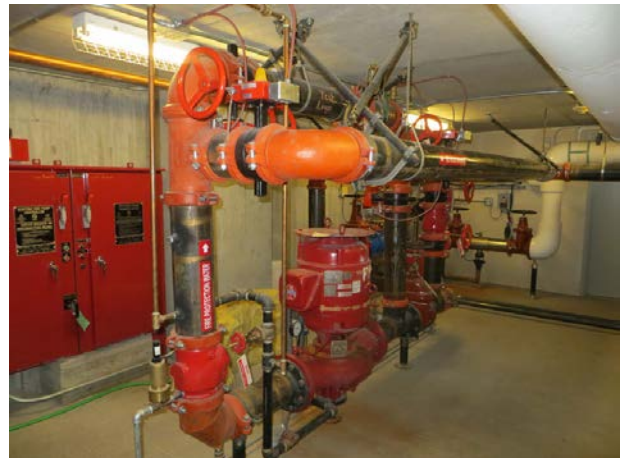
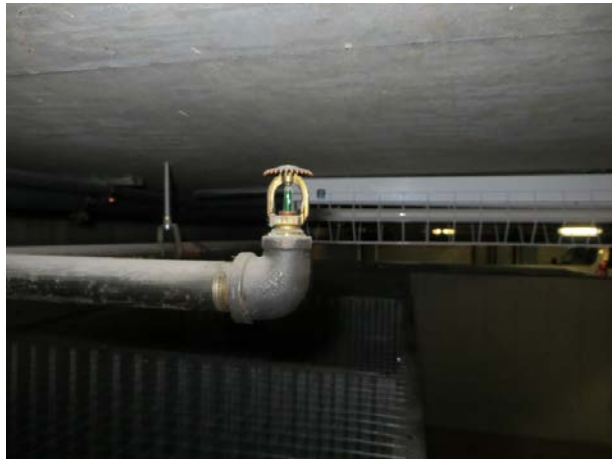
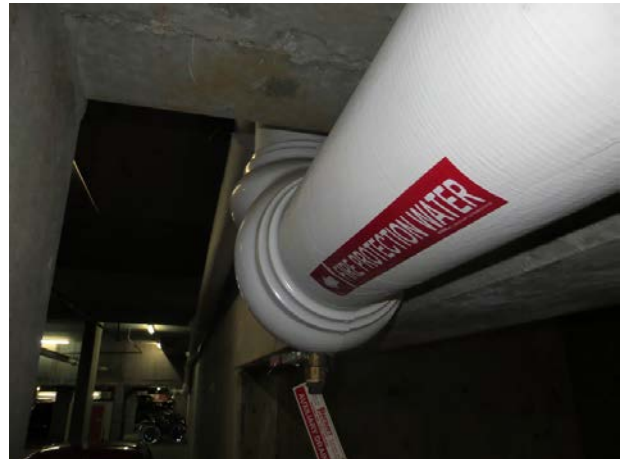
Issue	Inspect for component leaks and element finishes. Verify maintenance schedule and inspections.
Investigation	Visual inspections.
Analysis	Equipment was noted as operating normally and as intended. Based on interviews, element has a good working history. Equipment is on a regular maintenance schedule. PFCS did not note any components as in distress. PFCS did not note the finishes in need of immediate maintenance. No leaks were observed throughout the inspections. No repairs recommended at this time.
Conclusion	No repairs recommended. Continue to maintain current schedule.
Costs

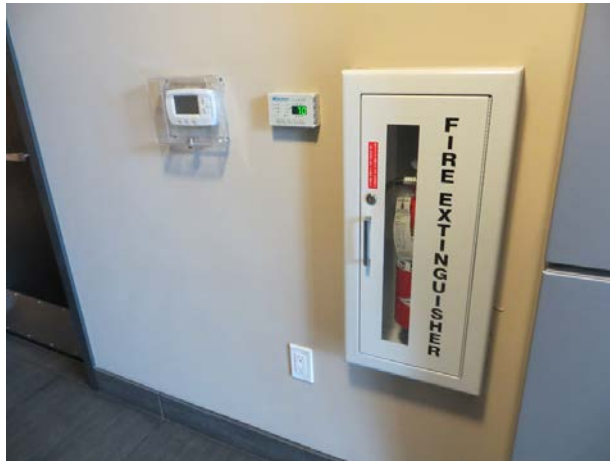
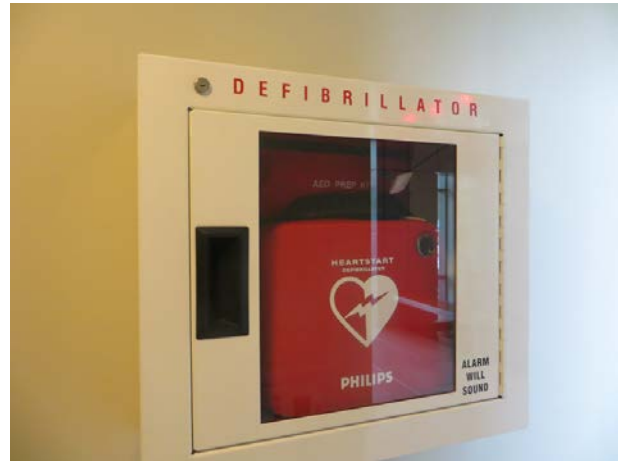
Issue	Inspect for accessibility.
Investigation	Visual inspections.
Analysis	Equipment was noted as operating normally and as intended. Based on interviews, element has a good working history. PFCS did not note any components as in distress. PFCS did not note the finishes in need of immediate maintenance. No repairs recommended at this time.
Conclusion	No repairs recommended.
Costs

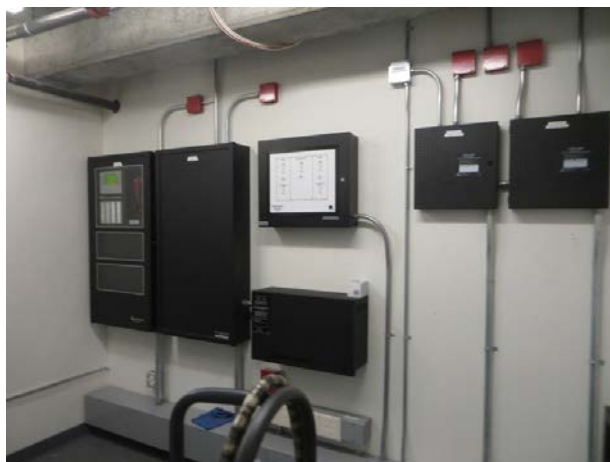
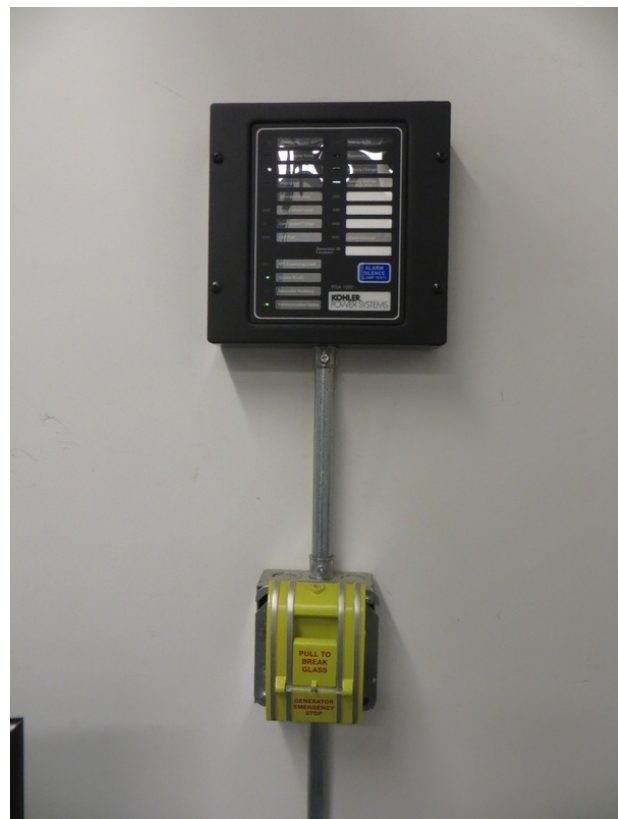
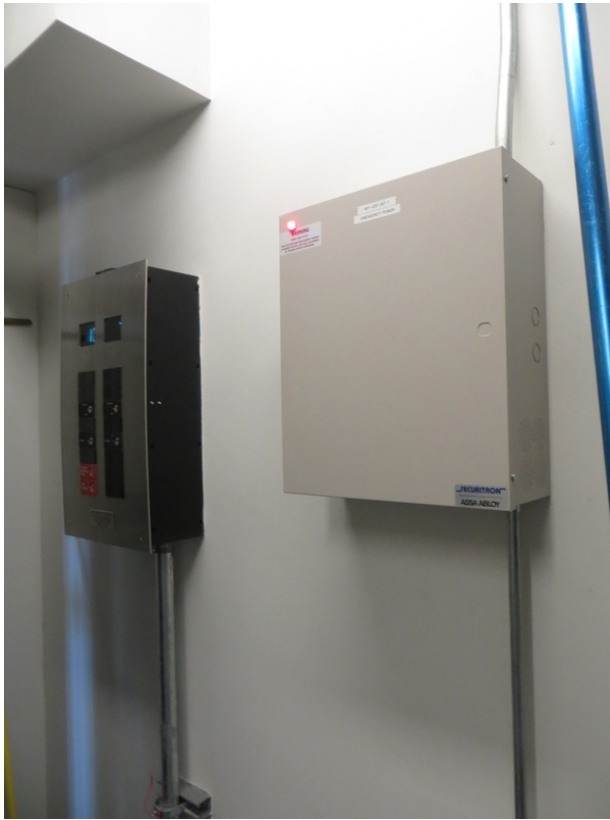
Issue	Verify maintenance schedule.
Investigation	Visual inspections.
Analysis	Equipment was noted as operating normally and as intended. Based on interviews, element has a good working history. Equipment is on a regular maintenance schedule. PFCS did not note any components as in distress. PFCS did not note the finishes in need of immediate maintenance. No repairs recommended at this time.
Conclusion	No repairs recommended.
Costs

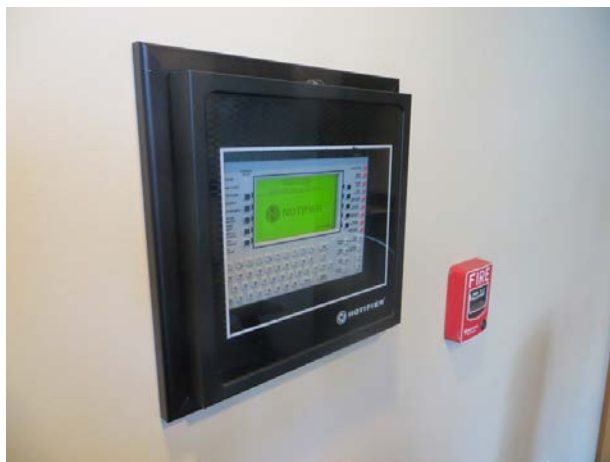
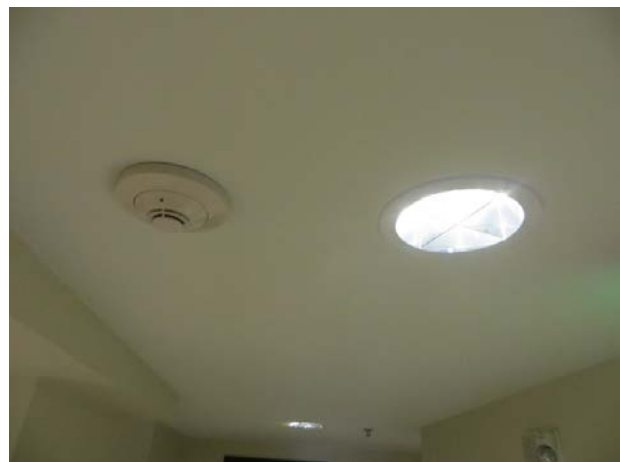
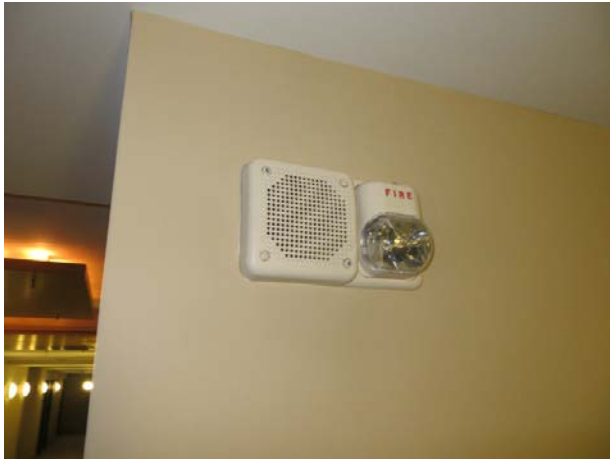
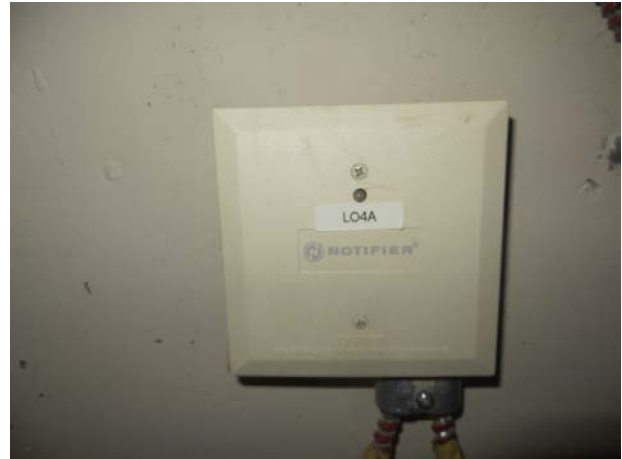
Issue	Verify location of sensors.
Investigation	Visual inspections.
Analysis	Equipment was noted as operating normally and as intended. Based on interviews, element has a good working history. Equipment is on a regular maintenance schedule. PFCS did not note any components as in distress. PFCS did not note the finishes in need of immediate maintenance. No repairs recommended at this time.
Conclusion	No repairs recommended.
Costs

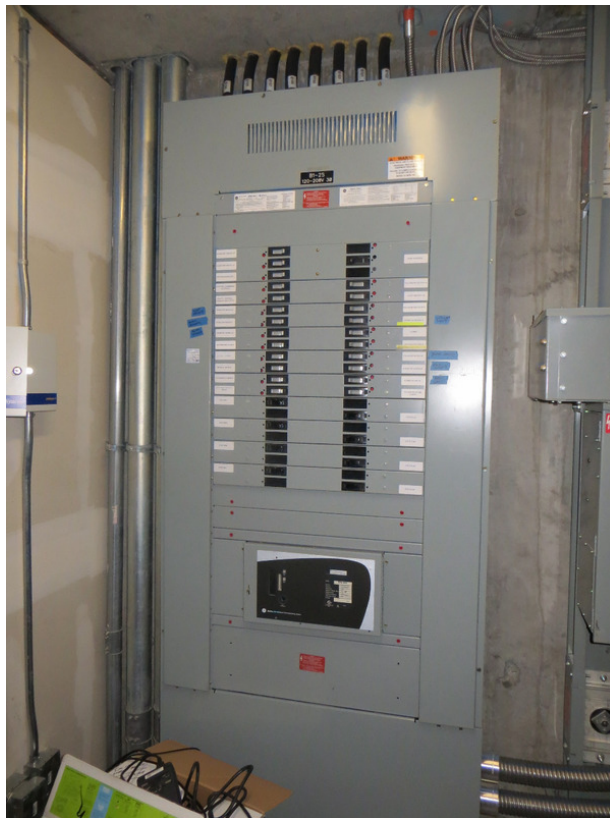
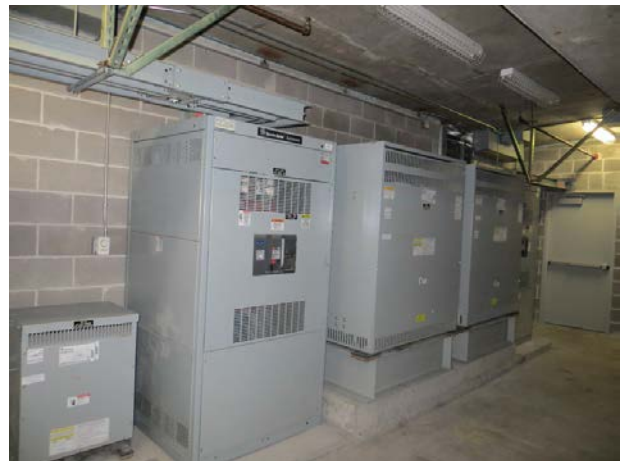
Issue	Verify maintenance schedule.
Investigation	Visual inspections.
Analysis	Equipment was noted as operating normally and as intended. Based on interviews, element has a good working history. PFCS did not note any components as in distress. PFCS did not note the finishes in need of immediate maintenance. No repairs recommended at this time.
Conclusion	No repairs recommended.
Costs

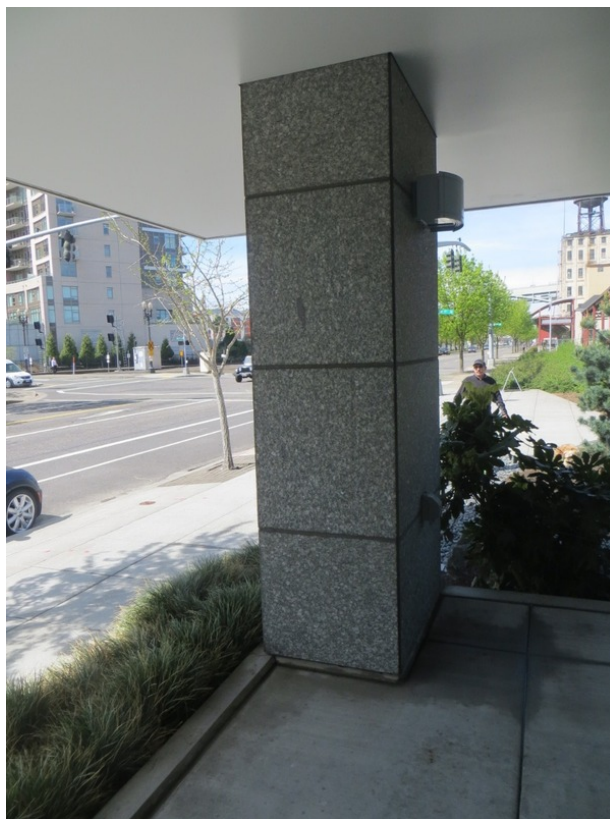
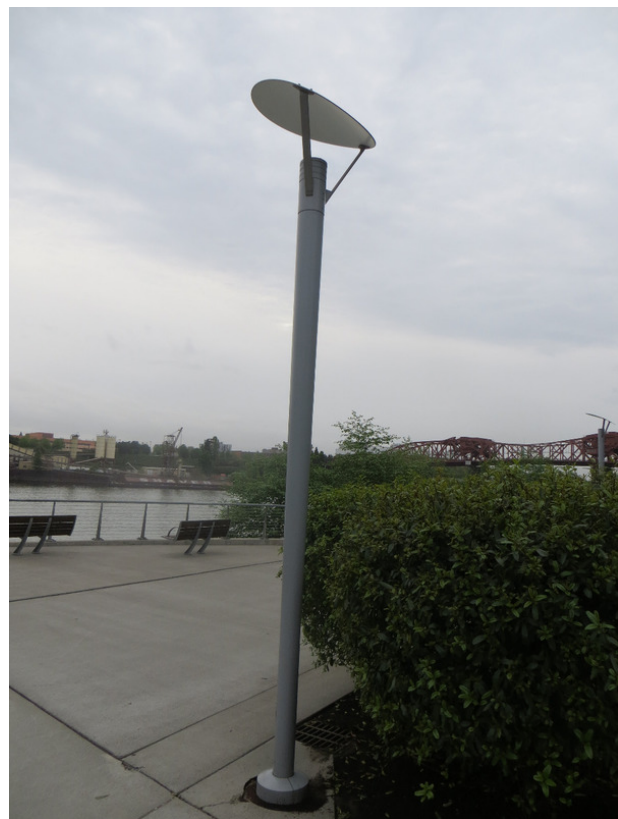
Issue	Verify locations of light components.
Investigation	Visual inspections.
Analysis	PFCS did not inspect at night. All light fixtures appear to be positioned in an effort to provide adequate lighting throughout intended areas. No issues noted with finishes. Maintain all light components within common areas in order to provide adequate lighting and security.
Conclusion	No repairs recommended.
Costs

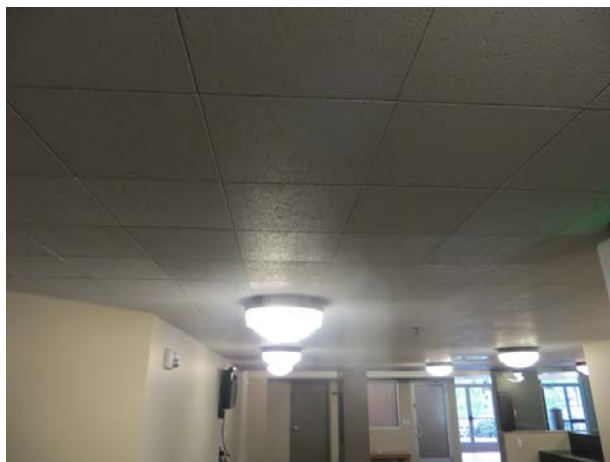
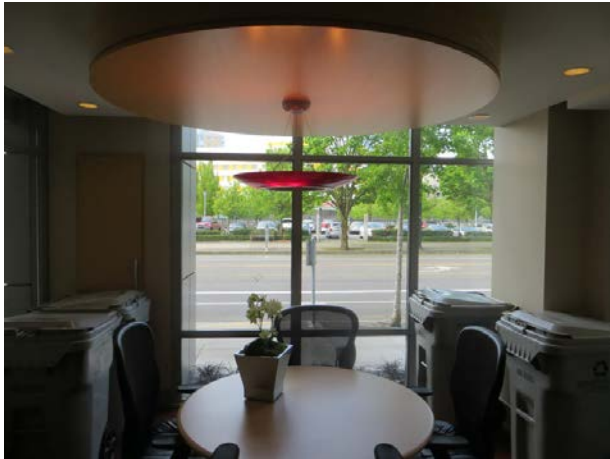
Issue	Verify locations.
Investigation	Visual inspections.
Analysis	PFCS did not inspect at night. All light fixtures appear to be positioned in an effort to provide adequate lighting throughout intended areas. No issues noted with finishes. Maintain all light components within common areas in order to provide adequate lighting and security.
Conclusion	No repairs recommended.
Costs

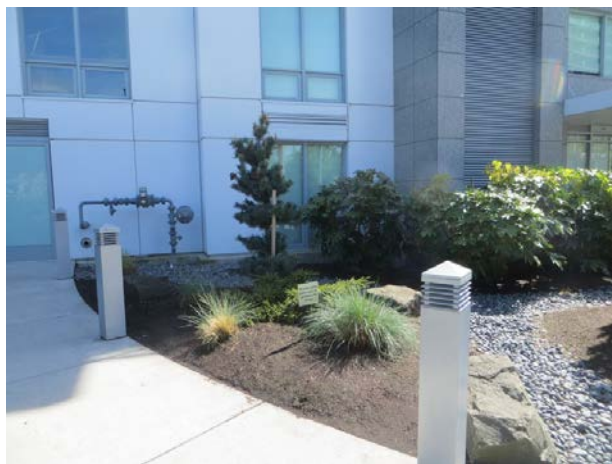
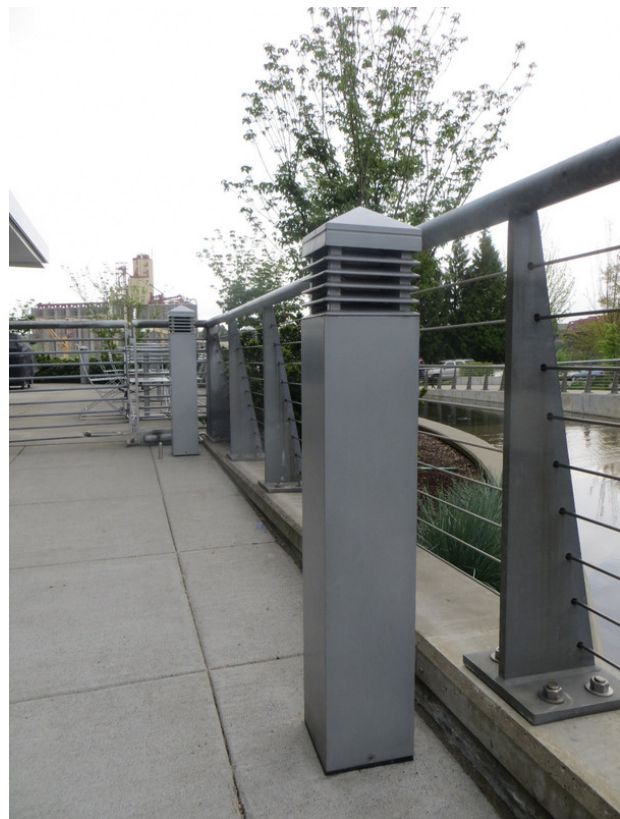
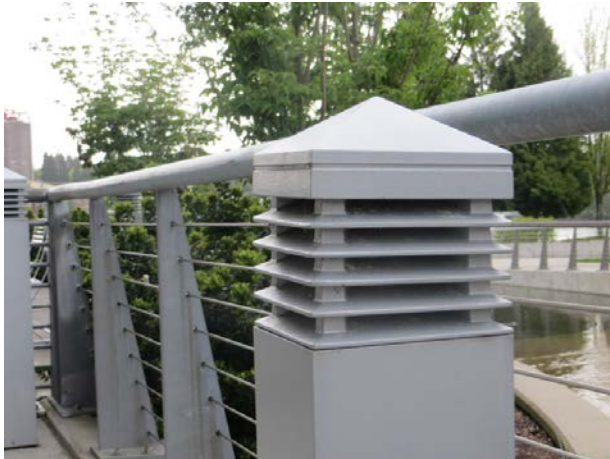
Issue	Verify locations.
Investigation	Visual inspections.
Analysis	PFCS did not inspect at night. All light fixtures appear to be positioned in an effort to provide adequate lighting throughout intended areas. No issues noted with finishes. Maintain all light components within common areas in order to provide adequate lighting and security.
Conclusion	No repairs recommended.
Costs

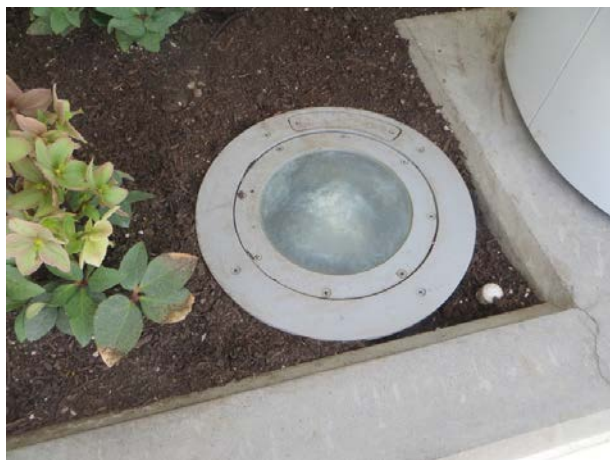
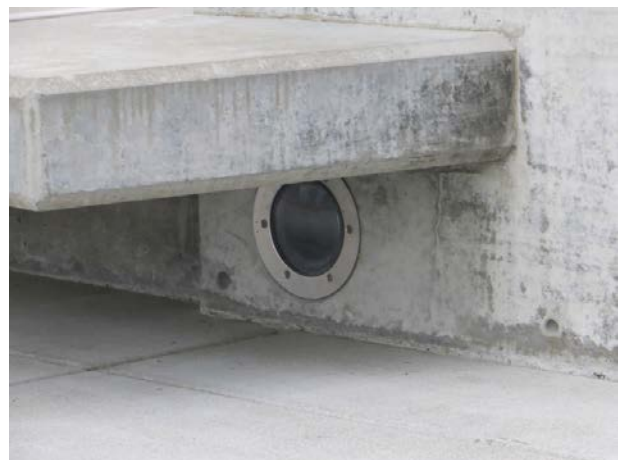
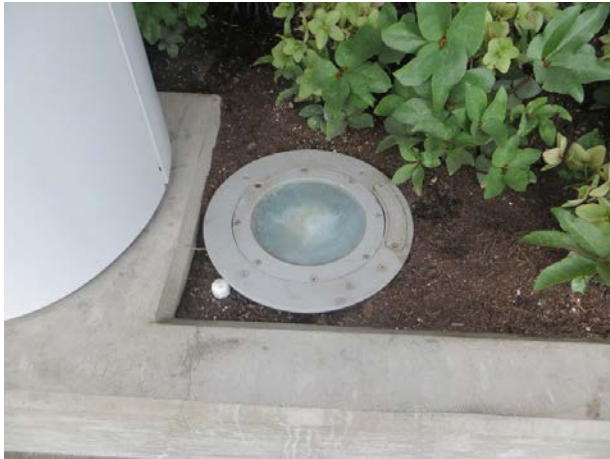
Issue	Verify locations.
Investigation	Visual inspections.
Analysis	PFCS did not inspect at night. All light fixtures appear to be positioned in an effort to provide adequate lighting throughout intended areas. No issues noted with finishes. Maintain all light components within common areas in order to provide adequate lighting and security.
Conclusion	No repairs recommended.
Costs

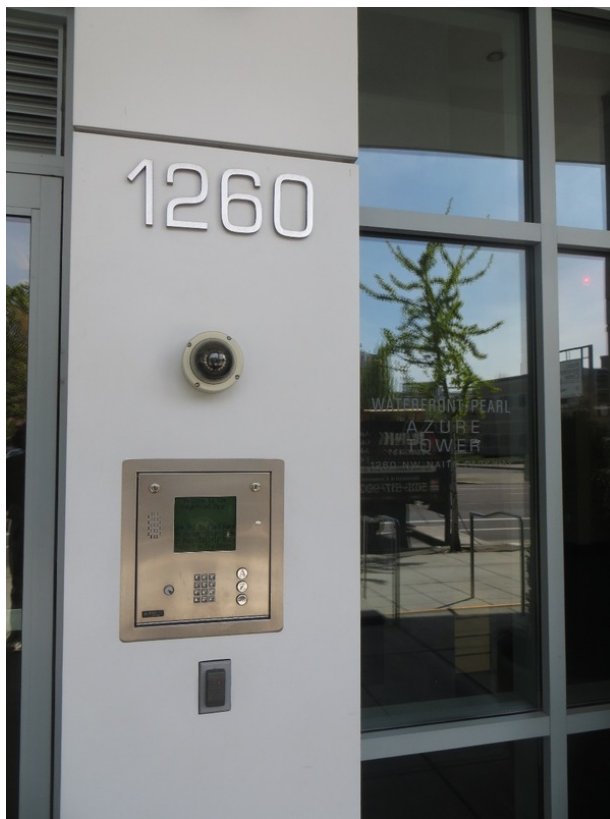
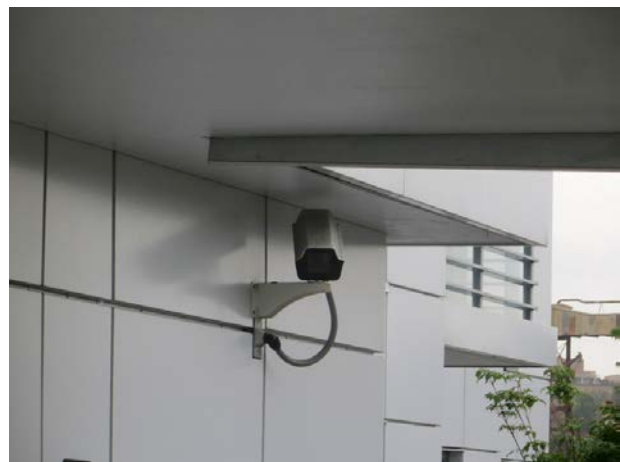
Issue	Verify locations and functionality.
Investigation	Visual inspections.
Analysis	Equipment was noted as operating normally and as intended. Based on interviews, element has a good working history. Equipment is on a regular maintenance schedule. PFCS did not note any components as in distress. PFCS did not note the finishes in need of immediate maintenance. No repairs recommended at this time.
Conclusion	No repairs recommended.
Costs

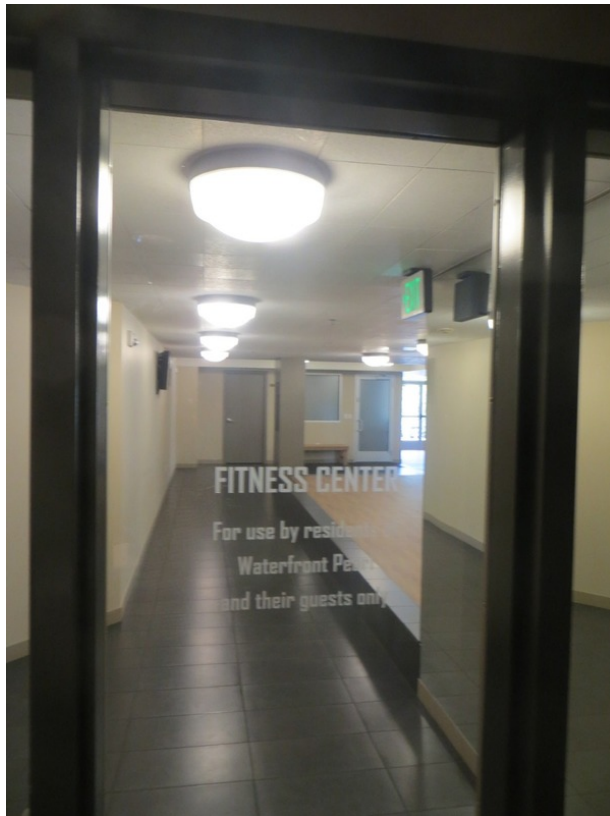
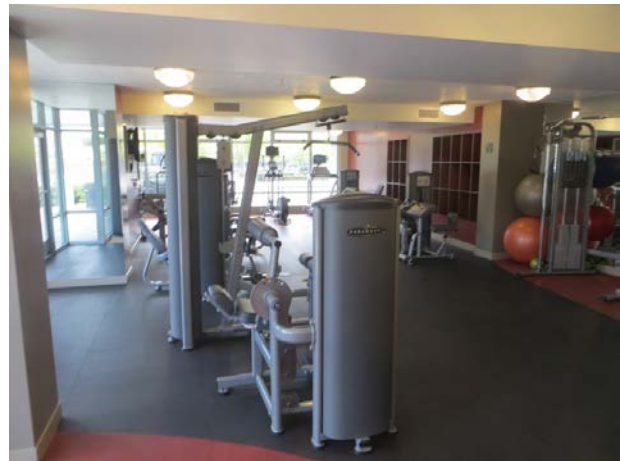
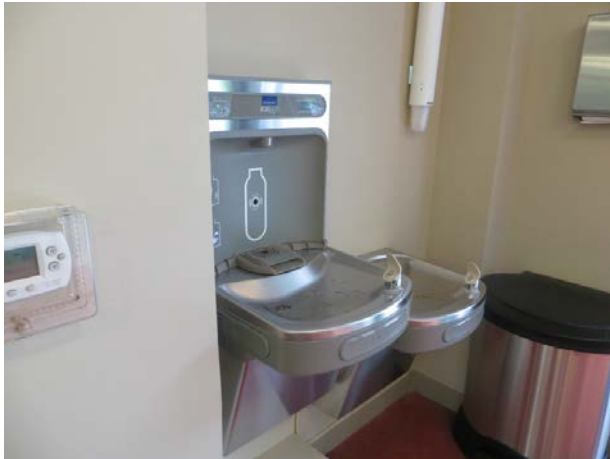
Issue	Visual evaluation of the equipment.
Investigation	Visual inspections.
Analysis	Equipment was noted as functional and operations. No issues were reported.
Conclusion	No repairs recommended.
Costs

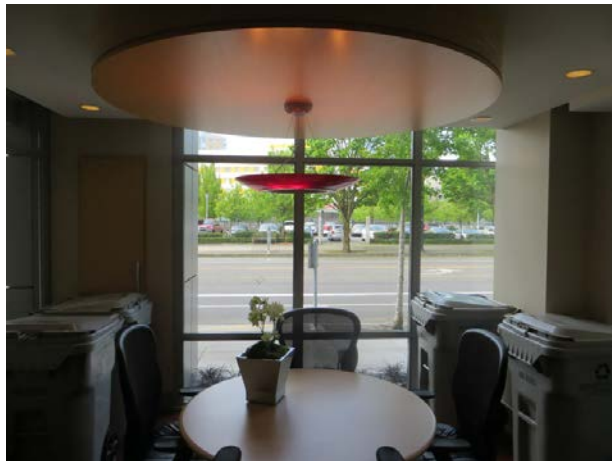
AP-01.379; 04/21/2014

Issue	Visual evaluation of the furnishings.
Investigation	Visual inspections.
Analysis	All furnishings were noted to be in good to fair condition.
Conclusion	No repairs recommended.
Costs

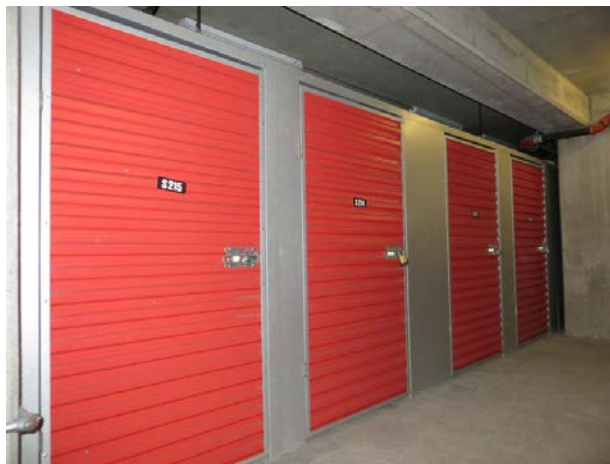
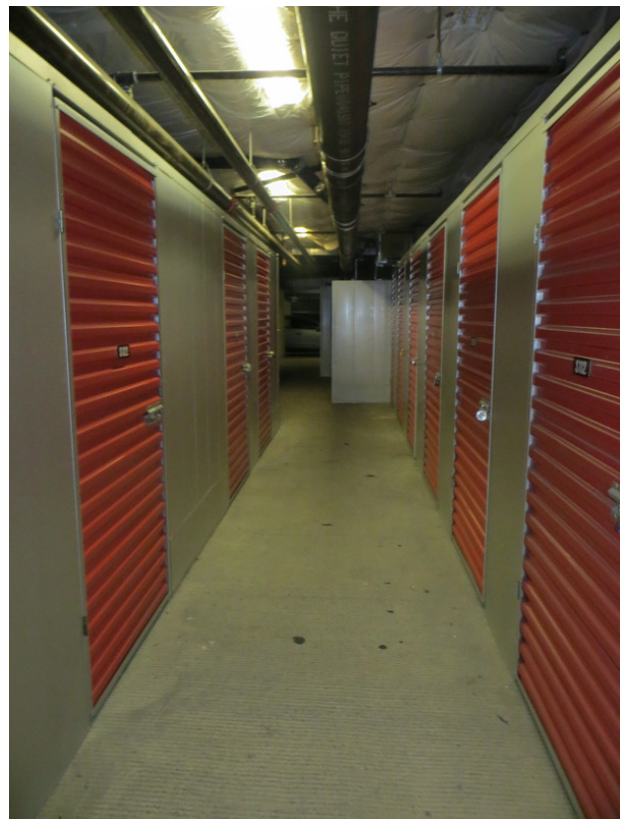
Issue	Inspect for functionality and finishes.
Investigation	Visual inspections.
Analysis	All components are performing as intended. Finishes are in good condition. PFCS did not observe any components in distress.
Conclusion	No repairs recommended.
Costs

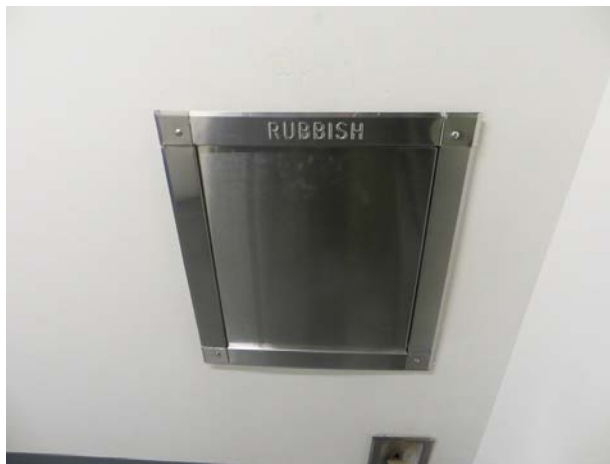
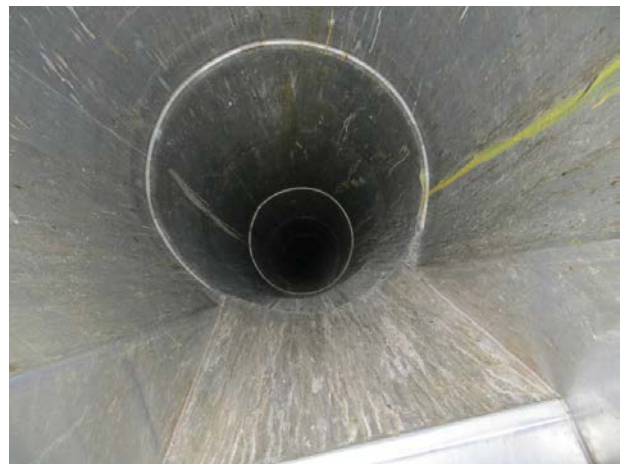
Issue	Inspect for functionality, wear and tear.
Investigation	Visual inspections.
Analysis	Trash chute and trash components are in good condition. No defects or distress observed.
Conclusion	No repairs recommended.
Costs

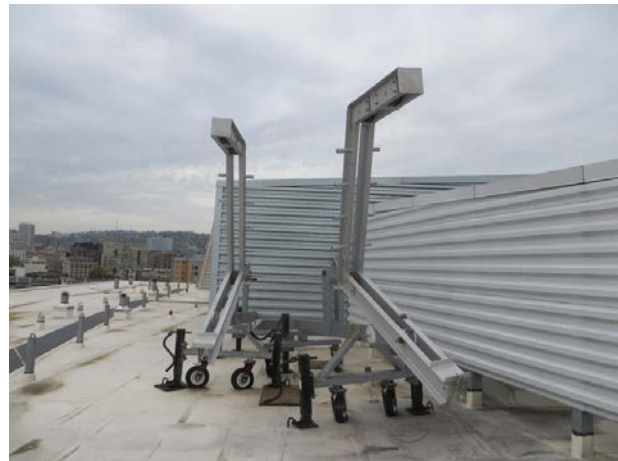
AP-01.240; 04/21/2014; Roof

Issue	Visual evaluation of the Window Cleaning Equipment.
Investigation	Visual inspections.
Analysis	Current window cleaning equipment is not being used, as contractor ties off on existing roof anchors. Maintain plywood or some isolation materials between equipment bases and roofing membrane in order to avoid damage to roof membrane.
Conclusion	Maintain isolation materials between equipment and roof membrane.
Costs

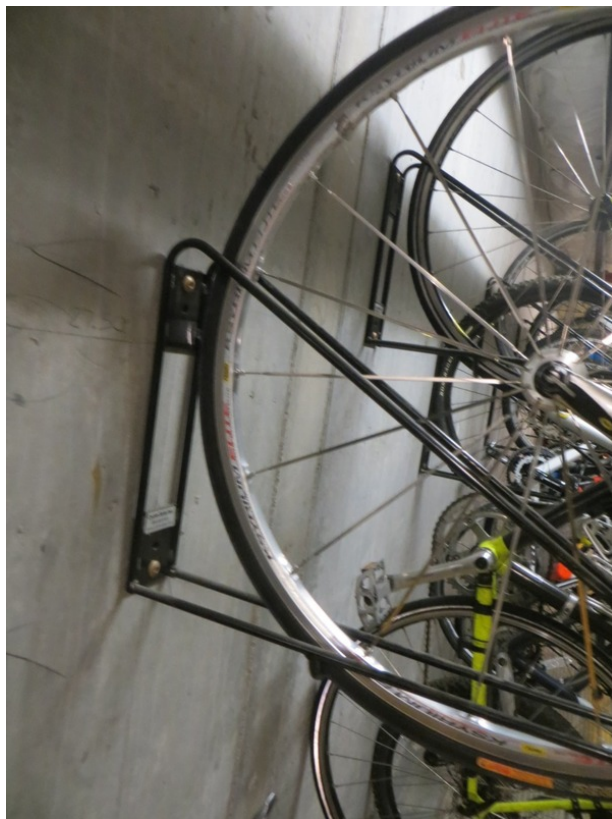
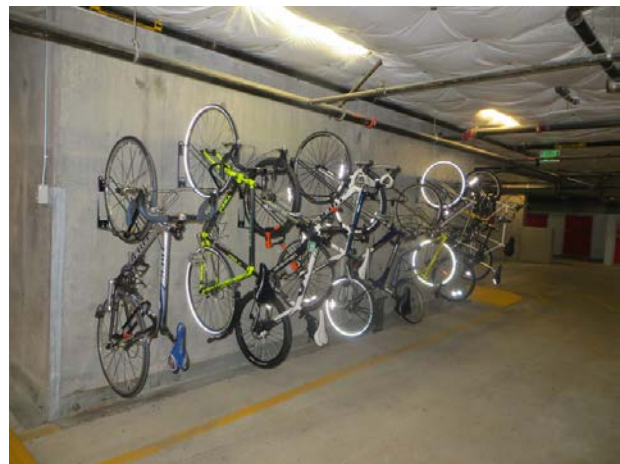
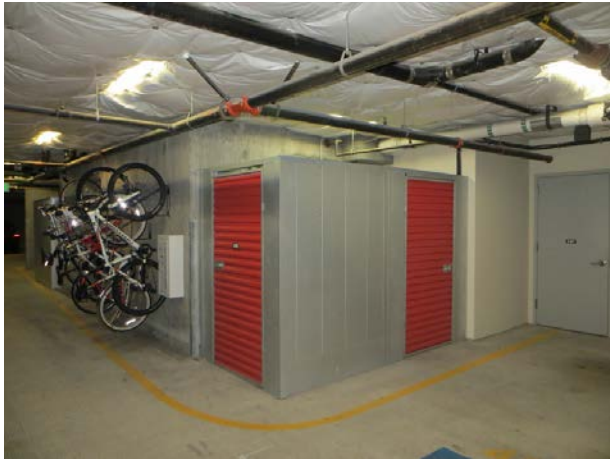
Issue	Inspect for functionality and finishes.
Investigation	Visual inspections.
Analysis	All components are performing as intended. Finishes are in good condition. PFCS did not observe any components in distress.
Conclusion	No repairs recommended.
Costs

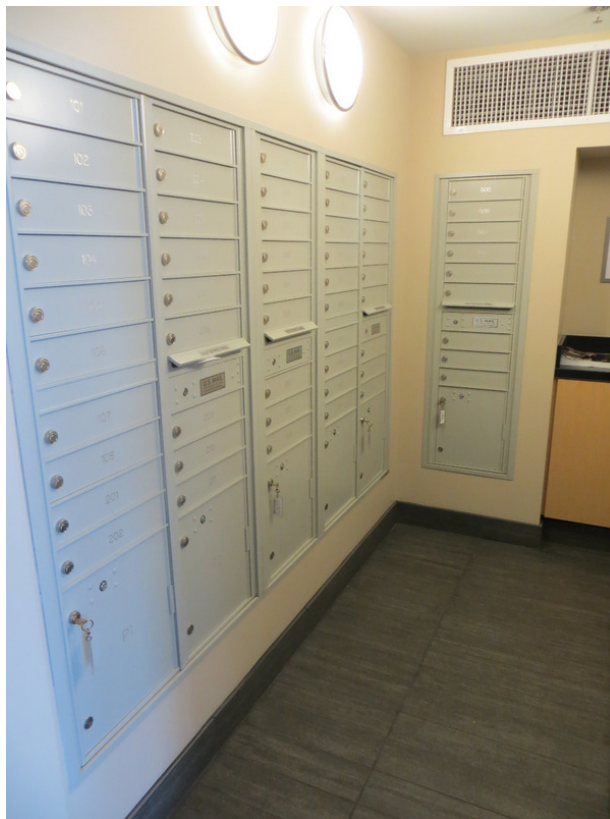
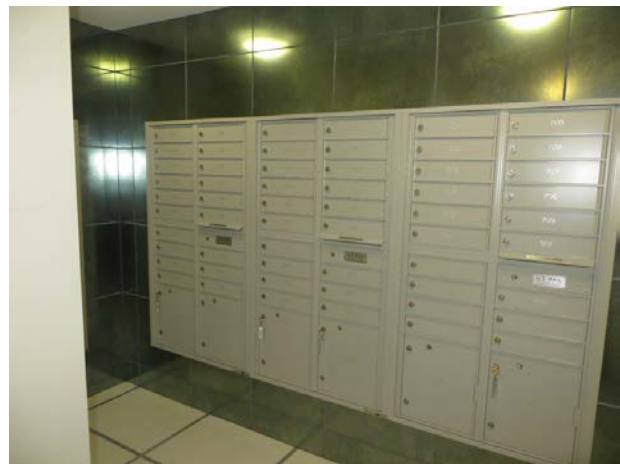
Issue	Inspect for functionality and finishes.
Investigation	Visual inspections.
Analysis	All components are performing as intended. Finishes are in good condition. PFCS did not observe any components in distress.
Conclusion	No repairs recommended.
Costs

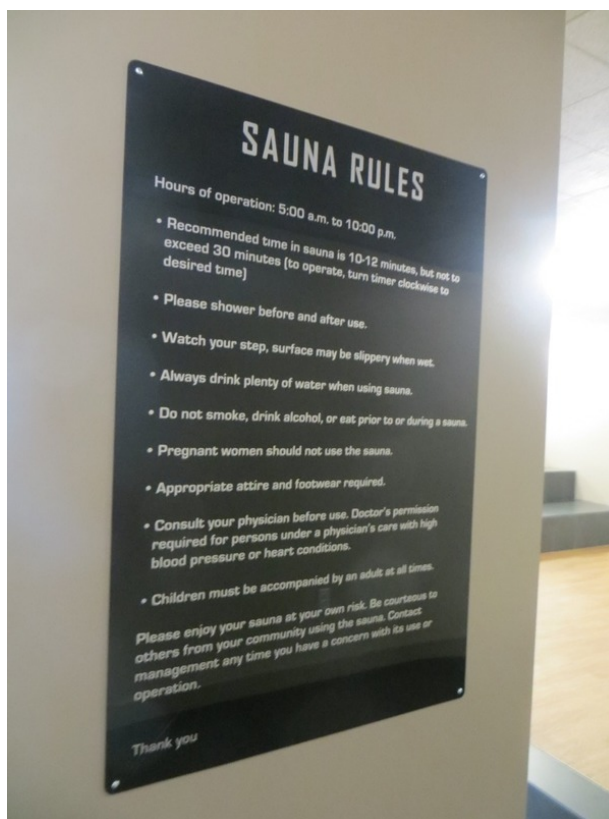
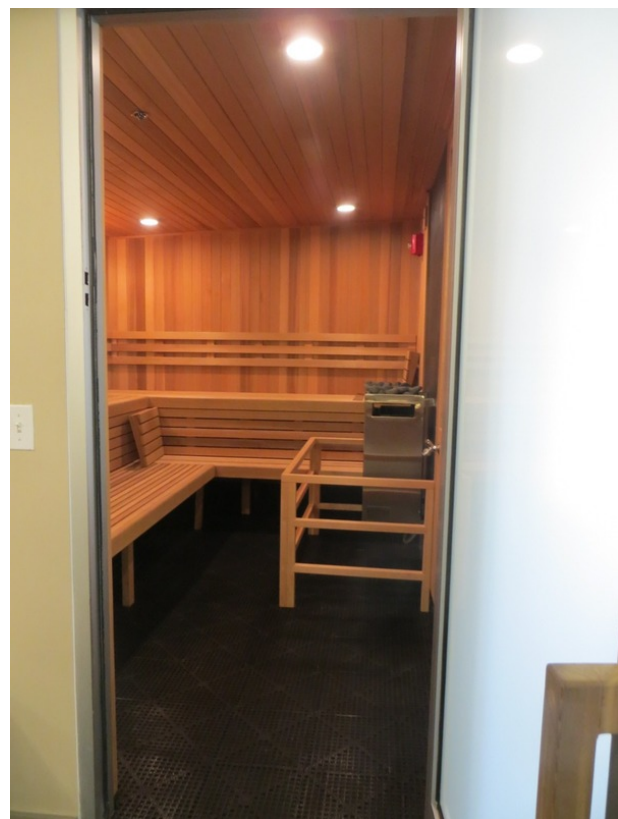
Issue	Verify, via interview that sauna is performing as intended.
Investigation	Visual inspections.
Analysis	Visual inspection only. Per Jason Cunningham, sauna is performing as intended and no issues have been reported.
Conclusion	No repairs recommended.
Costs

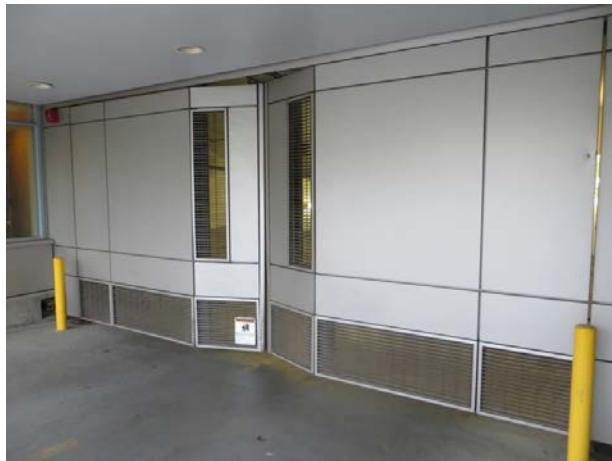
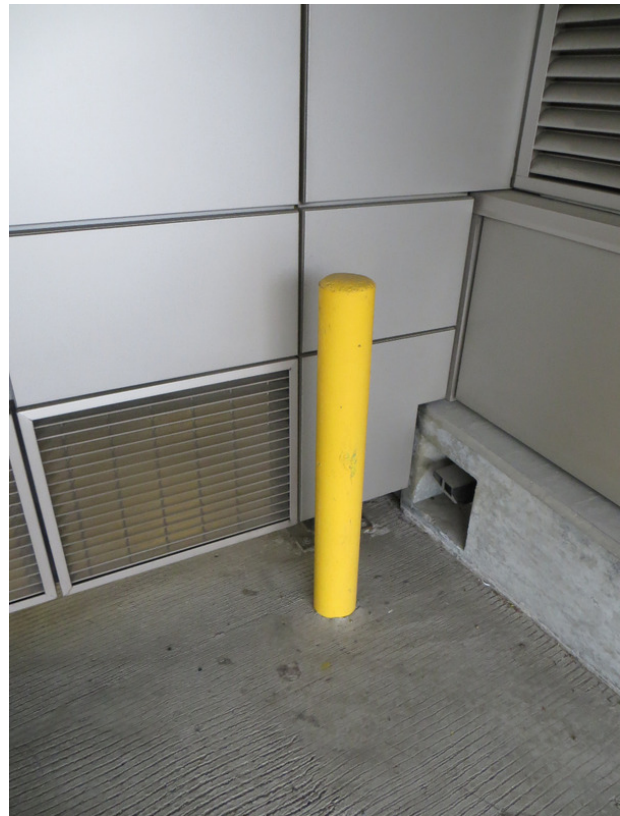
Issue	Verify locations of protective bollards.
Investigation	Visual inspections.
Analysis	PFCS noted numerous bollards located in appropriate locations.
Conclusion	No repairs recommended.
Costs

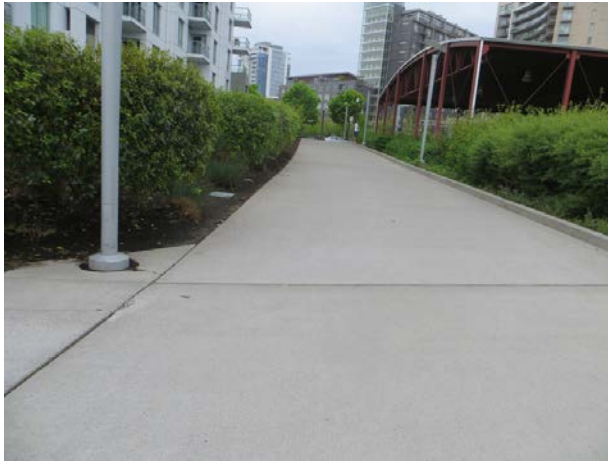
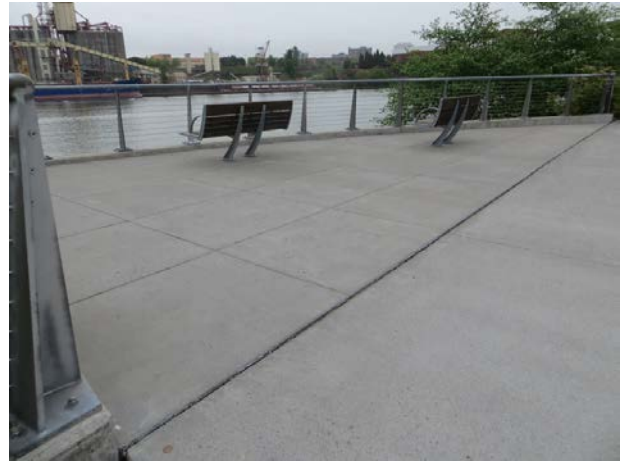
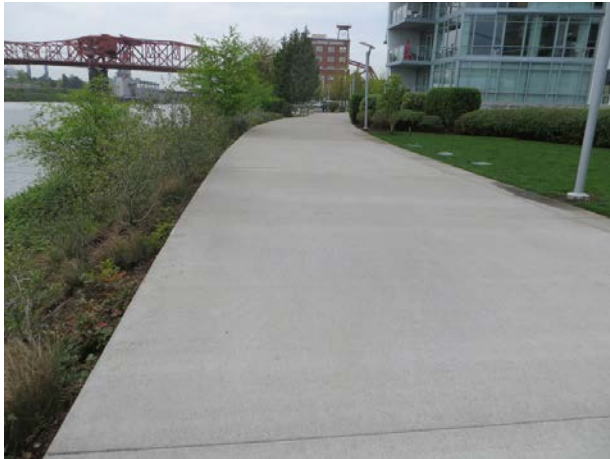
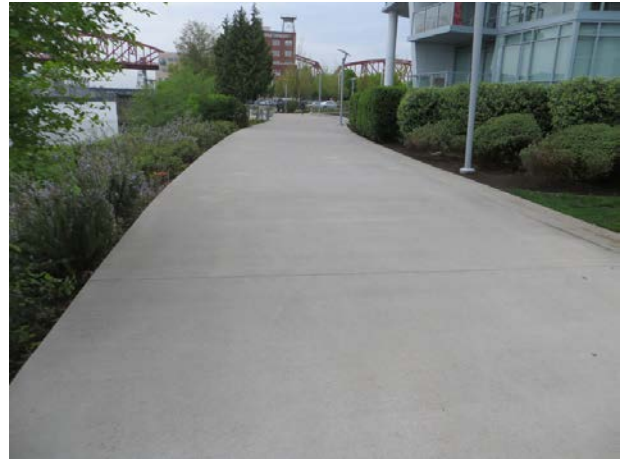
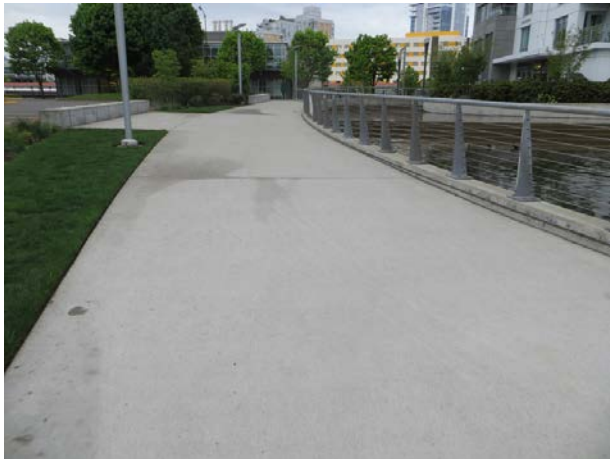
Issue	Inspect for excessive cracks, trip hazards, drainage, and overall condition of pedestrian walkways.
Investigation	Visual inspections.
Analysis	<p>Concrete sidewalks and pedestrian walkways are provided at the perimeter of the buildings and along the Riverwalk. All sidewalks are constructed with regularly spaced control joints and broom finish. Ramps are provided throughout to accommodate ADA requirements.</p> <p>Sidewalks are considered to be in good condition. PFCS noted excessive irrigation water flowing onto the sidewalks at isolated areas, which is not an issue unless the region experiences freezing conditions.</p>
Conclusion	No repairs recommended.
Costs

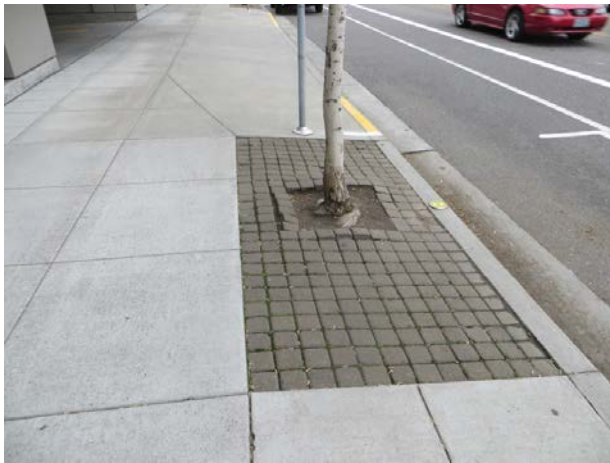
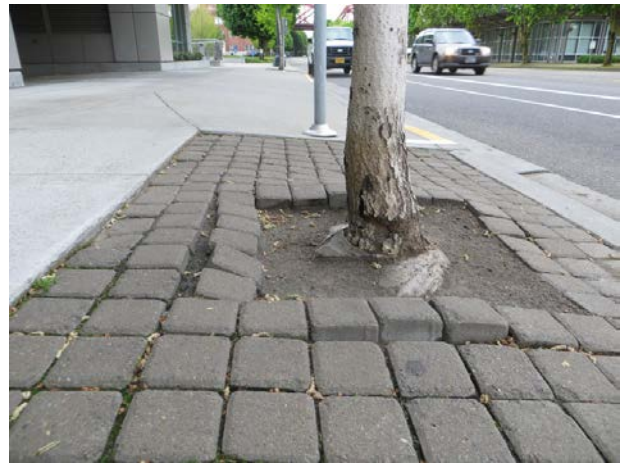
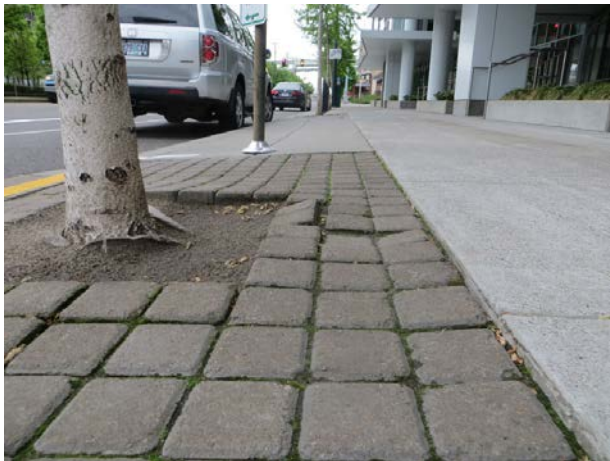
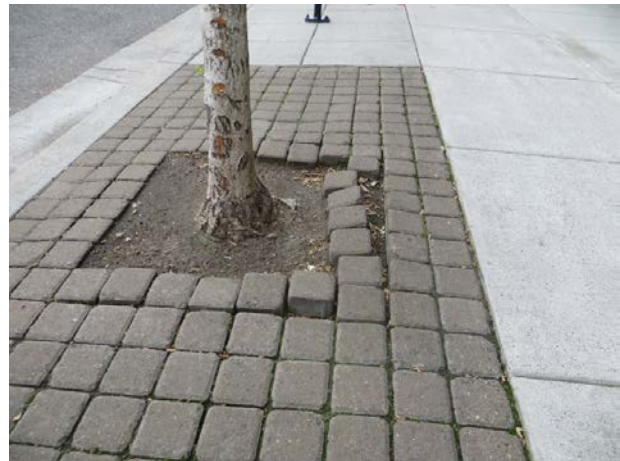
Issue	Inspect for drainage, and trip hazards.
Investigation	Visual inspections.
Analysis	PFCS noted numerous masonry pavers to be displaced and elevated, creating a potential trip hazards. The paver areas are not intended for pedestrian traffic, however are often used that way by the public.
Conclusion	Recommended maintenance to be performed in order to avoid potential trip hazards.
Costs

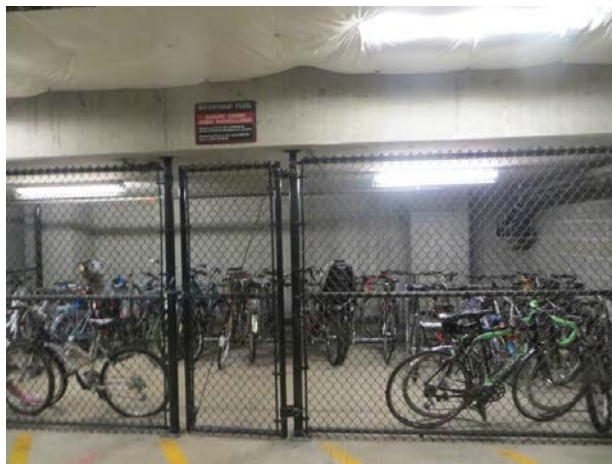
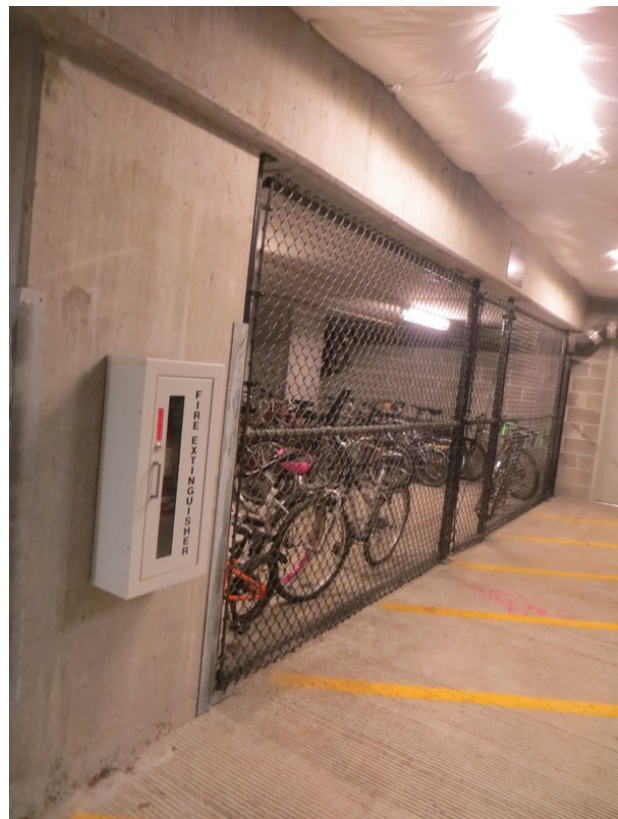
Issue	Visual evaluation of the functionality.
Investigation	Visual inspections.
Analysis	All chain link fencing, at the subterranean garage areas was noted to be in good condition.
Conclusion	No repairs recommended.
Costs
