# River Front Living

*100 Main St, Seattle, WA*

Date: May 12, 2014  
To: PFCS - PDX  
PFCS - PDX  
T: (503) 246-3744 E: pdxstaff@petefowler.com  
From: Pete Fowler Construction Services, Inc.  
Project: River Front Living (PFCS 14-000)  
Regarding: Property Condition Assessment  
Note: Confidential Attorney-Client and Attorney Work Product. Protected under all applicable evidence codes.

The following report conforms to ASTM (American Society for Testing and Materials) E-2018, Standard Guide for Property Condition Assessments, with the primary goal being to identify and communicate physical deficiencies for the property located at 100 Main St, Seattle, WA.

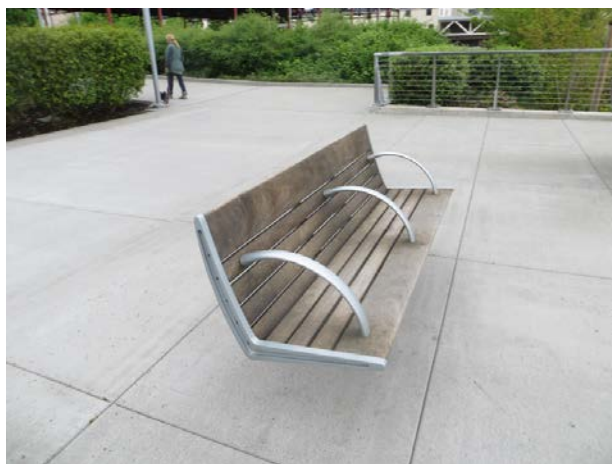
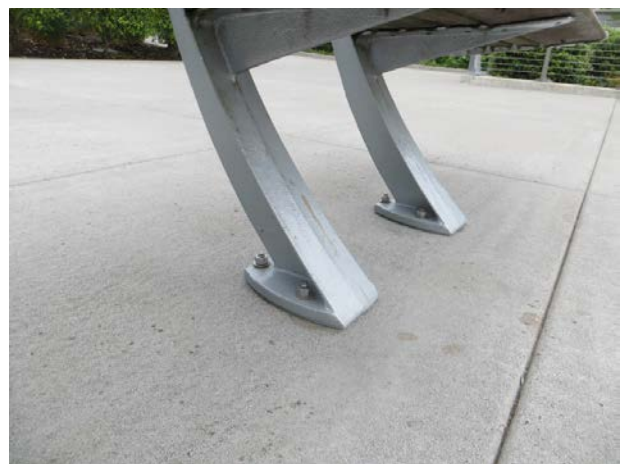
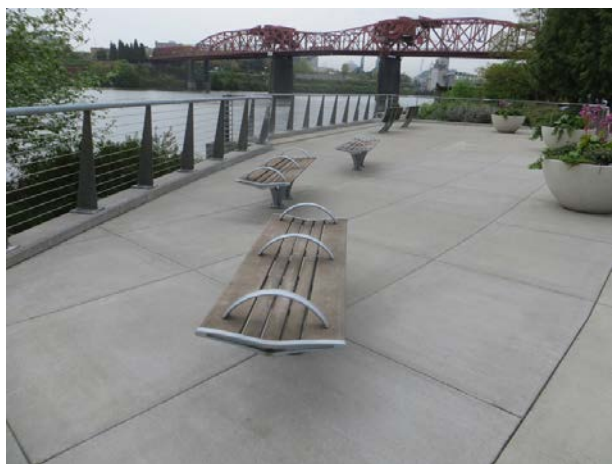
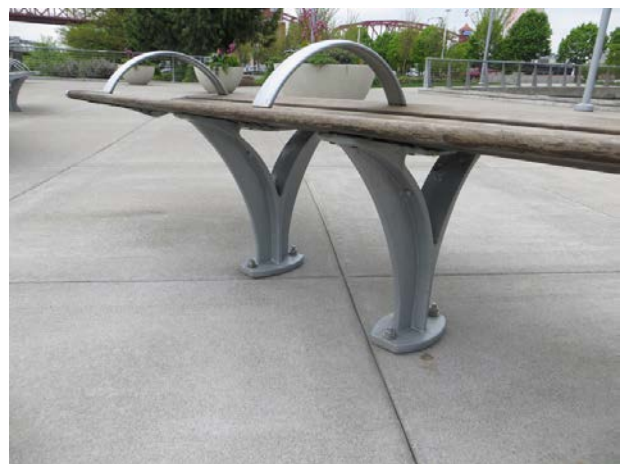
Issue	Visual evaluation of the site benches.
Investigation	Visual inspections.
Analysis	All benches were noted as in good condition, adequately attached to the concrete surfaces and with good finishes.
Conclusion	No repairs recommended.
Costs

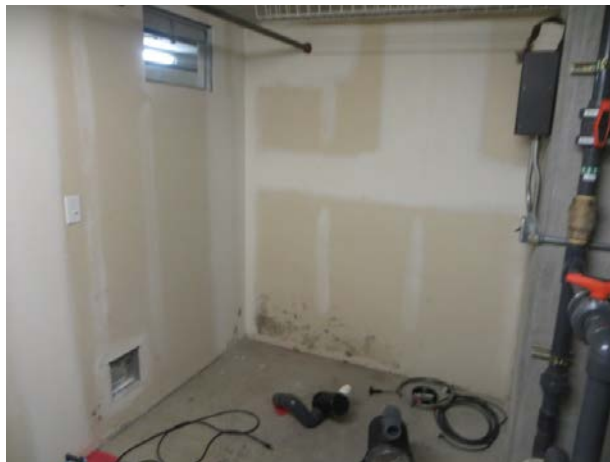
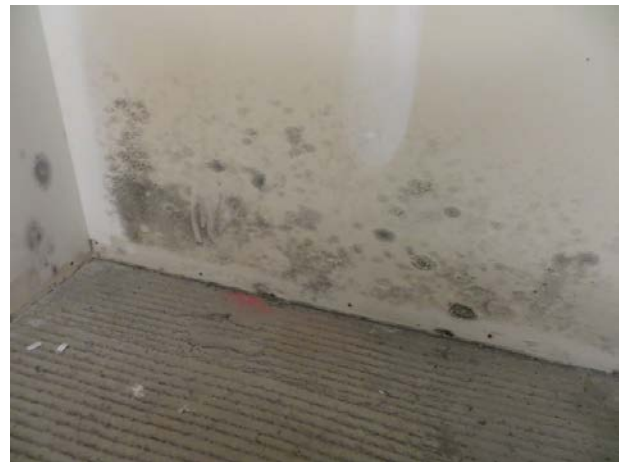
Issue	Inspect for leaks.
Investigation	Visual inspections.
Analysis	<p>PFCS noted very high humidity levels at the entrance of Building A. It is recommended that the humidity levels are monitored and maintain adequate air exchange within the entry areas.</p> <p>PFCS noted high humidity levels within the Building A pump and equipment room, where resultant mold was noted on the drywall surface. It appears that additional venting was introduced in order to mitigate this condition.</p>
Conclusion	<p>Item 1: Monitor humidity levels at Building-A entry, and maintain adequate air exchange.</p> <p>Item 2: Monitor and maintain adequate venting at Building-A pump room and maintain adequate air exchange.</p> <p>Item 3: Clean small amount of mold that has accumulated in Building A pump room. See PFCS or other sources of information for guidance (<a href="http://pfcs.co/mold">pfcs.co/mold</a>).</p>
Costs

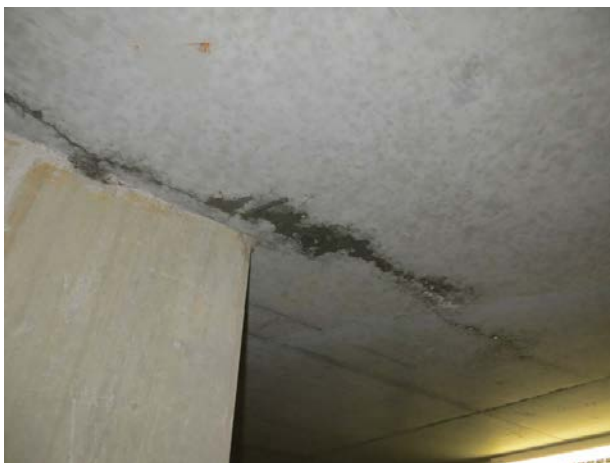
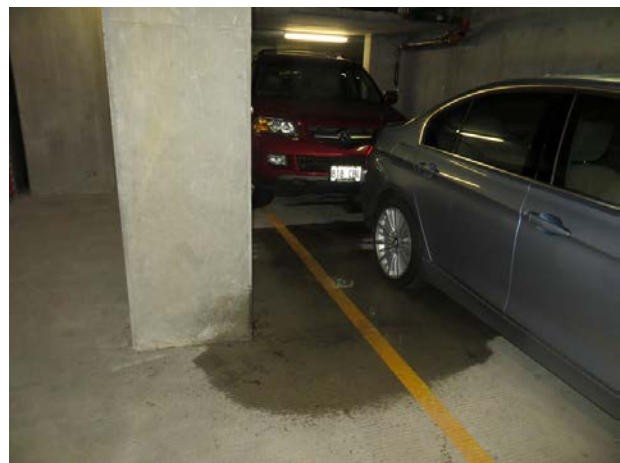
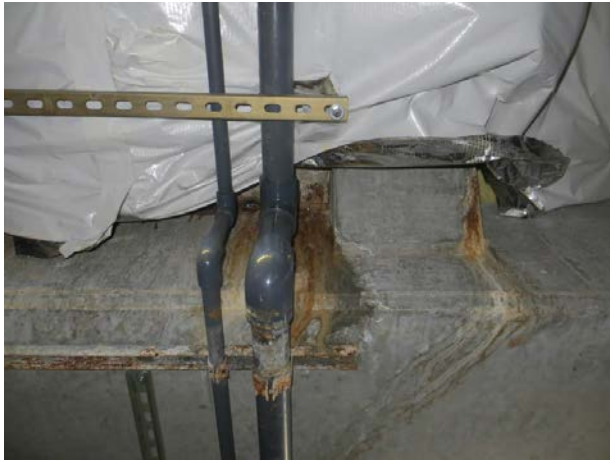
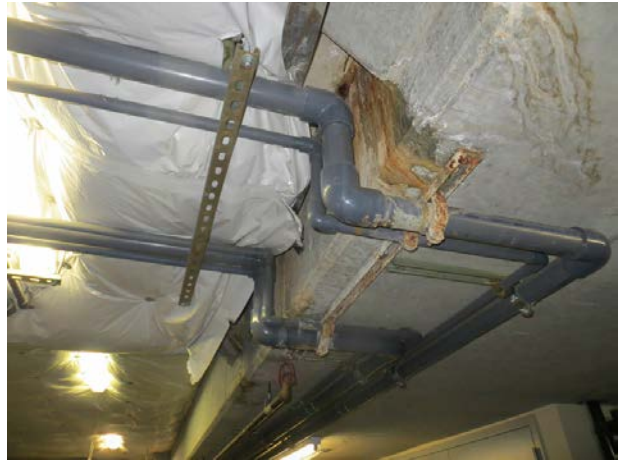
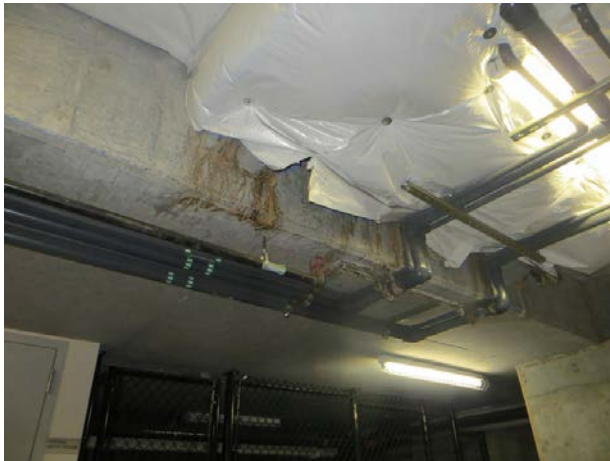
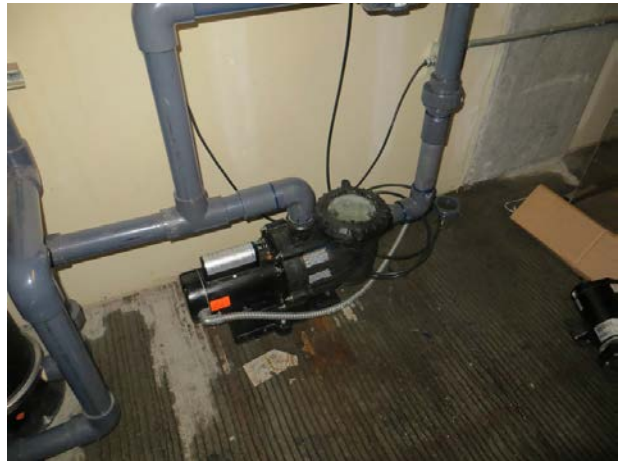
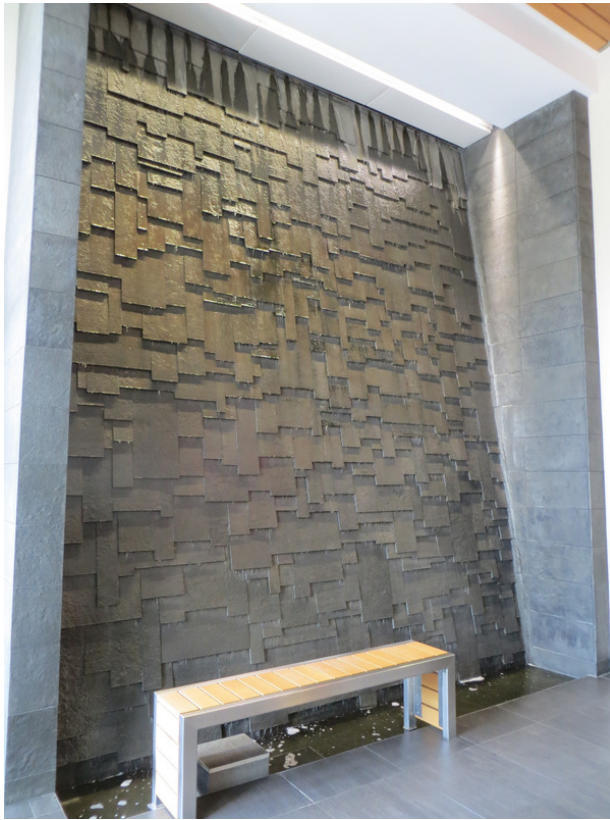
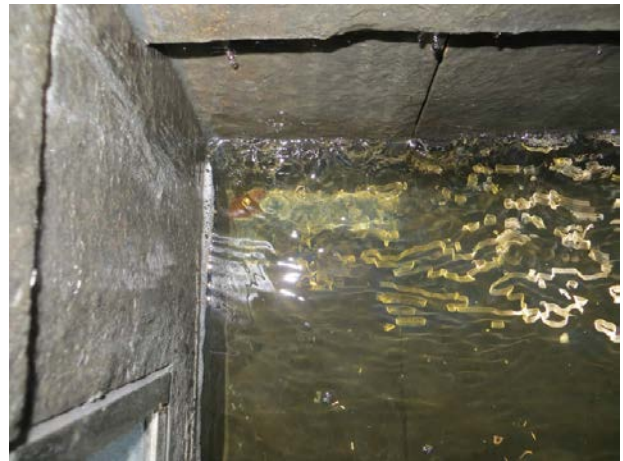
Issue	Inspect for leaks.
Investigation	Visual inspections.
Analysis	<p>PFCS noted water intrusion in the subterranean parking area P1, below of the water feature, located above in the Building-B entry.</p> <p>PFCS also noted an isolated event where the water feature pump overflow (pump recently replaced) was discharging water in excess, flooding the equipment room, and allowing water to migrate outside of the equipment room and into the parking garage. This event was being monitored by the building engineer therefore we believe that it is not a long term condition.</p>
Conclusion	<p>Repairs and further investigation required due to potential water feature leak.</p> <ol style="list-style-type: none"> <li>1. Turn off water feature, and drain.</li> <li>2. Clean off area of water intrusion at P1.</li> <li>3. Monitor to see if the source is indeed the water feature.</li> <li>4. Inspect all plumbing components, associated with the water feature to assure that all are performing and not leaking.</li> <li>5. Flood water feature basin, and monitor for potential leaks.</li> <li>6. Once the source is identified, consult with a 3rd party for scope of repair and specifications. (PFCS can assist in the further analysis, testing, and specifications for repairs in order to assure future performance).</li> </ol>

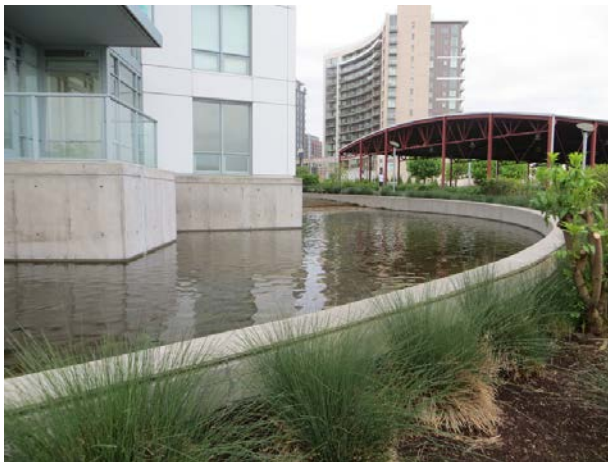
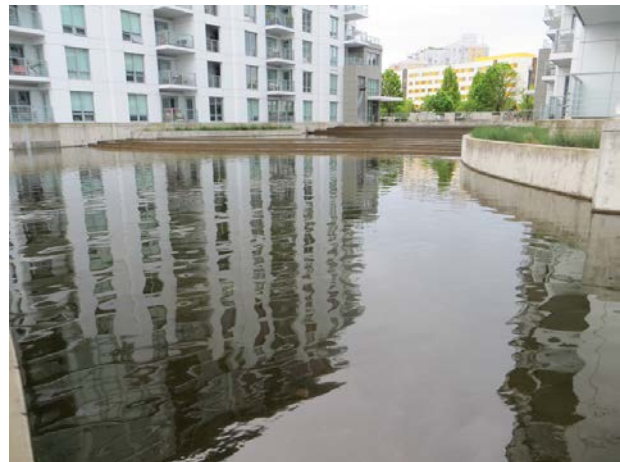
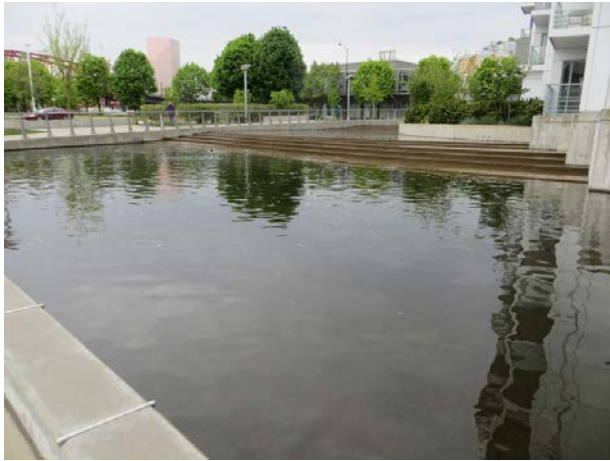
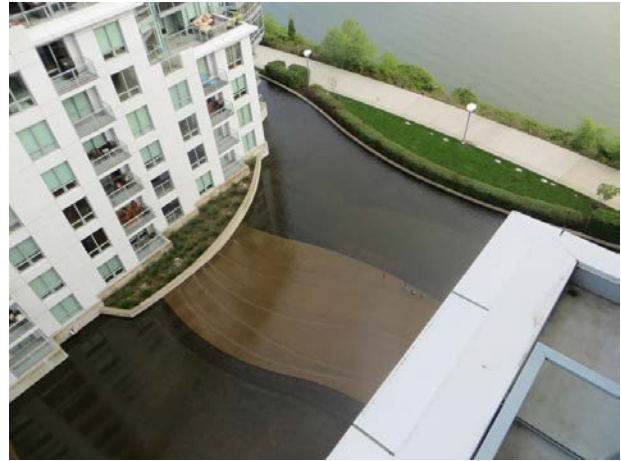
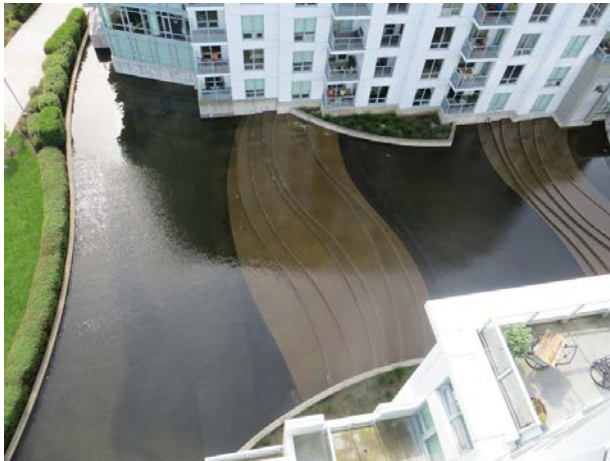
Issue	Inspect for leaks.
Investigation	Visual inspections.
Analysis	Exterior water feature is well maintained, free of moss, and overall in good condition. PFCS inspected all subterranean areas and no leaks were detected. Some cracks were noted within the water feature, noticeable from views above, however they appear to be at the top surface with no impact onto the waterproofing system.
Conclusion	No repairs recommended. Continue maintenance program. annual inspections of the subterranean levels for leak detections is crucial in order to assure long term performance and identify issues early, if any arise.
Costs

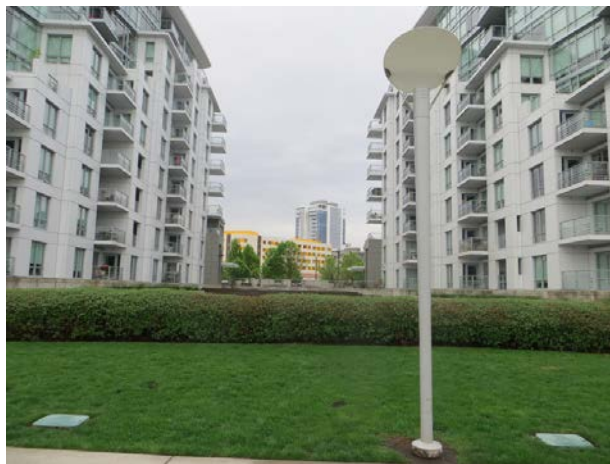
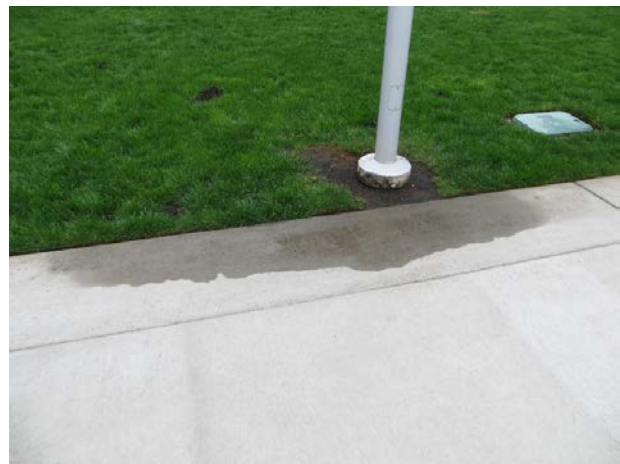
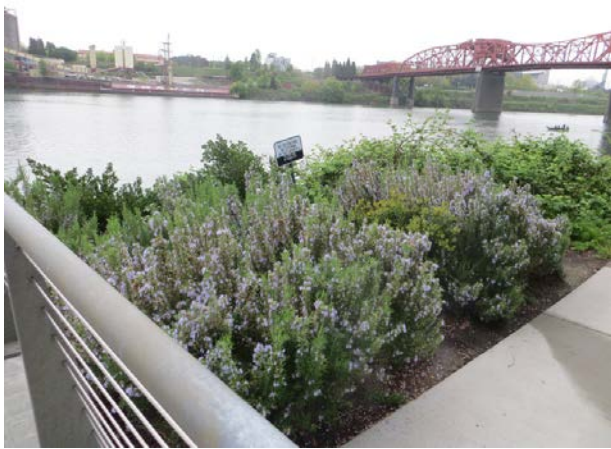
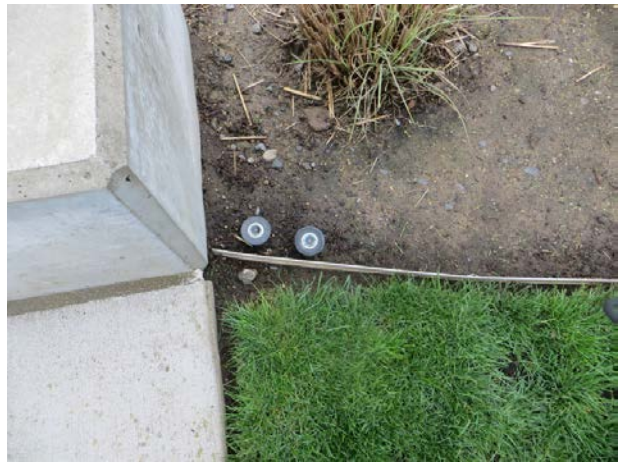
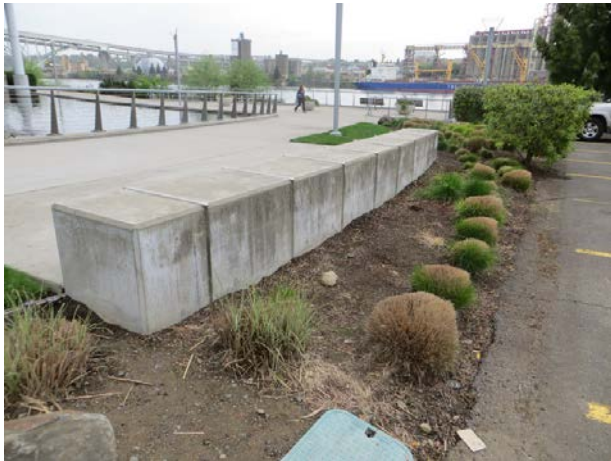
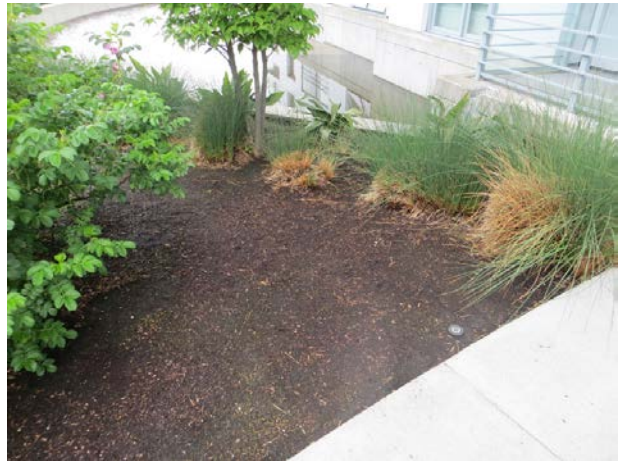
Issue	Inspect for over saturated areas, landscape against structures, and broken irrigation components.
Investigation	Visual inspections.
Analysis	Irrigation adjustments recommended for isolated areas. In general, landscaping is in very good condition. Continue current maintenance program.
Conclusion	Recommendations: 1. Adjust irrigation / turn-off at North elevation of Building A, due to water intrusion below and a constant heavily saturated condition 2. Adjust irrigation along Riverwalk in order to avoid irrigation spill over onto concrete pedestrian pathways
Costs

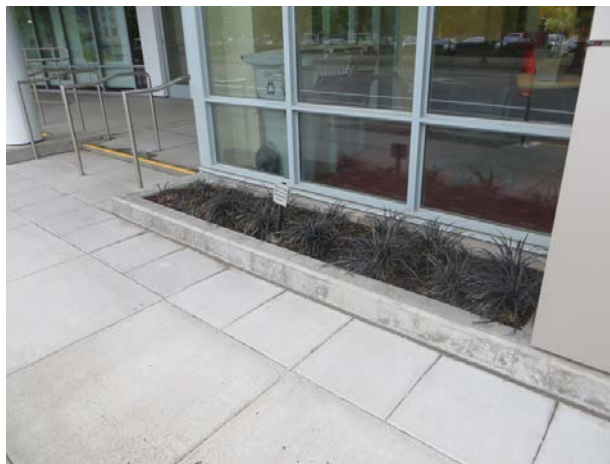
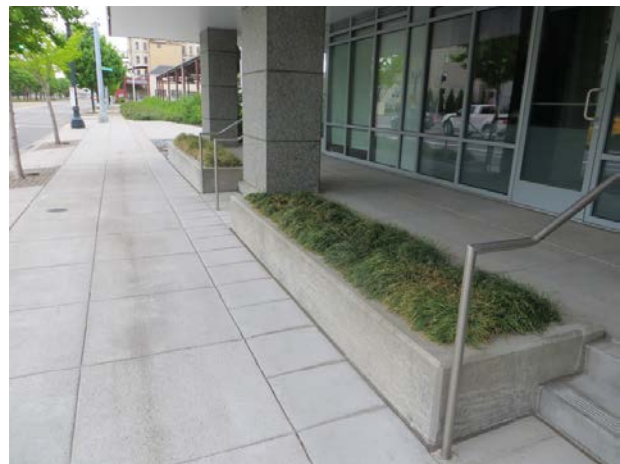
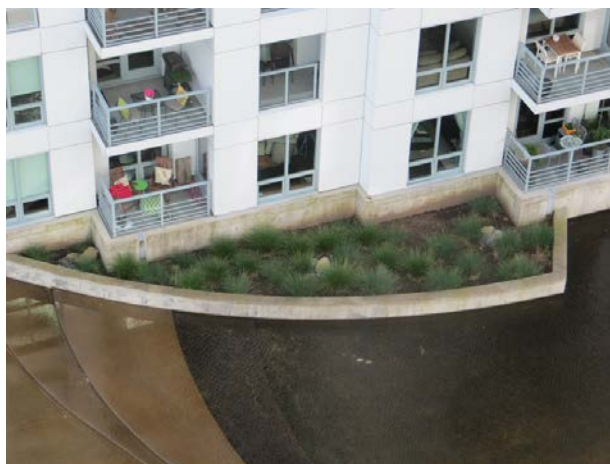
Issue	Inspect for signs of leaks and waterproofing details.
Investigation	Visual inspections.
Analysis	Concrete planters at front elevations. No signs of waterproofing failures. Concrete planters have local weather tolerant plants that require limited water source.
Conclusion	No repairs recommended.
Costs

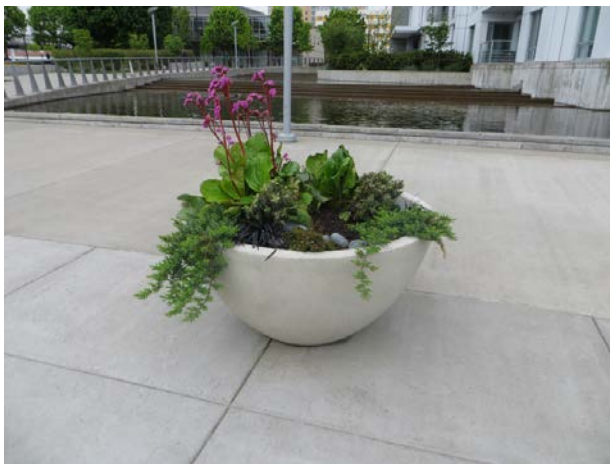
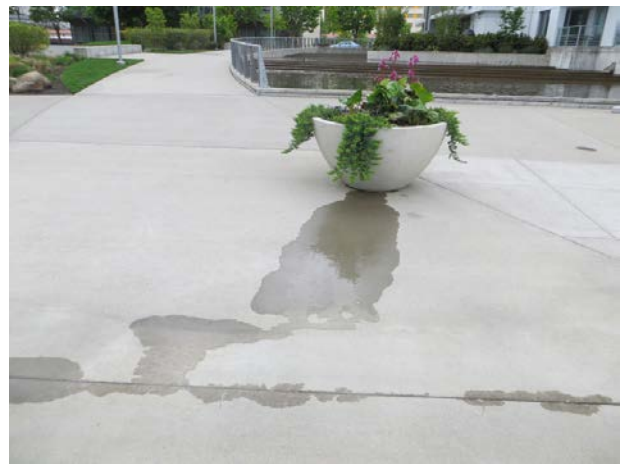
Issue	Inspect for leaks
Investigation	Visual inspections
Analysis	PFCS noted a few pots that had excess irrigation.
Conclusion	Consider adjusting irrigation in order to avoid discharge onto concrete pedestrian surfaces.
Costs

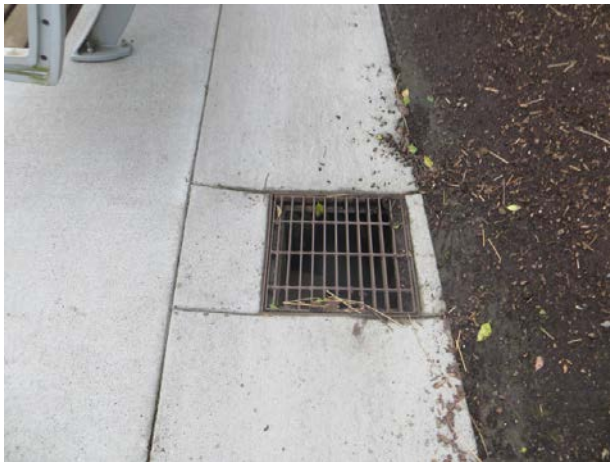
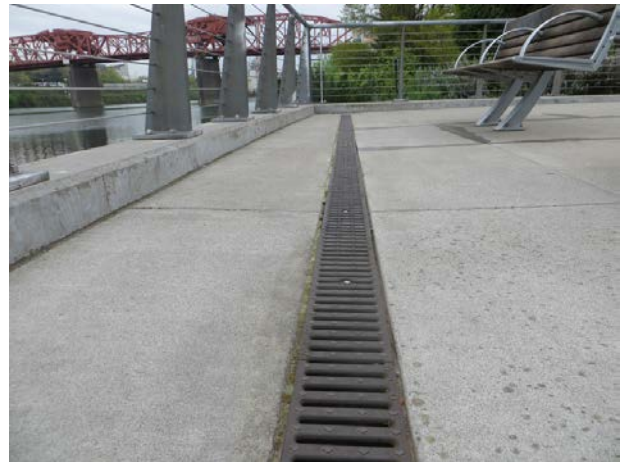
Issue	Inspect for standing water or negative slope conditions.
Investigation	Visual inspections.
Analysis	PFCS observed all drainage to be adequate and no standing water was observed throughout the property. A few locations along the Riverwalk indicated excessive irrigation, therefore it is recommended for irrigation to be adjusted. North elevation of Building-A also has excessive wet conditions at the grade level, which is recommended for irrigation adjustment, due to water intrusion below (see section A1010).
Conclusion	Consider irrigation adjustment in order to avoid water discharge onto pedestrian sidewalks.
Costs

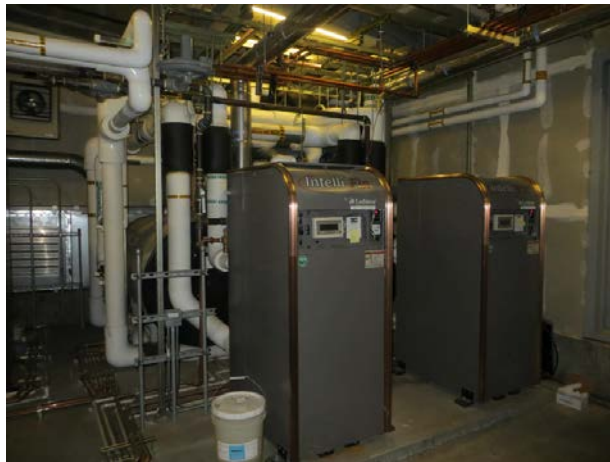
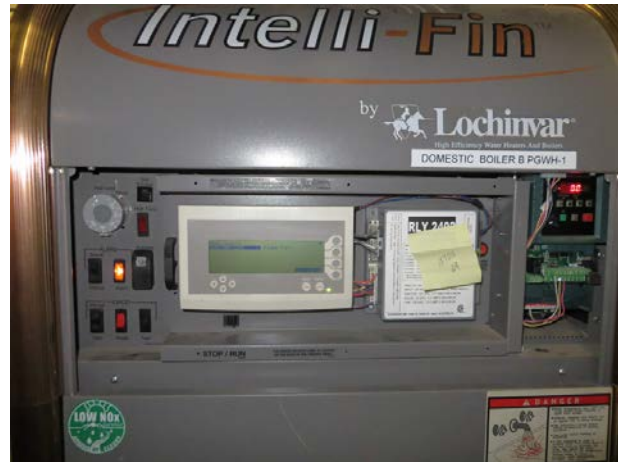
Issue	Identify leaks (if any), confirm type of equipment and maintenance
Investigation	Visual inspections
Analysis	<p>The building has municipal water supplied by copper and PVC water piping and cast iron sewer and storm drain. There are (2) Lochinvar high efficiency domestic boilers per building. Access panels and unit shut-off valves were noted in hallways where water is distributed to individual units. The domestic water pressure is unknown, however was not mentioned as a problem during the walk-through and interviews.</p> <p>The installed systems appear well suited to the needs of the buildings. No leaks, corrosion, galvanic action, or pipe deterioration was noted by PFCS. Roof surface drainage is integrated into the exterior pond feature and no back ups or evidence of such problems was observed.</p>
Conclusion	No repairs recommended, continue to service system as needed
Costs

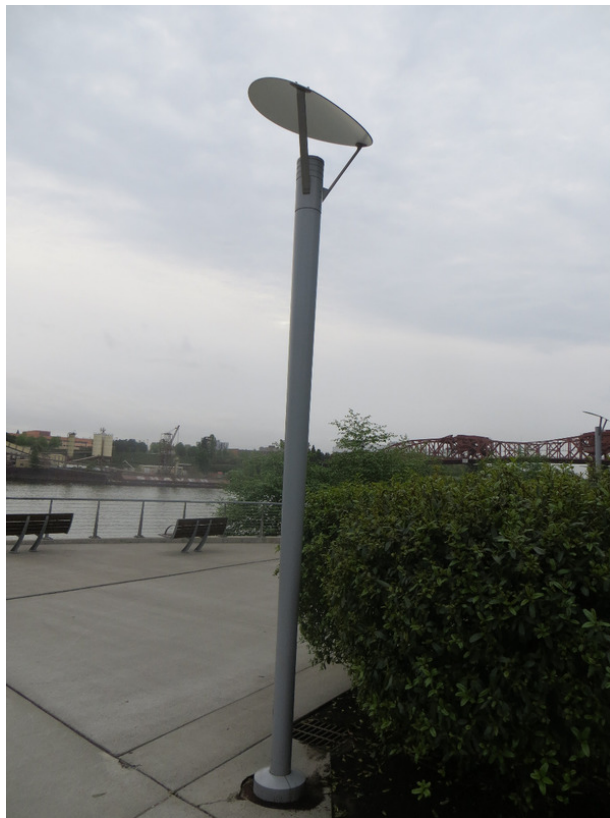
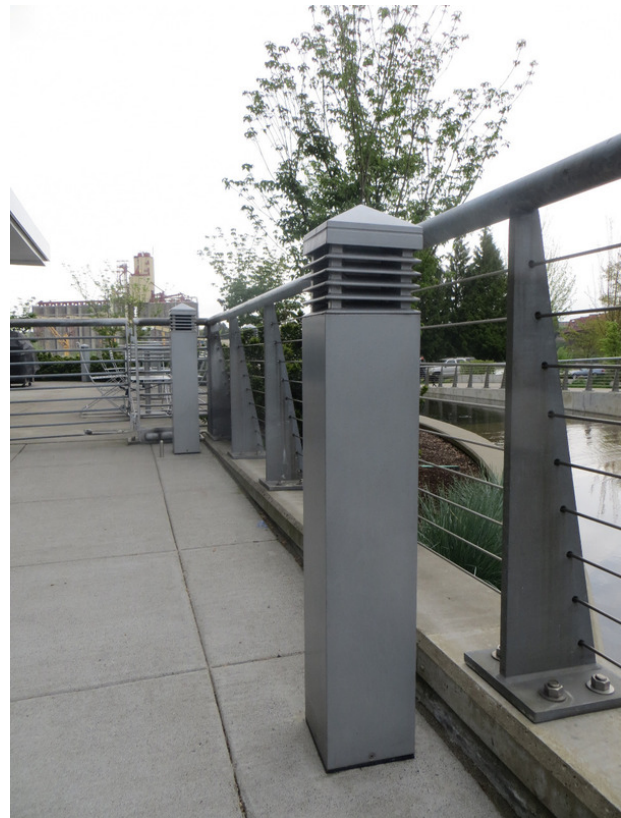
Issue	Verify that site lighting is functional and sufficient in order to promote night safety. Also see Element D5020.
Investigation	Visual inspections during daytime hours only.
Analysis	PFCS did not inspect the site at night however numerous types of lighting was noted. Street lighting at front elevations, walkway lighting along pedestrian pathways (Riverwalk), bollard pedestrian lighting, surface lighting at building entries, and landscape lighting throughout.
Conclusion	No repairs recommended, maintain all light fixtures.
Costs

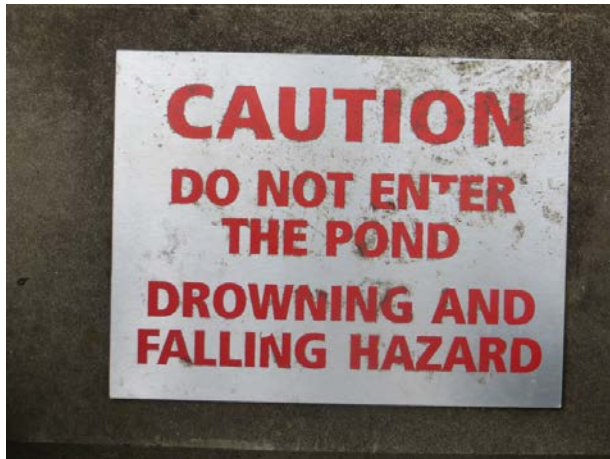
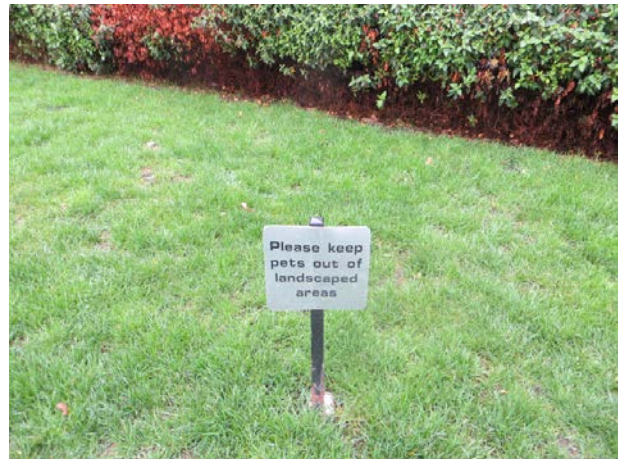
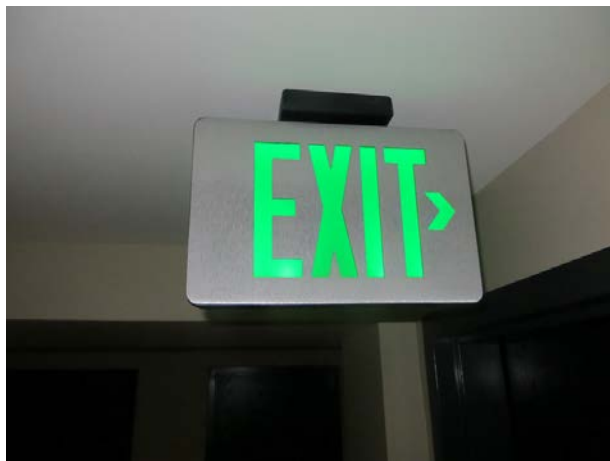
Issue	Verify directional signage is adequate and room identifications.
Investigation	Visual inspections.
Analysis	All directional signage within garages was clear and highly visible. Directional signage was adequate and straight forward. All additional signage throughout the buildings was noted as in good condition and with clear understanding of meaning.
Conclusion	No repairs recommended.
Costs
