Construction Defect Litigation from the Plaintiff Perspective

Construction Defect Litigation from the Plaintiff Perspective is a series of case studies in successful planning, analysis and execution of expert work on behalf of plaintiff real property owners. This program will walk you through the process, standards and reasoning for inspection, analysis, testing, reporting, specifying repairs, and estimating costs of the repair work.

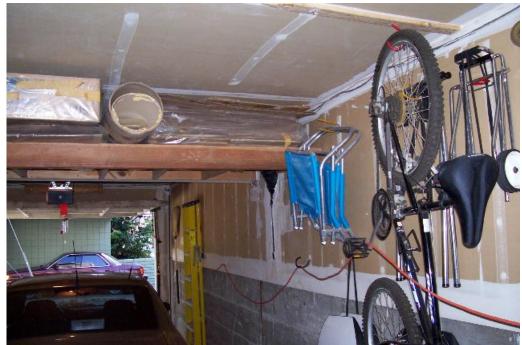
PF 01.326 PF 01-326.jpg Garage: unit C garage - water damage at ceiling and walls. Lots of water per owner.

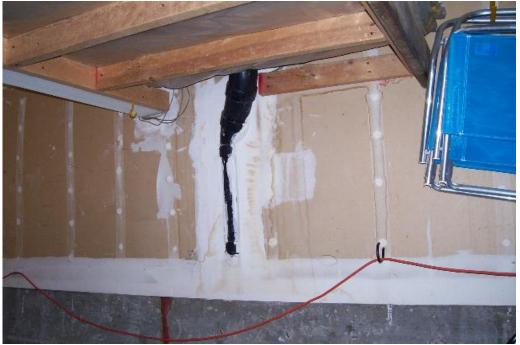
PF 01.327 PF 01- 327.jpg Garage: unit C garage - water damage at ceiling and walls. Lots of water per owner.

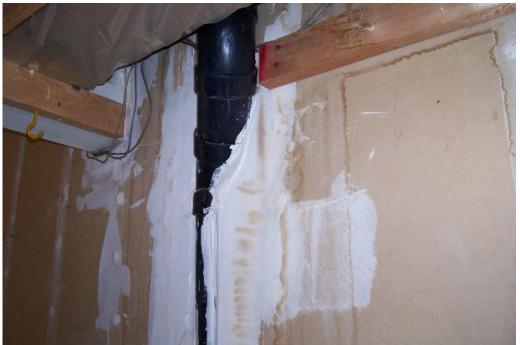
PF 01.328 PF 01-328.jpg Garage: unit C garage - water damage at ceiling and walls. Lots of water per owner.

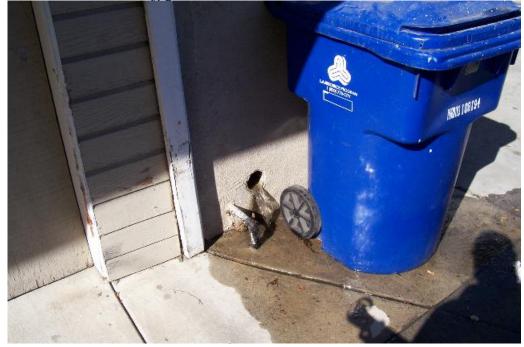
PF 01.336 PF 01-336.jpg

Back left elevation: drain is flowing, probably from testing that is continuing over left side of building and roof.

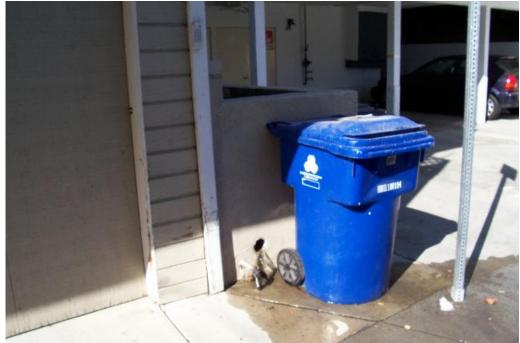
PF 01.337 PF 01-337.jpg

Back left elevation: drain is flowing, probably from testing that is continuing over left side of building and roof.

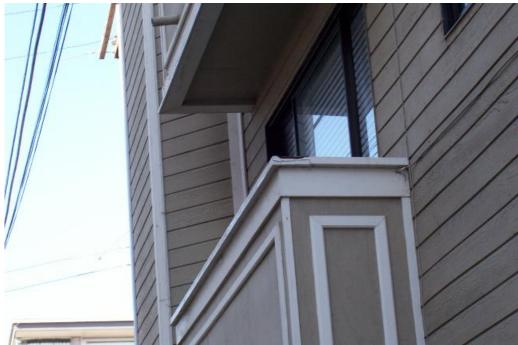
PF 01.343 PF 01-343.jpg

Right elevation: trim at planter on level 2 with deteriorated trim.

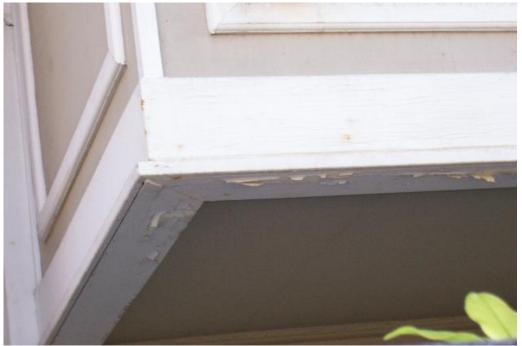
PF 01.349 PF 01- 349.jpg

Front elevation: trim on level 2 deck on left in poor condition.

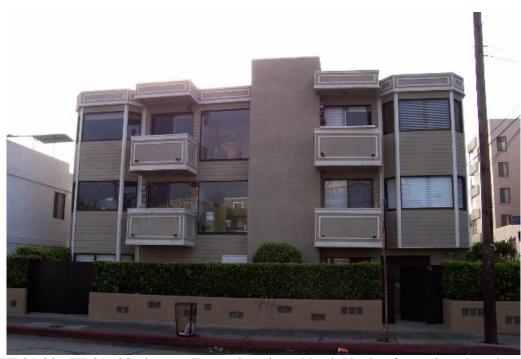
PF 01.006 PF 01- 006.jpg

Front elevation: North Venice front elevation shot. Three floors (above grade), flat roof, wood siding and stucco walls. There are four balcony decks on front elevation, each with two scuppers.

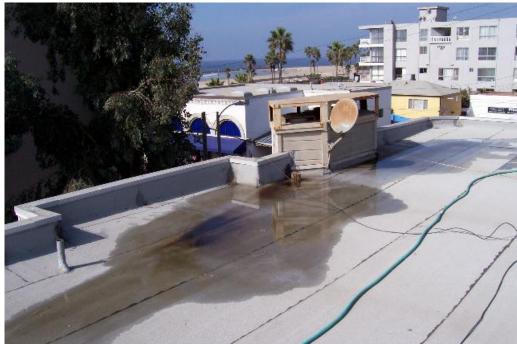
PF 01.135 PF 01- 135.jpg Roof test A: water is ponding around drain at right elevation near chimney.

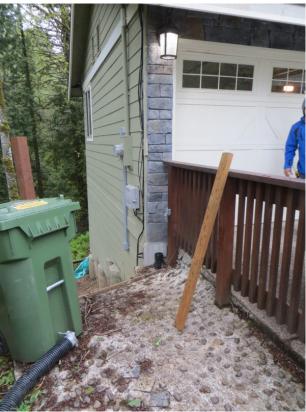
AP-02.207; Elevation Front; Garage left portal, removal of masonry at base of wall / interface to concrete footing.

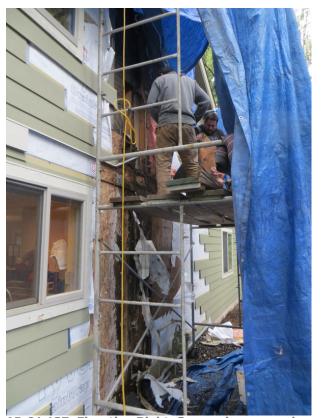
AP-01.137; Elevation Right; Severe damage and active water intrusion event. Source of water intrusion at roof-to-wall interface / lack of diverter flashings / failed condition at roof assembly / failed condition at siding components.

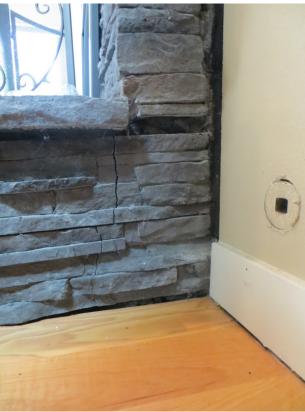
AP-02.045; Living Room; Excessive settlement of veneer surround

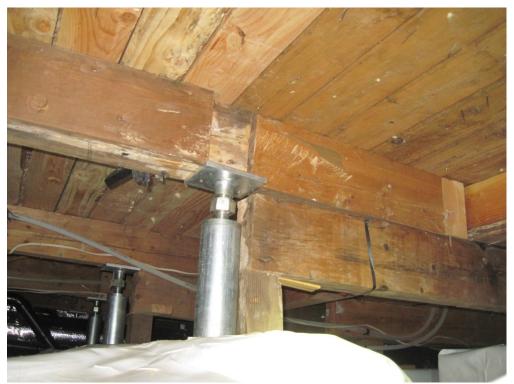
Photograph 8: Main level floor support at crawlspace below foyer

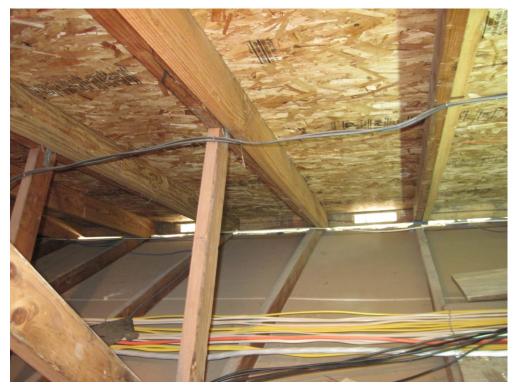
Photograph 9: Garage attic truss web members removed

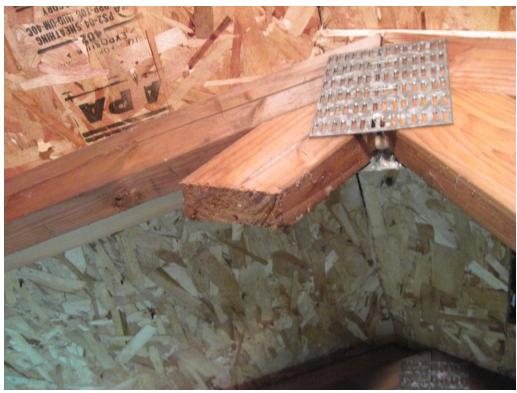
Photograph 10: Attic truss with web members removed

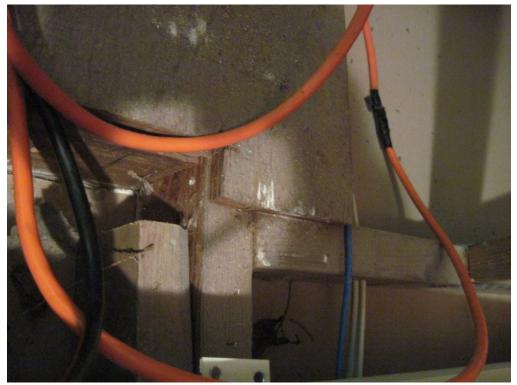
Photograph 11: Attic truss with discontinuous bottom chord

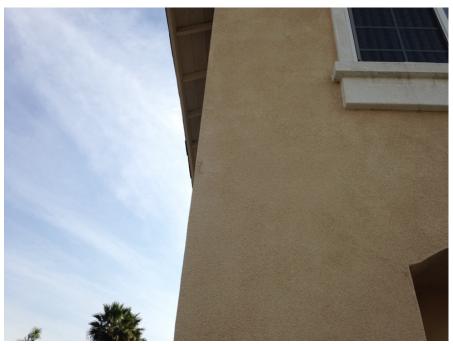
B2011 A.: EXCESSIVE STUCCO CRACKING

PV-01.197; 12/11/2014; B4; Elevation Left; Stucco crack

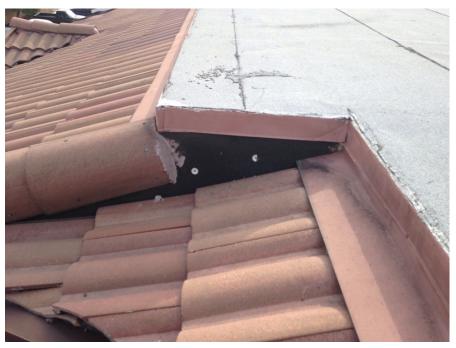
B2011 B.: MISSING CLADDING ON WALL

PV-01.092; 12/11/2014; B7; Roof; No flashing/ cladding

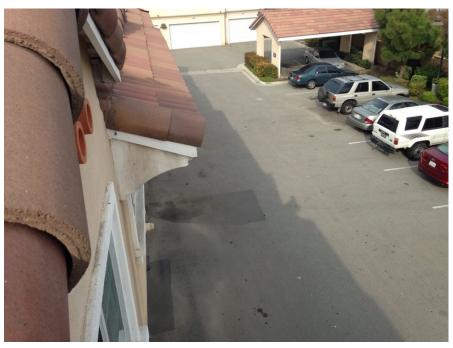
B2011 C.: STAINED STUCCO DUE TO UNCONTROLLED ROOF RUN OFF

PV-01.095; 12/11/2014; B7; Roof - Sloped; Above wall stain

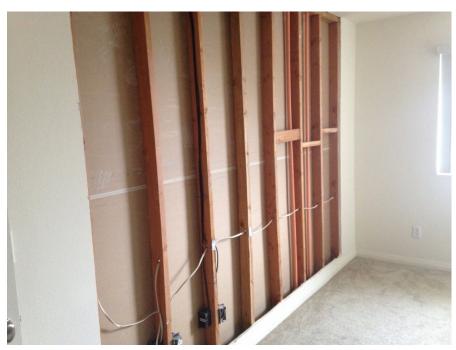
B3001 A.: WATER INTRUSION FROM ROOF ASSEMBLY

PV-01.014; 12/11/2014; B6/632; Bedroom 2; Overview

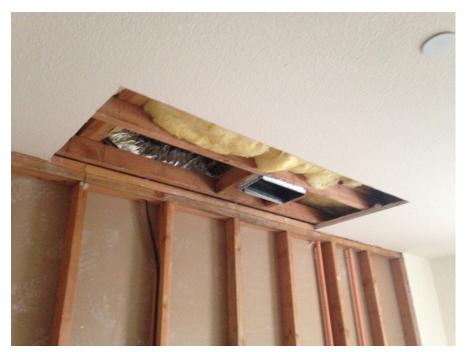
PV-01.015; 12/11/2014; B6/632; Bedroom 2; Overview

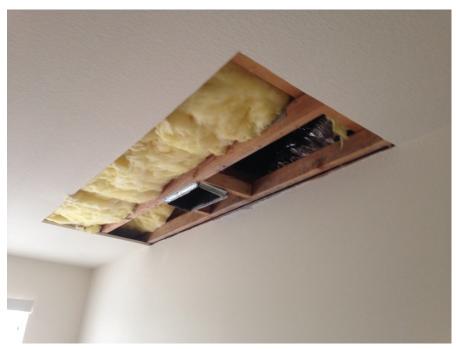
PV-01.023; 12/11/2014; B6/632; Bedroom 3; Ceiling

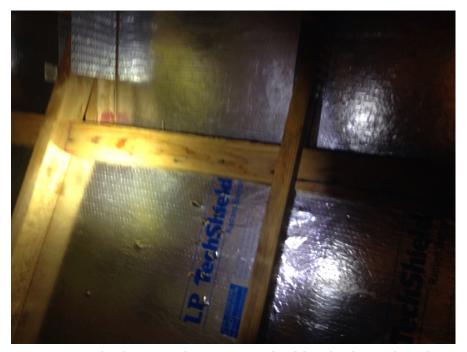
PV-01.036; 12/11/2014; B7/741; MBA; stained framing beneath roof

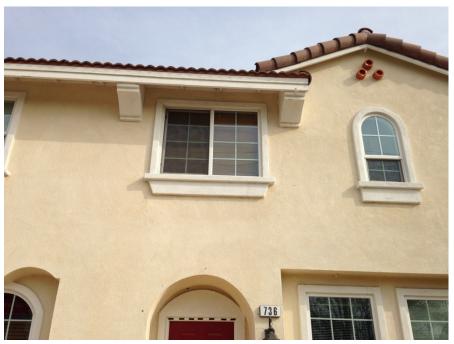
B3001 B.: MISSING DIVERTER FLASHING

PV-01.100; 12/11/2014; B7/736; Elevation Front; Valley drains over entry door

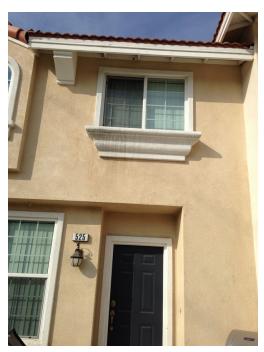
PV-01.193; 12/11/2014; B5/525; Roof - Sloped; No diverter over entry door

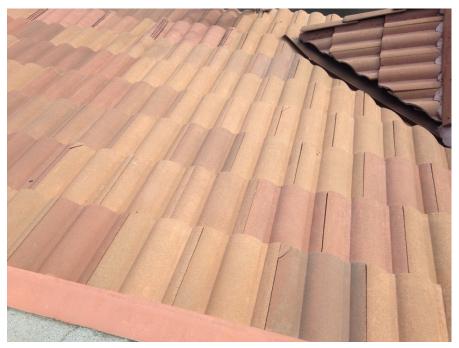
B3001 C.: BROKEN ROOF TILE

PV-01.131; 12/11/2014; B4; Roof - Sloped; Cracked tile corners

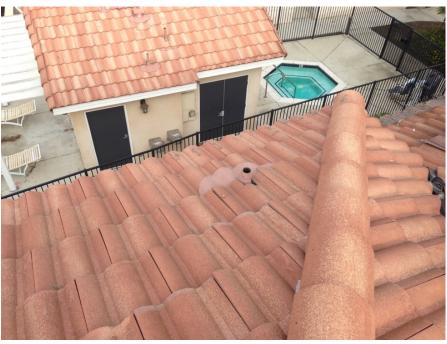
B3001 D.: INADEQUATE HEIGHT PLUMBING VENT

PV-01.044; 12/11/2014; B6; Roof - Sloped; Short vent

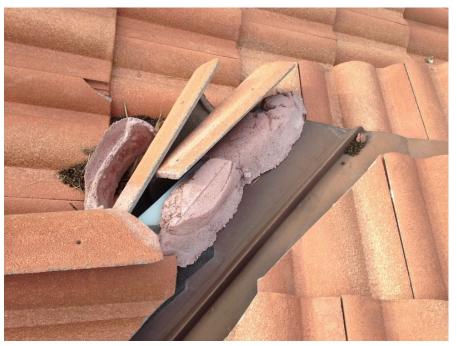
B3001 E.: LOOSE TRIM TILE USED AS DIVERTER

PV-01.045; 12/11/2014; B6; Roof - Sloped; Field fabricated diverter

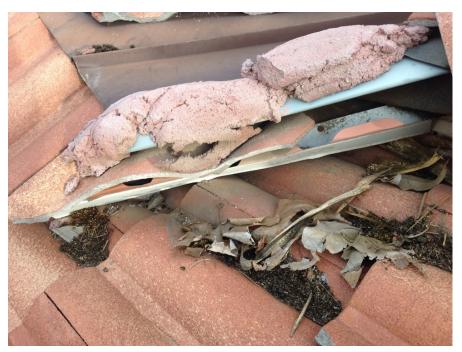
PV-01.046; 12/11/2014; B6; Roof - Sloped; Field fabricated diverter

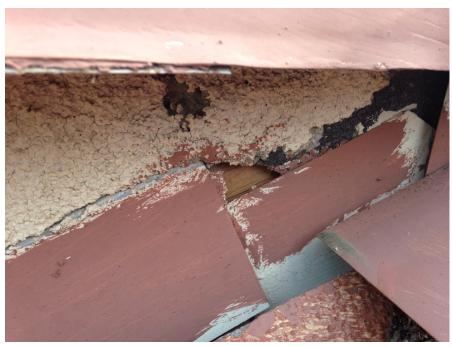
B3001 G.: VOIDS AT SHEET METAL FLASHING TO STUCCO WALL ASSEMBLY

PV-01.050; 12/11/2014; B6; Roof; Confined rake

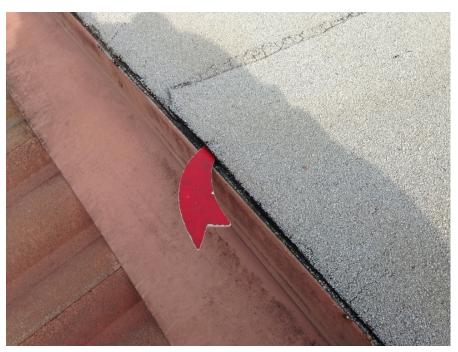
B3002 B.: MEMBRANE NOT ADHERED TO DRIP EDGE FLASHING

PV-01.087; 12/11/2014; B7; Roof; Membrane not sealed it drip edge

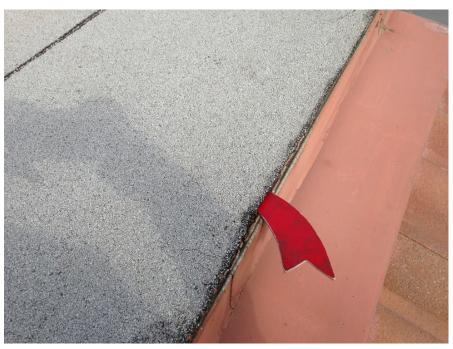
PV-01.118; 12/11/2014; B4; Roof; Membrane not sealed the drip edge

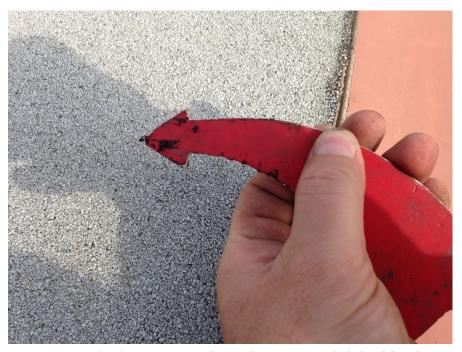
PV-01.119; 12/11/2014; B4; Roof; Membrane not sealed the drip edge

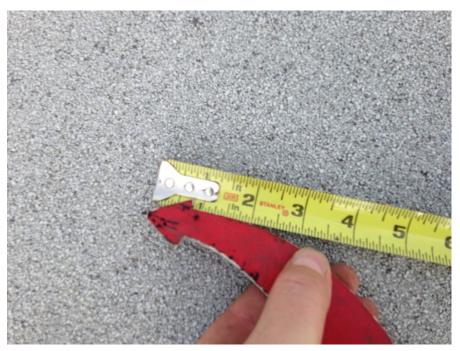
PV-01.120; 12/11/2014; B4; Roof; Membrane not sealed the drip edge

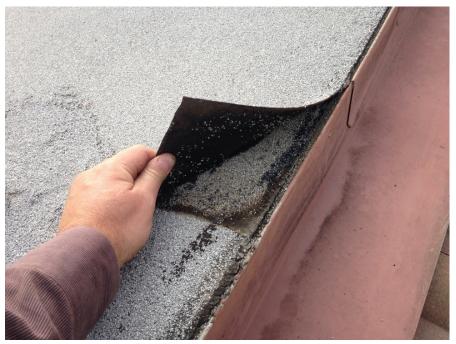
PV-01.139; 12/11/2014; B4; Roof; Membrane lap unsealed

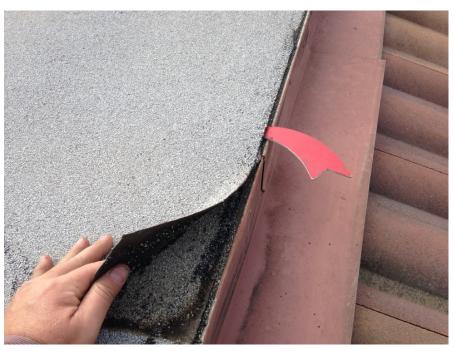
PV-01.140; 12/11/2014; B4; Roof; Membrane not sealed at drip edge

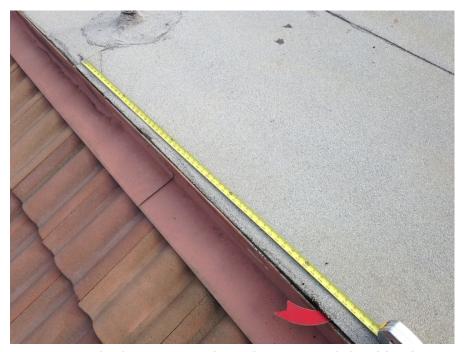
PV-01.143; 12/11/2014; B4; Roof; Membrane not sealed at drip edge

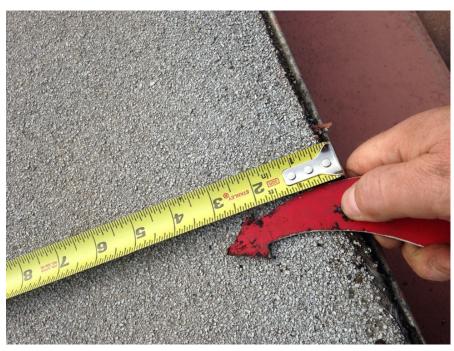
PV-01.144; 12/11/2014; B4; Roof; Membrane not sealed at drip edge

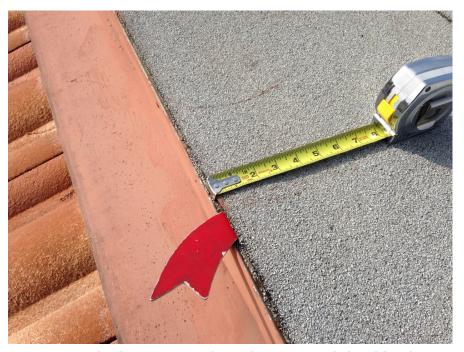
PV-01.171; 12/11/2014; B5; Roof; Membrane not sealed at drip edge

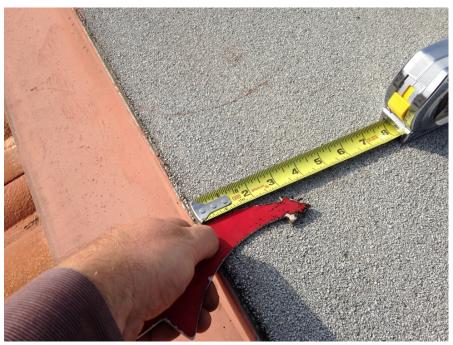
PV-01.172; 12/11/2014; B5; Roof; Membrane not sealed at drip edge

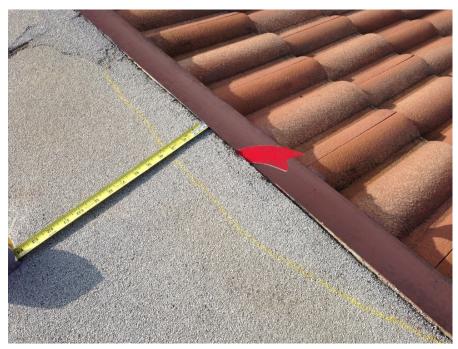
PV-01.186; 12/11/2014; B5; Roof; Membrane not sealed to drip edge at left

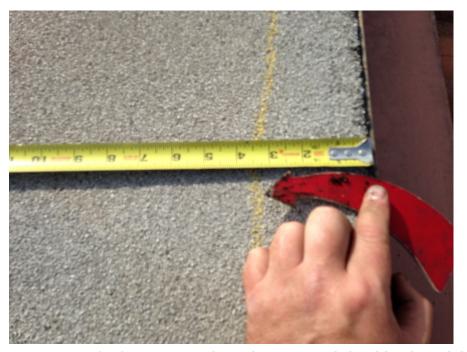
PV-01.187; 12/11/2014; B5; Roof; Membrane not sealed to drip edge at left

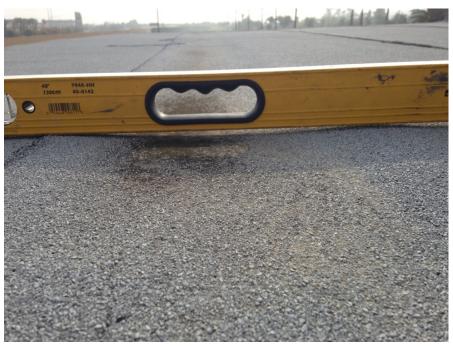
B3002 D.: PONDING ON ROOF MEMBRANE

PV-01.079; 12/11/2014; B7; Roof; Ponding

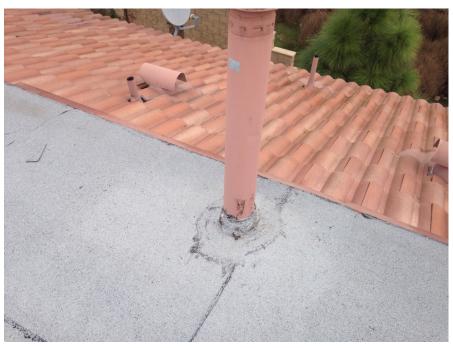
B3002 E.: STORM COLLARS NOT INSTALLED AT B-VENTS

PV-01.005; 12/11/2014; B6; Roof; No storm collar at b vent

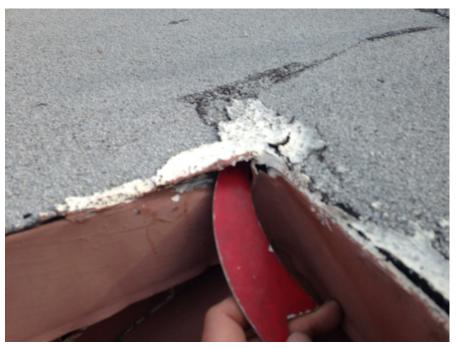
B3002 F.: VOIDS AT LOW SLOPE ROOF MEMBRANE TO SHEET METAL

PV-01.051; 12/11/2014; B6; Roof; Confined rake

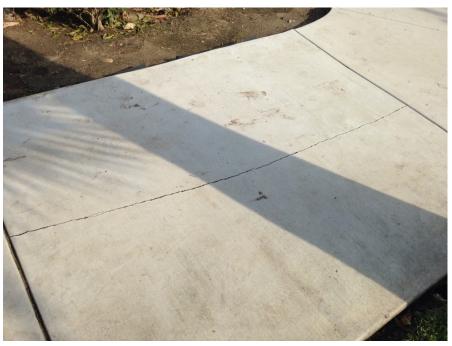
G2030 A.: EXCESSIVE CONCRETE CRACKING

PV-01.199; 12/11/2014; B6; Sidewalk; Concrete crack, at front

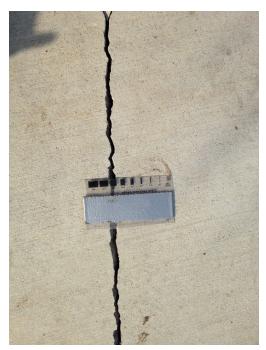
PV-01.200; 12/11/2014; B6; Sidewalk; Concrete crack, at front

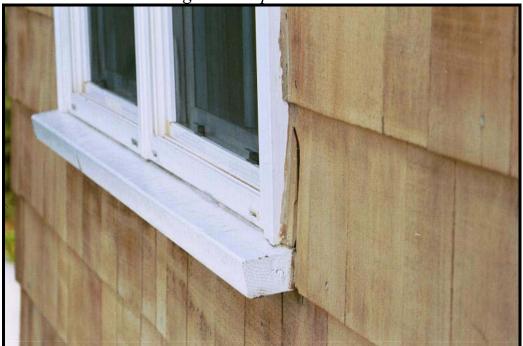
PF 10-03-03 jpg Siding is cracked and separating from window trim. Head flashing short at master bedroom – closet window.

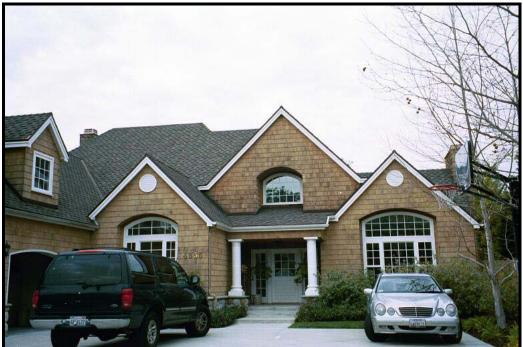
PF 10-35 -35 jpg

Overall at front elevation in general the residence appears to be significantly worse condition then when we first observed it. Siding looks worse, trim has deteriorated, gutters are more stained, flashing more rusted.

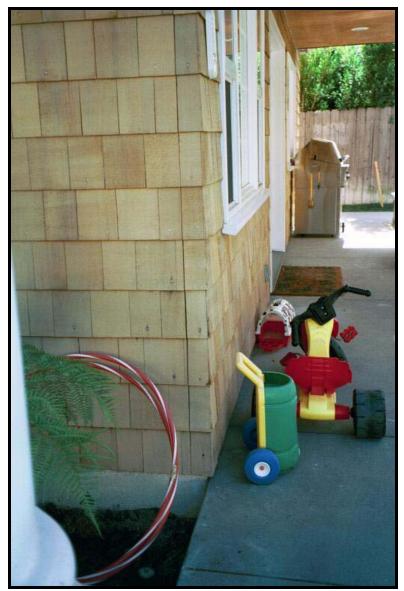
PF 02-21-045 jpg Line of siding at corner has a separation. Typical throughout.

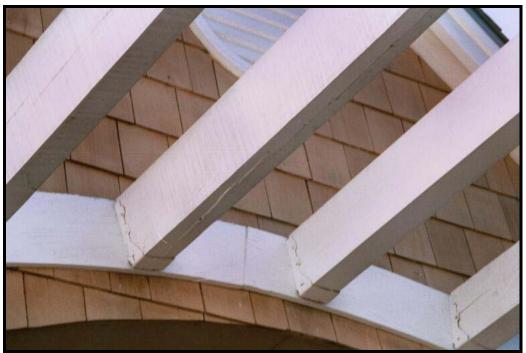
10.1.61	. 1 0 1	
<u>Analysis:</u>	12.1 Sheet metal flashing missing or short at siding to stone veneer		er
		on on exterior of residence.	
	12.2 Head fla	ashing at windows and doors has been cut short at	
	ends.

12.3 Head fla	ashing missing at decorative vent at front elevation	
		for trellises has been installed without adequate	
		at 2 ledgers at back elevation.	
	Trasining	at 2 leagers at ouck elevation.	
Possible Repairs:	The repair scope will be in context with other issues, including windows, siding, and masonry. See Section 9 "06-190 Exterior		
		es", Section 16 "08-500 Window and Installation	
		Section 7 "04-000 Masonry Issues". The trellis will	
		oval in conjunction with the siding removal. The trel	
		reinstalled with sheet metal flashing, integrated with	h
	weather res	stive barrier and siding.	
		22	
<u>PFCS Photos:</u>	Photo Ref.	Photo #	
	A B	PF 01-13	
	C	PF 01-17, PF 03-07, PF 06-24	
	D	PF 02-04 PF 01-19	
	E	PF 01-19	
	F	PF 02-12	
	G	PF 02-12, PF 03-02

PF 02-12-036 jpg Trellis without flashing. Curved plywood ledger applied over shingles. No flashing at decorative vent above.

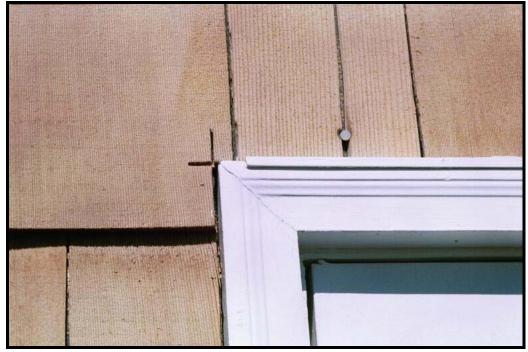
PF 03-07-055 jpg Head flashing does not cover door trim.

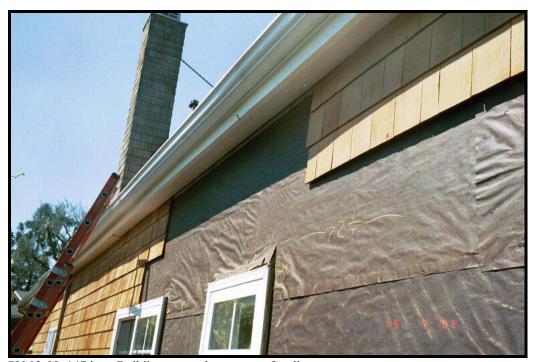
PV 03-09-147 jpg Building paper short at top of wall at eave.

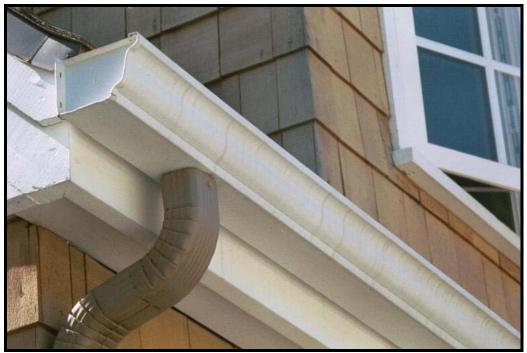
Issue Description:	14.1 Rain gutters are inadequately sized for this steep sloped roof	
Issue Locations:	Photo Ref.	Location
Issue Documons.	A	Front elevation, left elevation, rear elevation at kitchen
	В	Rear elevation at family room, left elevation, front elevation
Analysis:	At locations around exterior of residence the rain gutters are being overshot due to the pitch of the roof. The soffits show evidence of staining due to the overshooting of the rain gutters. This issue is contributing to the Section 9 "06-190 Exterior Siding Issues", Section 8 "06-170 Trim & Molding Issues" and Section 16 "08-500 Window and Installation Issues".	
Possible Repairs:	Remove and discard existing rain gutters. Install larger rain gutters to match.	
PFCS Photos:	Photo Ref	Photo #
TT CST NOTOS.	A	PF 01-15, PF 01-14, PF 02-20, PF 03-16, PF 03-17, PF 07-07, PF 07-08, PF 07-09
	В	PF 02-23, PF 03-16, PF 03-17, PF 01-16

PF 01-15-015 jpg Standard gutters are being over-shot by steep sloped roof.

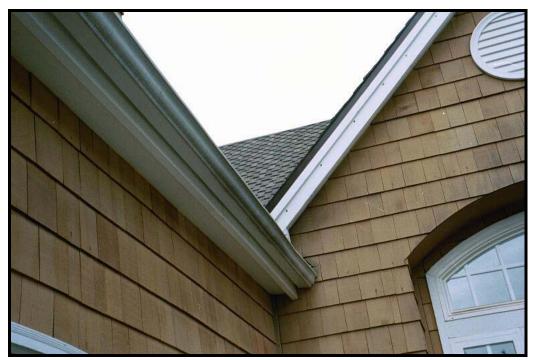
PF 10-29 -29 jpg

Rain gutters above drop a lot of water into this area.

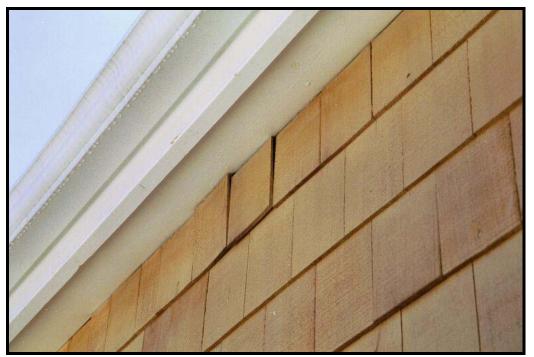
PF 07-09-033 jpg Siding installed in an un-workmanlike manner at garage nearest front elevation.

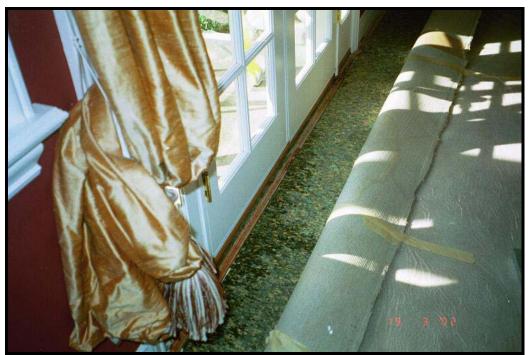
PV 04-10-173 jpg Carpet after four-minute spray test.

Possible Repairs:	Re-flash all doors in the context of the siding replacement in Section 9 "06-190 Exterior Siding Issues". This will involve removing the factory-installed stops, installation of flexible flashings and installation of new (pre-primed) stops. Install properly integrated sheet metal flashings at all doors. Those most susceptible to weather should have Jamb-Sill Guard sill pan installed between the foundation and the sill (this would require removal of entire unit and re-installation). Replace doors which are damaged with cracks and splits, or which leaked through product during testing (Living Room doors at back elevation). Install weather-stripping at all doors to create weather resistance. Coordinate with painting, as any cuts will require complete retreatment of painting as described below. Re-paint all wood doors and components on all wood surfaces (1 coat of primer before installation (i.e. back-prime) – no bare wood shall be installed, including all 6 sides of doors with 1-coat latex acrylic primer and 2 latex acrylic top coats of premium primer and paint.

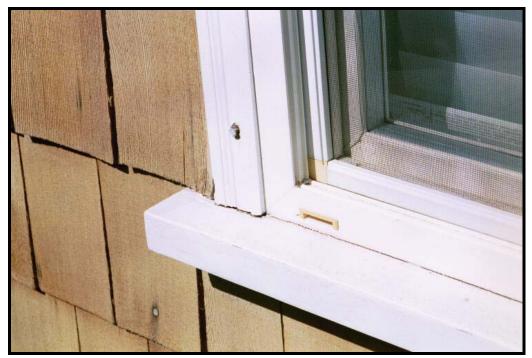
PF 03-12-060 jpg Window casing with popping nail and separation at sill.

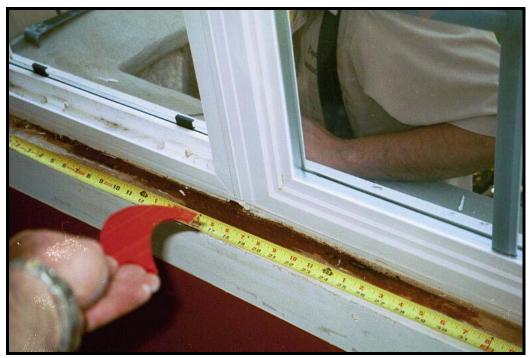
PF 07-23-047 jpg Left mullion - worst intrusion. Center of thirty-two inch wide completely soaked spot on rough sill.

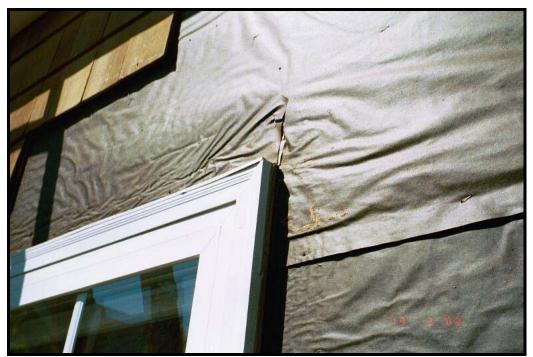
PV 03-14-152. jpg Guest bedroom window building paper cut for drip cap; sisal kraft cut clean through.

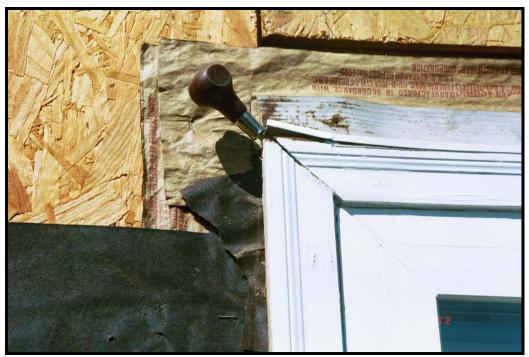
PV 03-17-155 jpg. Open joint at wood trim allows unimpeded awl penetration.

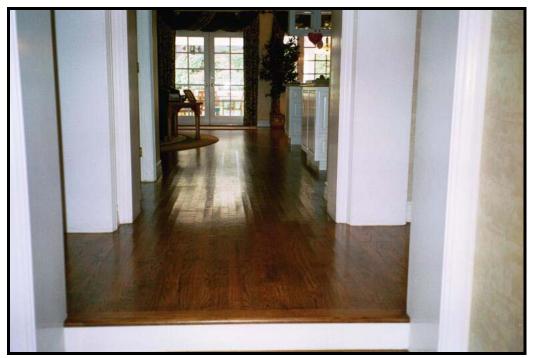
Issue Description:	18.1 Wood flooring is cupped. 18.2 Inadequate installation of vapor retarding system. 18.3 Un-workmanlike finish on wood floors.			
	18.3 Un-wo	rkmanlike finish on wood floors.		
Issue Locations:	Issue 18.1-3	Location Throughout kitchen – especially between kitchen and pantry.		
Analysis:	installe 18.2 Install standa 18.3 Evider on sur scratcl	 18.1 Wood flooring cupping at all downstairs locations where installed except at entry, due to elevated moisture. 18.2 Installed vapor retarding system does not conform to industry standards for installation of wood floor over concrete slab. 18.3 Evidence of sanding and finishing flaws and imperfections on surface of wood floor. Conditions including sanding scratches, machine marks, light hand prints, etc. exist throughout the surface of the wood floor. 		
Possible Repairs:	Issues" and Repair Opti 1. Rem floor spec 2. Rem syste tile, In the conte	Coordinate with repairs for Section 2 "00-164 Geotechnical Issues" and Section 4 "02-600 Drainage Issues". Repair Options: 1. Remove existing hardwood floor and install new hardwood floor over guaranteed vapor emission control system as specified by Donnelly. Replace all base boards. 2. Remove existing hardwood floor and install new flooring system less susceptible to damage by moisture (Granite tile, Tumbled limestone tile, etc.). In the context of these repairs the cabinets will need venting for the confined spaces at the toe kick level.

PF 04-17-089 jpg Flooring is cupped / lifting at edges across width of planks, especially between kitchen and pantry.

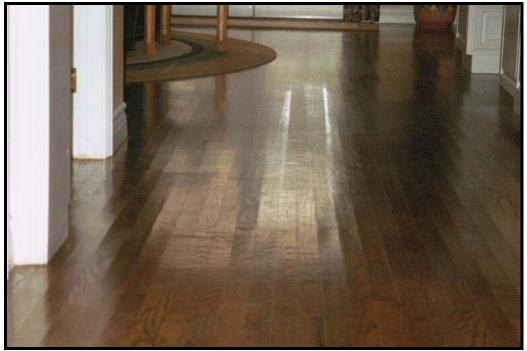
PF 04-18-090 jpg Flooring is cupped / lifting at edges across width of planks, especially between kitchen and pantry.

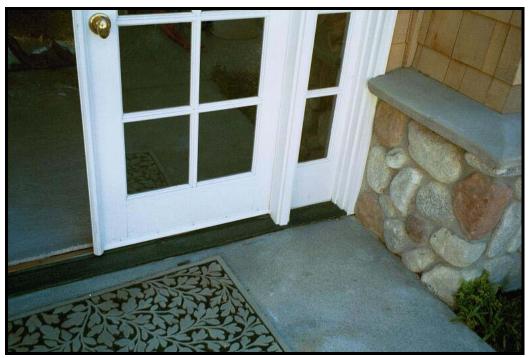
PF 06-14-014.jpg Exterior at French doors. Casing buried by masonry. Doors splitting.

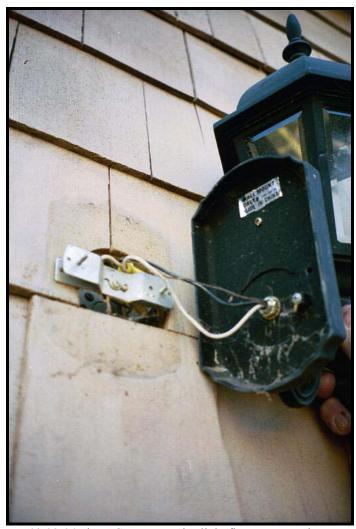
MP 02.09-045 jpg Garage exterior light fixture. No gasket or sealant. Typical all four.

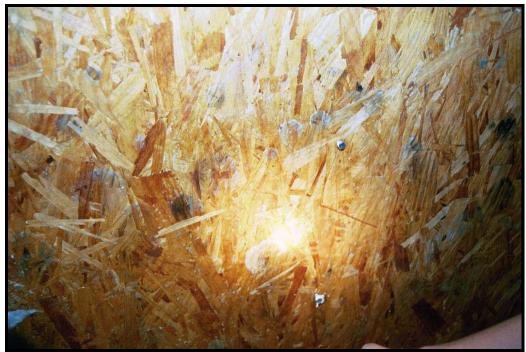
SB 03.25 JPG-96 Spots on OSB sheer panel in hall – hygienist Bancrof and Thinks it maybe mold.

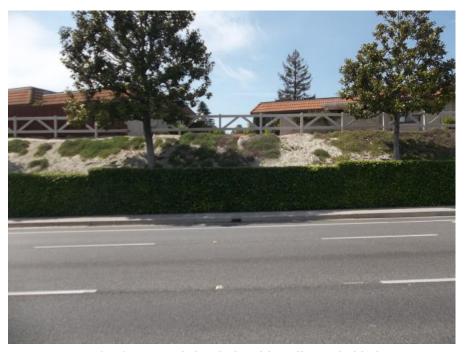
MP-01.111; 03/28/2013; 3rd slot drain with sediment behind.

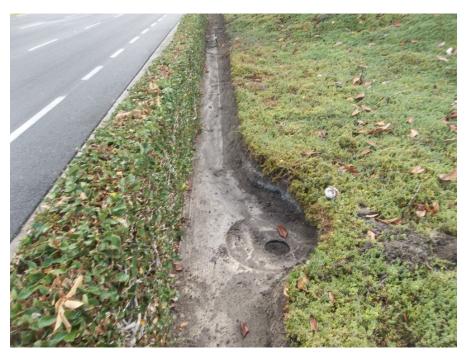
MP-02.012; 11/21/2013; Drain at low point on on left.

Pipe filled with mud. Looking south,

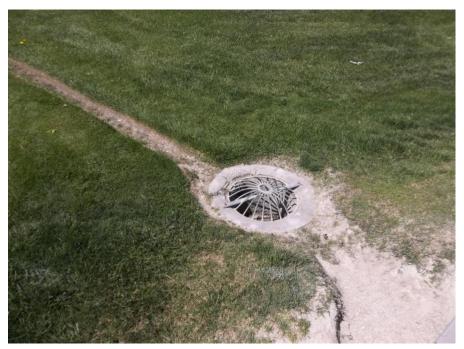
MP-01.052; 03/28/2013; Metal topped storm drain.

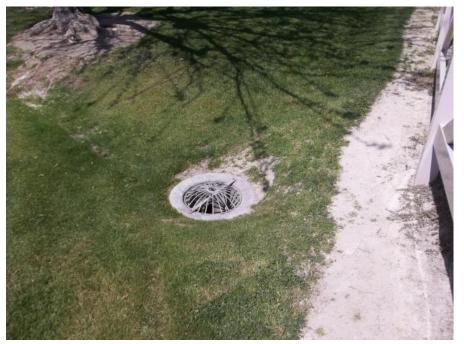
MP-01.057; 03/28/2013; Third metal drain cover.

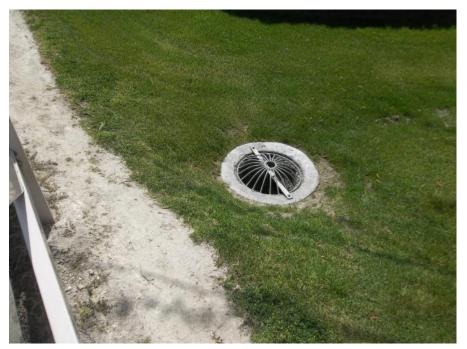
MP-01.084; 03/28/2013; Storm drain by 23463.

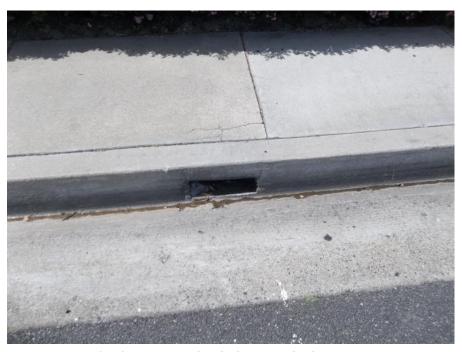
MP-01.103; 03/28/2013; 1rst slot drain to north, dry.
